Earthquake Reconnaissance: Guatemala, February 1976

D.H. Weichert
Division of Seismology & Geothermal Studies
Earth Physics Branch
Department of Energy, Mines & Resources
Ottawa, Ontario K1A 0Y3

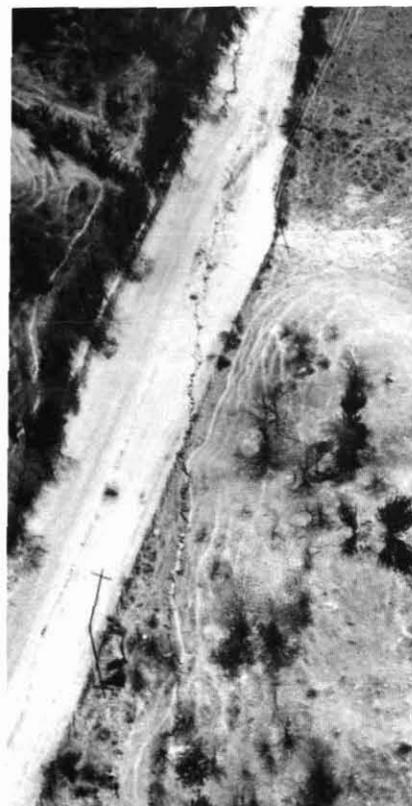
Figure 3

writer and some engineering colleagues found it difficult to convince themselves by air observation of the "continuity" of the fault trace in an area where our geologist friends had already established its existence. Figures 3 and 4 show examples of easily visible surface offset and cracking.

Faultbreak, easily visible as it crosses a dirt road, note the right-stepping en echelon pattern, which was generally observed.

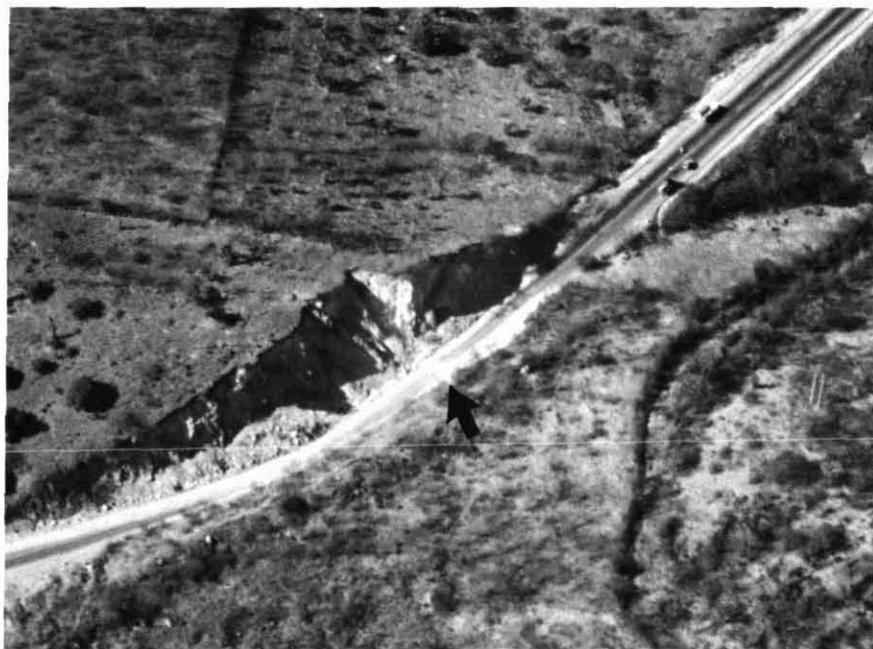
Figure 4

Road crossing of the fault, looking north. The far side has moved left, as confirmed by the offset in the white centerline of the road.

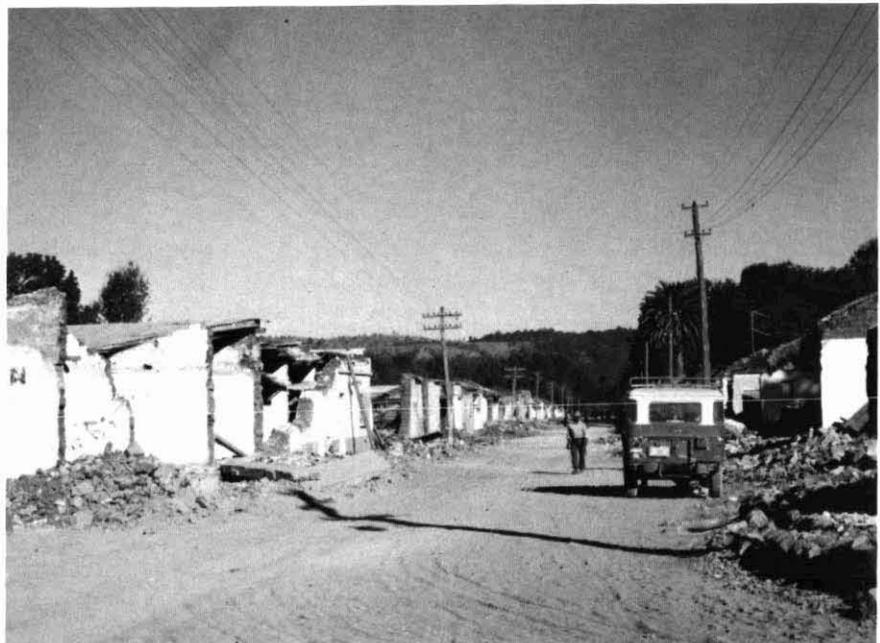
Figure 5
Chimaltenango: typical adobe damage, about 20 km from surface break.

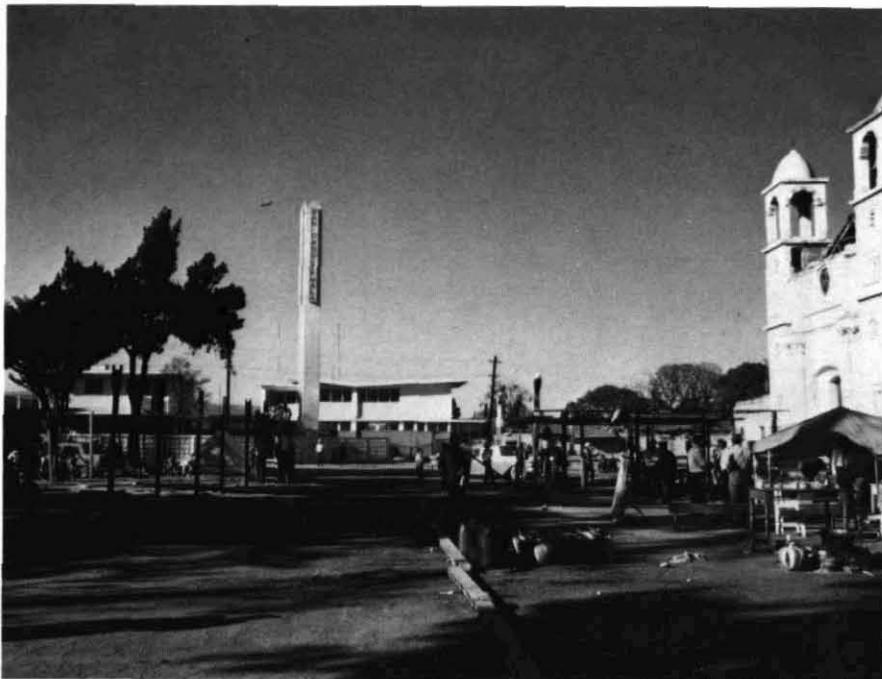
Figure 6
Chimaltenango: modern bank building and decorative brick wall remained standing.

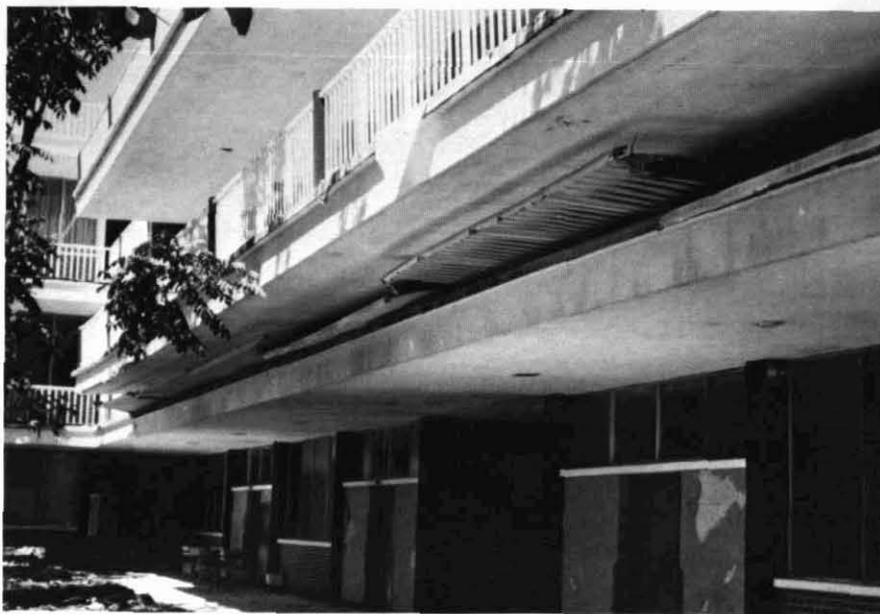
Complete collapse of heavy concrete canopies supported by rather fragile looking reinforced concrete columns was widespread, but not surprising. Collapses of engineered buildings were rare and usually attributable to doubtful design. Figure 7 shows a view of a collapsed second story of a school: it contained no shear walls. Collapse of some columns caused the Terminal Hotel to break in half. At the Camino Real Hotel, an unusual architectural effect was achieved by a supporting X-type outside frame. Here, many of the eastern legs in the ground floor were shattered

Figure 7
Collapsed second floor of a school in southeast Guatemala City, about 30 km from fault.
