Heritage Stone 3. Degradation Patterns of Stone Used in Historic Buildings in Brazil*

A.G. Costa

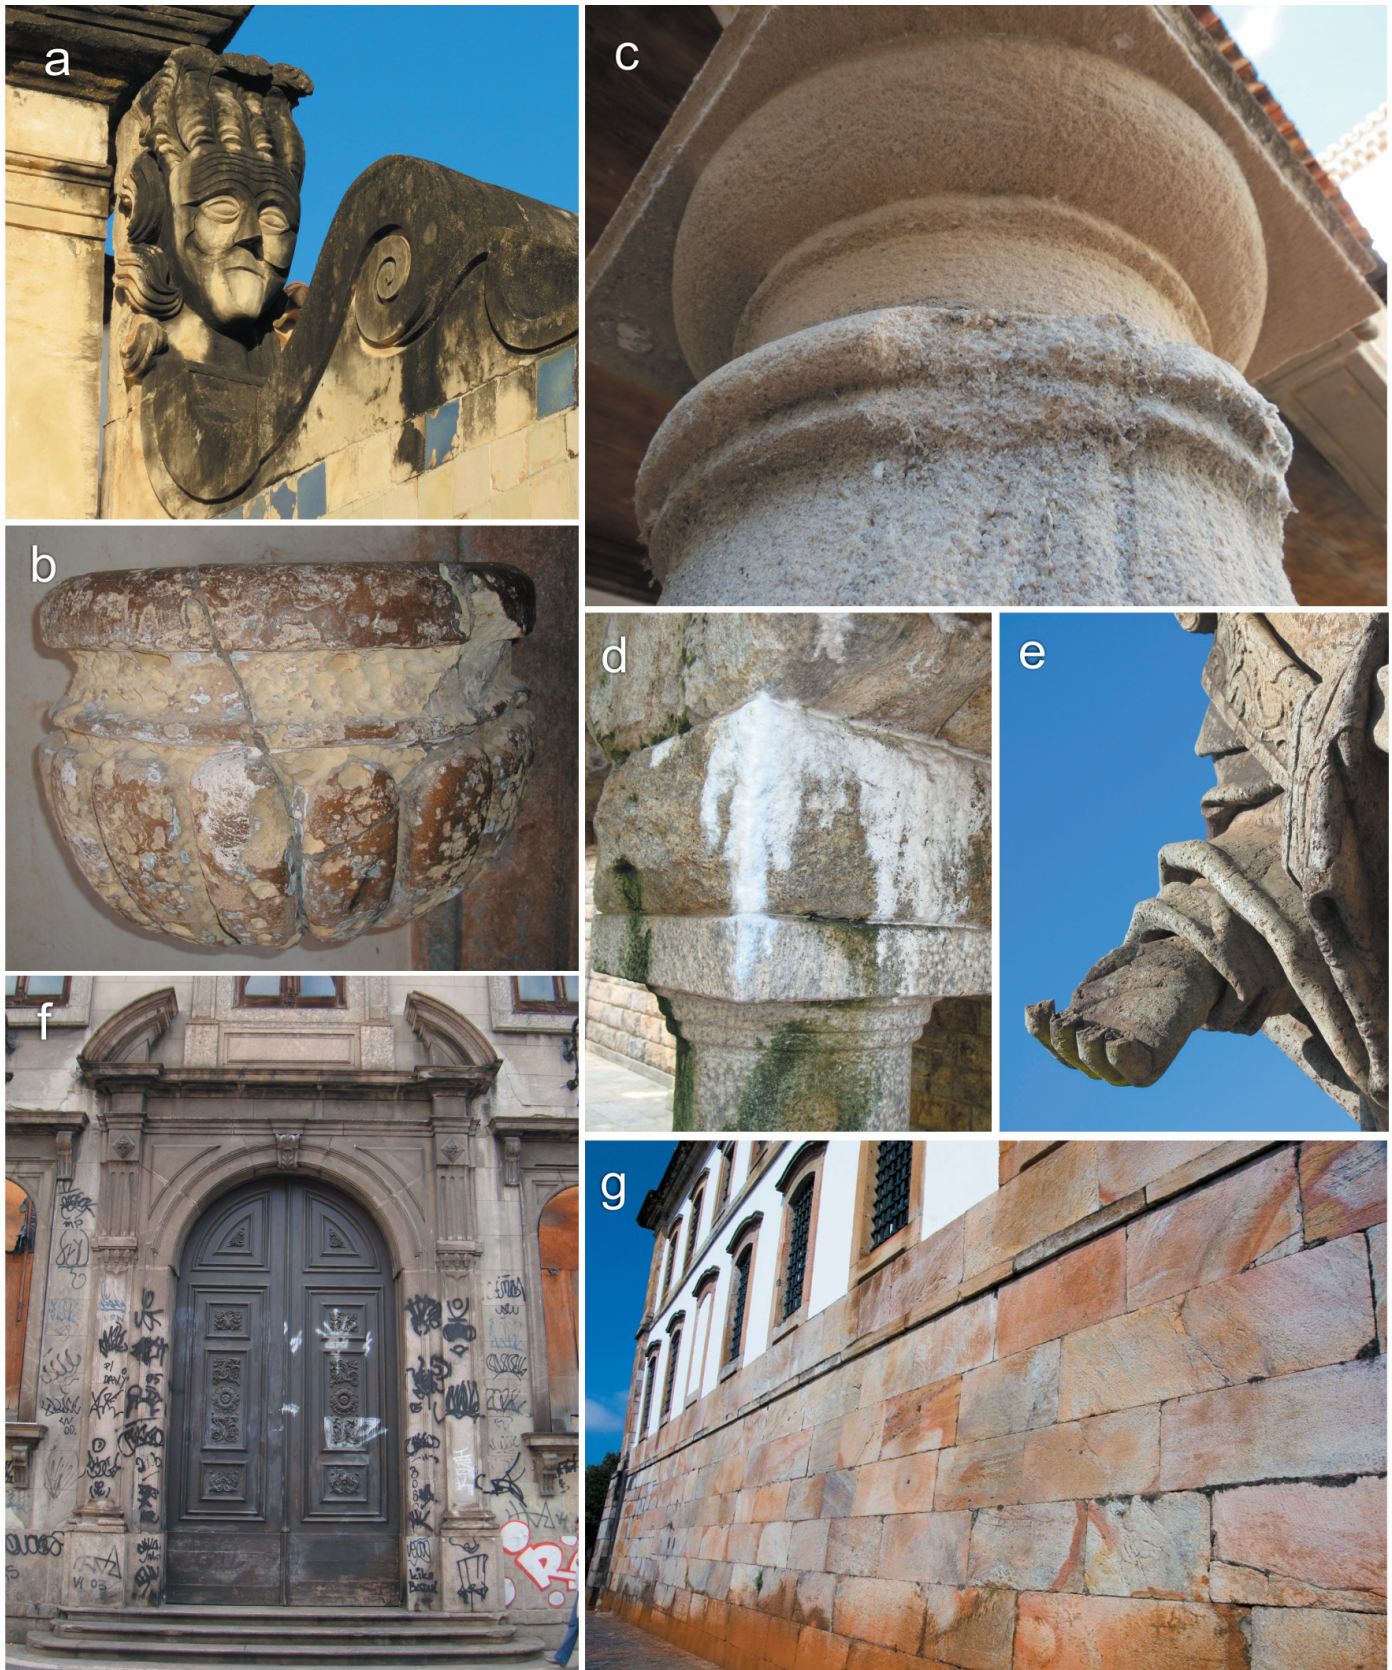
Figure 3. Examples of damage that attest to some of the processes responsible for decay or alteration of the stone in some historic monuments built in Brazil. a) Biological colonization and black crust on limestone in the São Francisco's Convent in João Pessoa (state of Paraíba); b) crack and alveolization of limestone in the Church of São Pedro dos Clérigos in Recife (Pernambuco); c) disintegration of calcarenite in São Francisco's Convent in João Pessoa (state of Paraíba); d) encrustation associated with gneiss in the Palacete Laje in Rio de Janeiro (state of Rio de Janeiro); e) missing part on one of the prophet statues at the Bom Jesus Sanctuary of Congonhas (state of Minas Gerais); f) graffiti on the Church of Santíssimo Sacramento in Rio de Janeiro (state of Rio de Janeiro); g) patina formed on quartzite in the old Chamber and Prison House in Ouro Preto (state of Minas Gerais).

cavities or alveoli formed on the rock surface have also been observed. Other degradation patterns were noted, such as fragmentation of the stone surface, blistering, presence of crusts associated with deposits of soot and dust (representing the accumulation of both foreign material and that produced by the rock itself), changes in colour, efflorescence, sub-efflorescence, encrustations interfering with surface morphology and with the colouration of the rocks involved, patinas, graffiti, and varying degrees of biological colonization by mold, lichen, algae and plants.

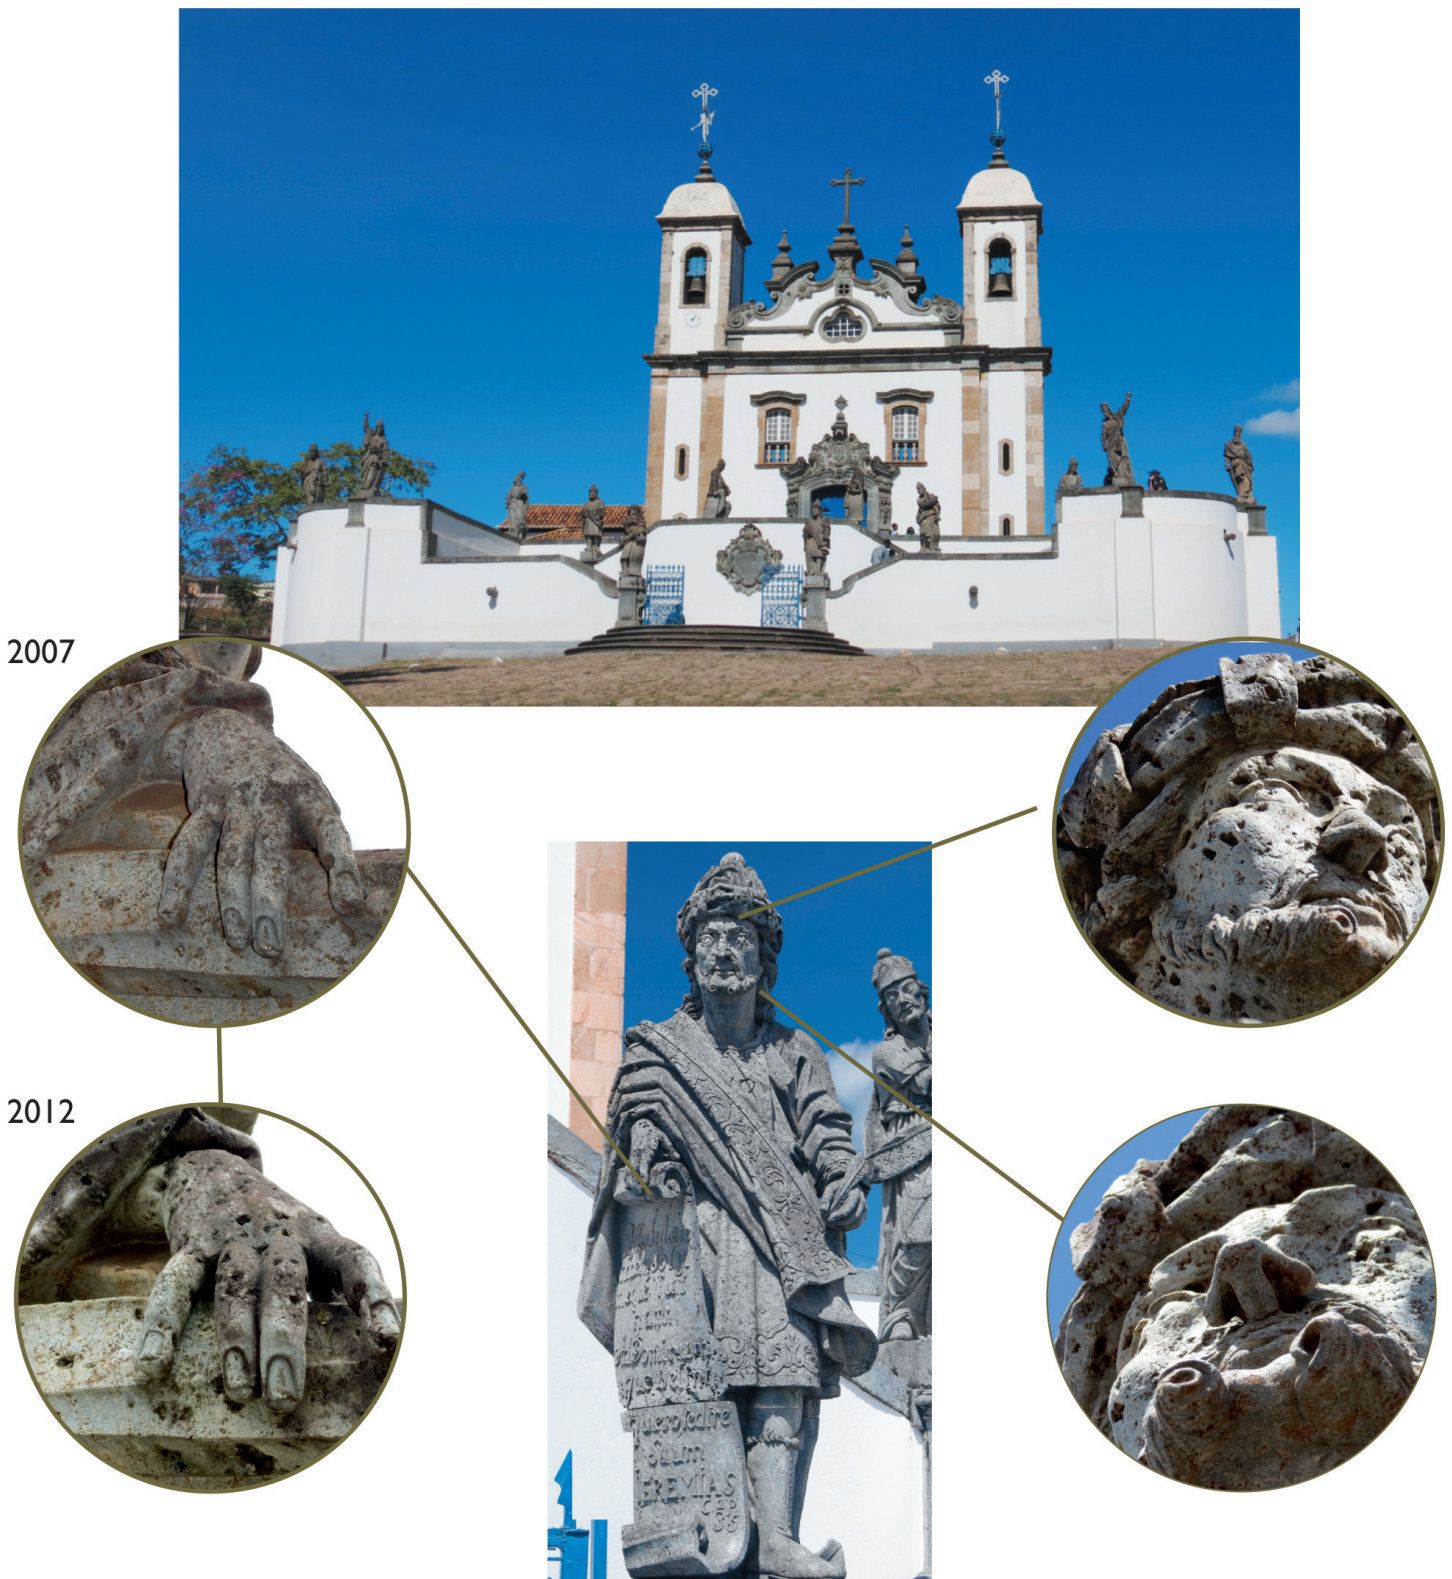
The presence of sedimentary structures inherited in metamorphic rocks may influence processes of degradation, such as in some of the quartzite used. Banding by compositional variation, or cross-bedding, occurring alone or in combinations, can lead to different degrees of degradation, and the effect of these structures may be enhanced by differential erosion. Some of the processes observed were strongly influenced by the mineralogical composition of the rocks employed, as in the case of steatite. Although prone to scratching because of the softness of its main mineralogical component, steatites contain a significant number of different minerals, and each mineral phase has its own coefficient of thermal expansion, contributing to the appearance of fissures and cracks. Broadly speaking, however, the main types of damage observed in steatite applications involve the appearance of cavities, because minerals formed from local enrichment of iron oxide or sulfide (pyrite) are easily removed by alteration/weathering. The common presence of carbonate crystals, usually dolomite, also contributes to the formation of such cavities through dissolution, accelerated in part by acid rain. An instructive example of the process of cavity or alveoli formation in steatite is seen in the statues of the prophets installed in the churchyard of the Santuário do Bom Jesus (Good Jesus Sanctuary) in Congonhas, Minas Gerais. Visual examination over the past 15 years has showed that, within the last 7 years, the process has accelerated. Throughout this period, it was noted that stains

gave rise to cavities, some of which were 0.5 to 1.0 cm deep (Fig. 6).

Figure 6. Deterioration of steatite (soapstone) works produced in the late 18th century, such as those shown here in Congonhas Sanctuary, mainly caused by weak rock resistance, and by biological and anthropological factors leading to cavity or alveoli formation.
