Rain-Induced Landslides in the Canadian Cordillera, July 1988

S.G. Evans
 Geological Survey of Canada
 601 Booth Street
 Ottawa, Ontario K1A 0E8

Abstract

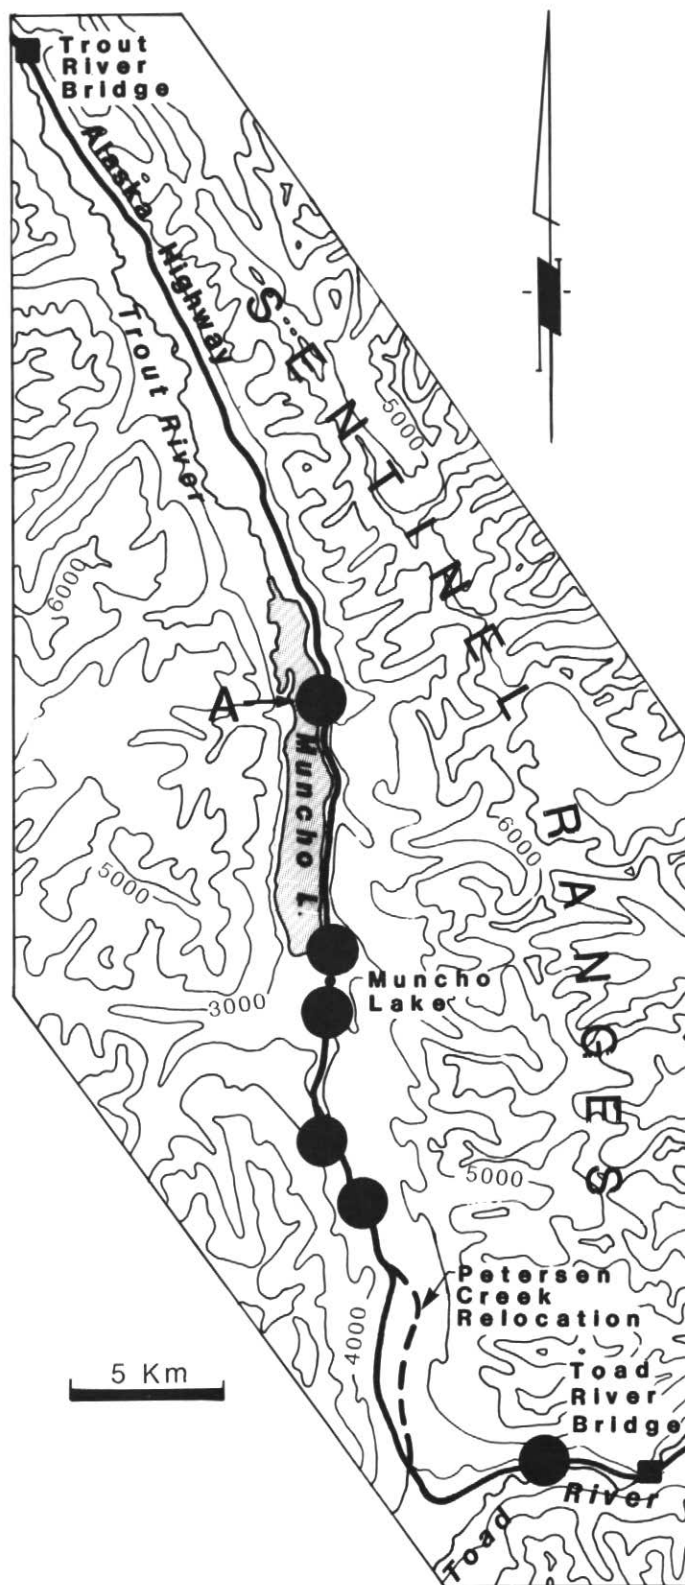
In 1988, the Alaska Highway was closed at 2000 h on July 12. It was severed in six locations by sediment-water flow processes, either by the destruction of the roadbed itself or by the deposition of material on the surface of the road (Figure 2). These flows were triggered by rainfall of 68.8 mm in 48 hours on July 12 and 13 (Figure 4). The Alaska Highway was re-opened at 1800 h on July 14, 1988.

Figure 2 Alaska Highway route in the vicinity of Muncho Lake, British Columbia. The Highway was severed at 6 locations (black circles) by debris flow and associated sediment-water flow processes during the July 1988 rainstorm.

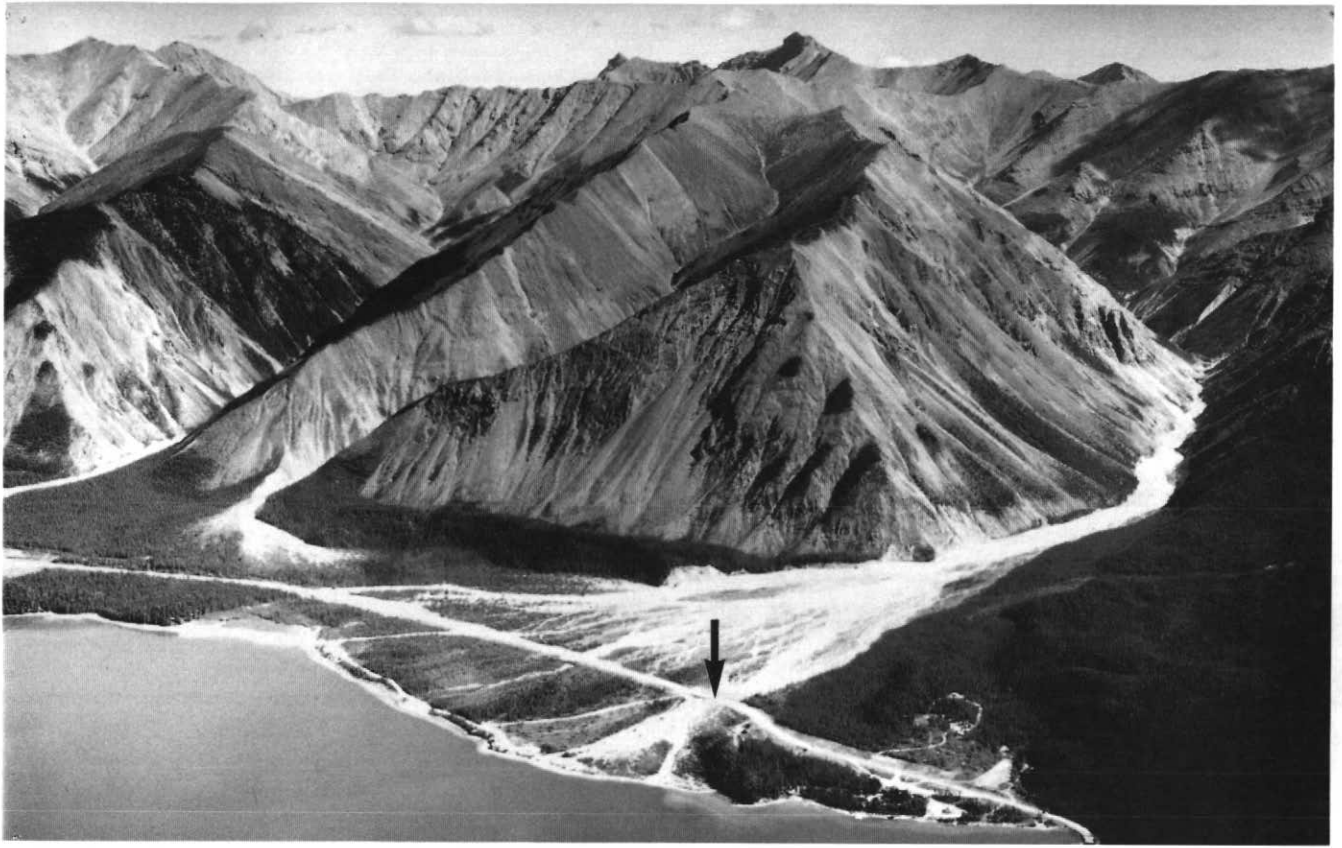
Figure 3 Oblique aerial photograph illustrating the nature of the watersheds developed in the Paleozoic carbonates of the Sentinel Ranges in the vicinity of Muncho Lake. Note active fan surface and steep bare slopes. The Alaska Highway was severed at the location indicated by the arrow (A in Figure 2) during July 1988 rainstorm. Elevation difference between Muncho Lake in foreground and peak on centre skyline is 1255 m.

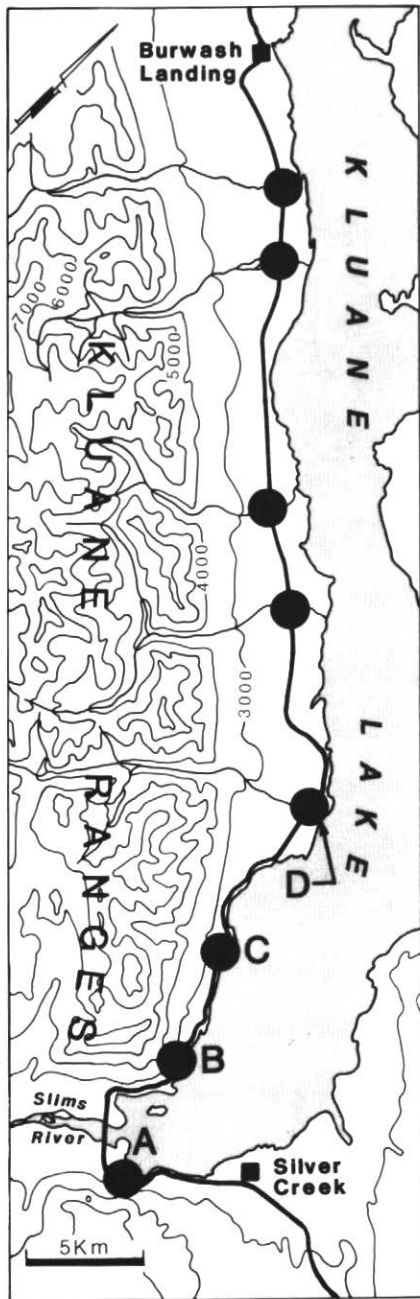
Figure 6 Alaska Highway route in the vicinity of Kluane Lake, Yukon Territory. The highway was severed at 8 locations (black circles) by debris flow and associated sediment-water flow processes during the July 1988 heavy rainfall. A-D are locations discussed in text.

In July 1988, the Alaska Highway was severed at numerous locations between Silver Creek and Burwash Landing (Figure 6). A major debris flow covered more than 500 m of highway about 1.5 km east of the Slims River bridge (A in Figure 6, Figure 7). It occurred approximately 2 km west of the site of a previous major debris flow (Figure 7) which blocked the Alaska Highway after a period of intense rainfall in the summer of 1967 (Hughes *et al.*, 1972).

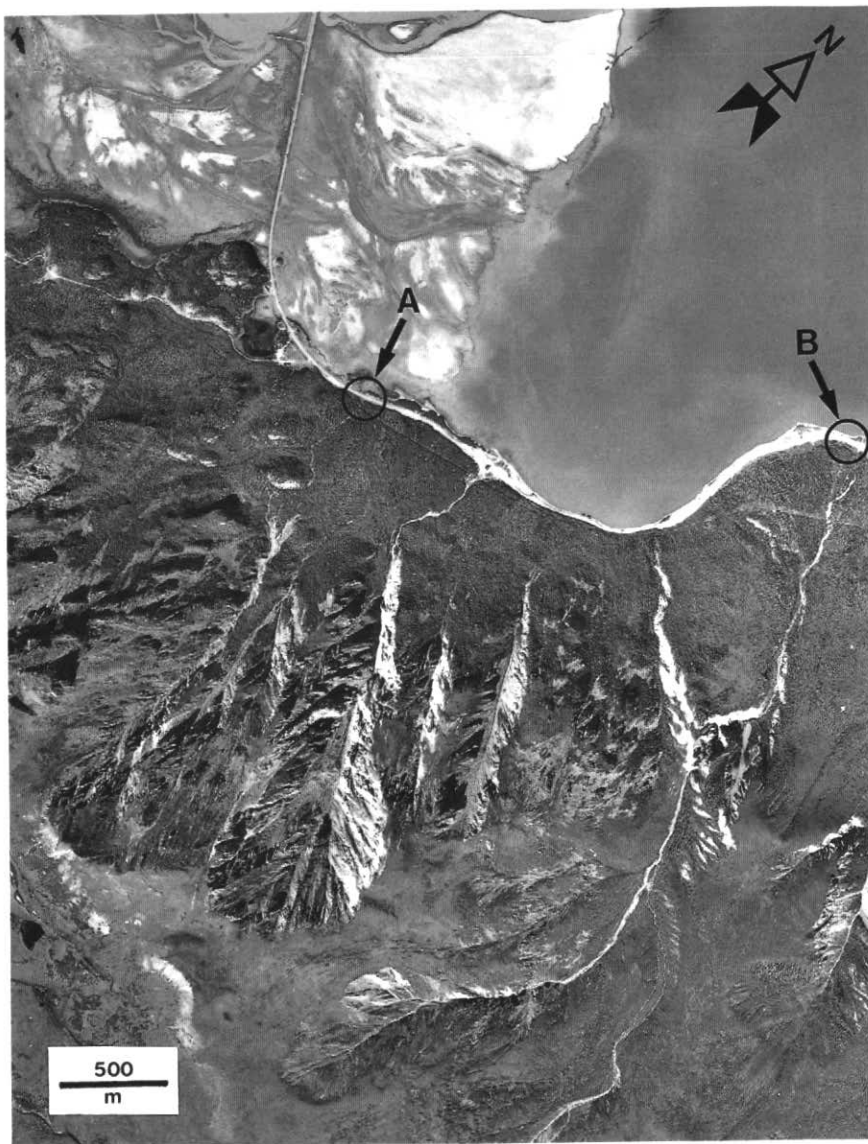
Figure 7 Aerial photograph (Canada A23820-19) showing the location of a major rainfall-triggered debris flow (A) which blocked the Alaska Highway in July 1988. Also shown (B) is the location of a debris flow which blocked the Alaska Highway in 1967.

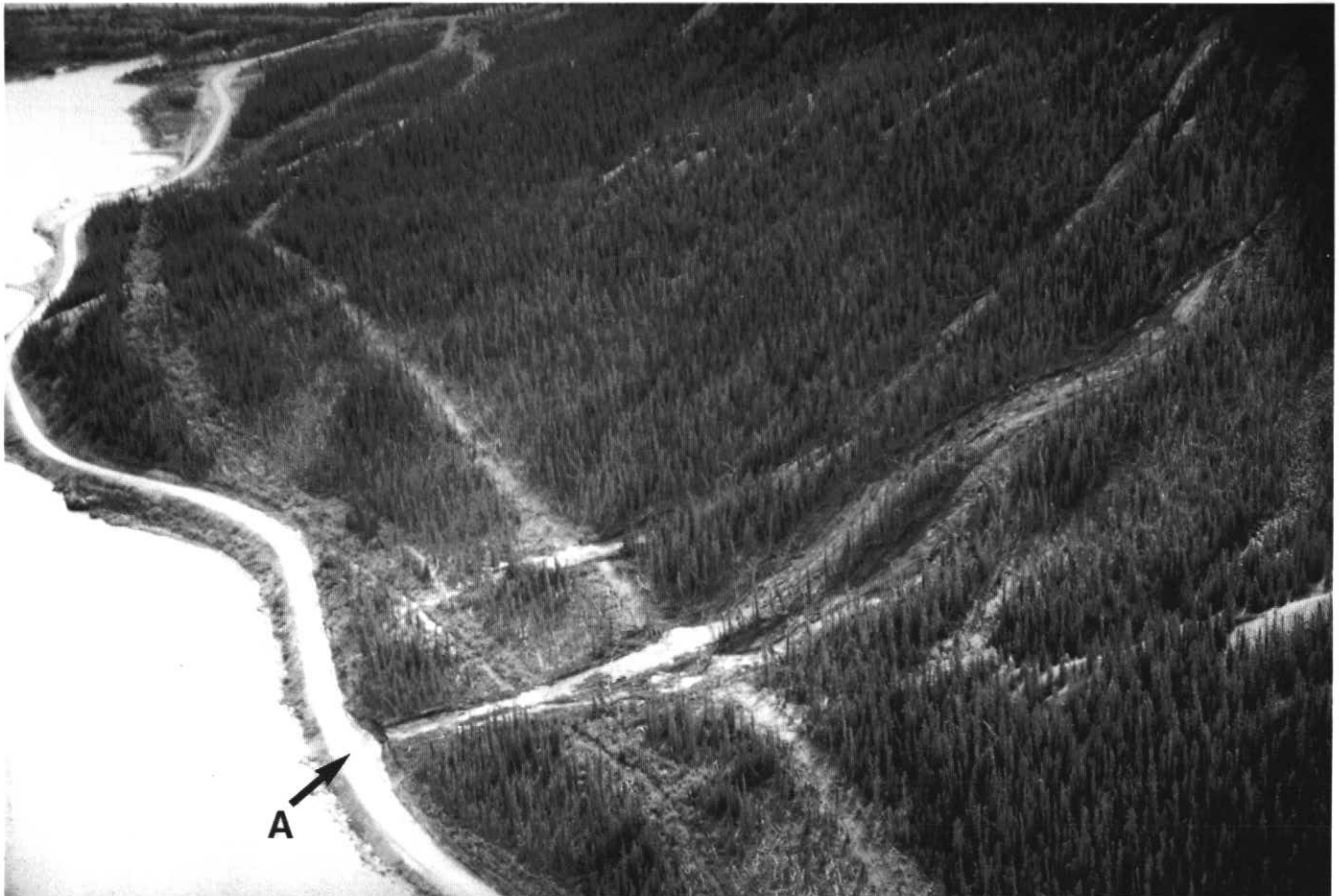
Two debris avalanches occurred in Holocene colluvium on slopes above the highway approximately 3.5 km north of the Slims River (B in Figure 6). Debris of one of these landslides blocked the road (Figure 8).

Figure 8 Oblique aerial photograph of two debris avalanches which occurred on open slopes above the Alaska Highway during the July rains. The Highway was blocked at A. Kluane Lake is seen on the left of the photograph.

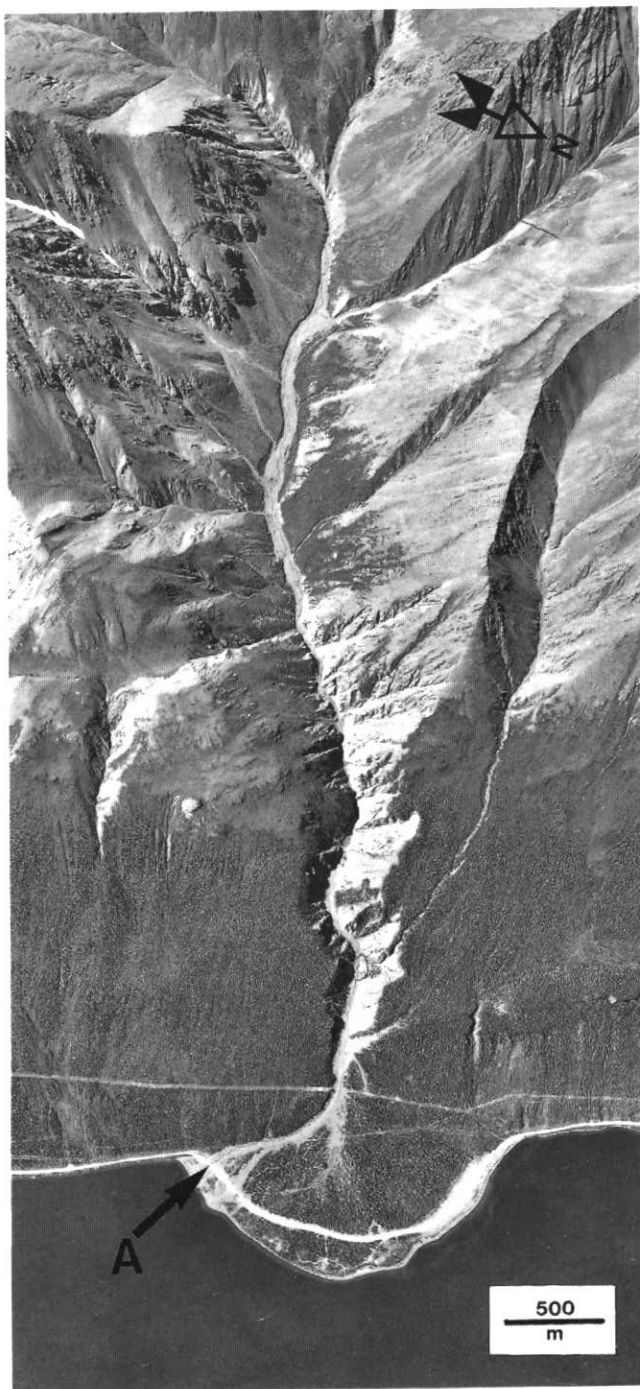
Between this point and Burwash Landing, the Alaska Highway was severed by debris flows or sediment-water flows at six locations where it crosses major alluvial fans. Large amounts of coarse material were mobilized on the surfaces of these fans as braided channels shifted due to the plugging of existing channels, the erosion of natural levees and the breaching of artificial berms. A typical example of an active fan along the foot of the Kluane Range (Williscroft Creek) is shown in Figure 9 (C in Figure 6).

Figure 9 Aerial photograph (Canada A23820-50) of a typical mountain watershed in the eastern slopes of the Kluane Ranges (Williscroft Creek). The Alaska Highway was severed at A during the July rains.

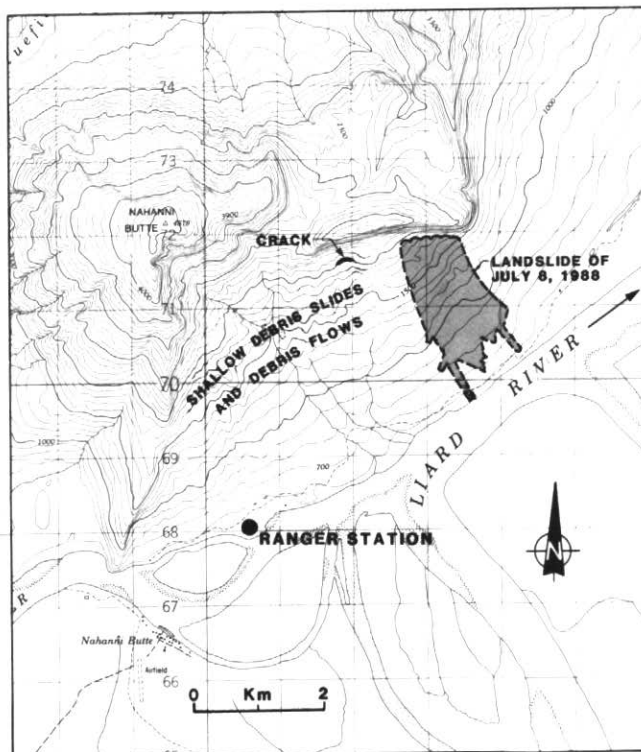
The July rainstorms triggered a large landslide (ca. 1.5-2 km² in area) in Quaternary sediments 3 km northeast of the Nahanni National Park Ranger Station at Nahanni Butte, NWT (Figures 1 and 11). There were numerous other smaller slope failures in this region during these storms.

The large landslide took place on a slope that dips about 10° away from a 200 m high limestone escarpment toward South Nahanni and Liard Rivers (Figure 11). Sediments underlying this slope are over 100 m thick and heterogeneous in character. Much of the sediment is colluvium (rubble and diamict) derived from the escarpment by rockfall and other processes. The slope

Figure 11 Topographic map of the Nahanni Butte area, NWT, showing the locations of the Nahanni National Park Ranger Station and the large landslide that occurred on July 8, 1988.

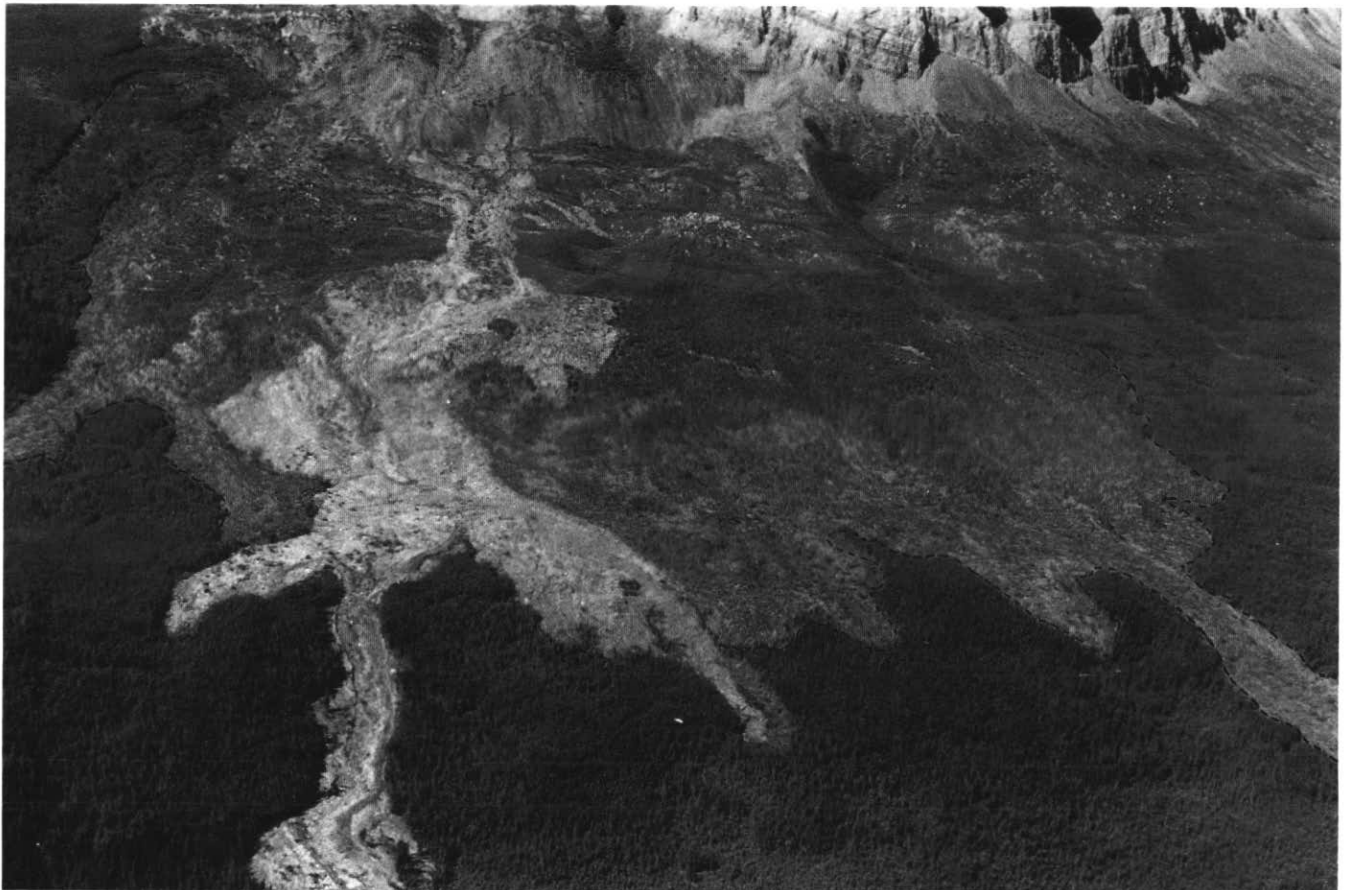
The large landslide northeast of the ranger station (Figure 11) developed over a period of several days, although most of the displacement probably occurred within hours of initial failure. On the upper part of the colluvial slope, directly below the limestone escarpment, sediments moved downward and outward along one or more deep-seated, curving shear planes. Farther downslope, sediments slid rather passively along shear planes oriented more or less parallel

to the ground surface, disrupting and locally destroying vegetation and extensively fracturing the ground. A large, mobile mudflow swept across this portion of the slope to beyond the terminus of the main slide (Figure 13). A tongue of this flow reached Liard River after travelling almost 2 km. Other tongues of debris moved downslope from the south and west margins of the landslide; these, however, retained surface vegetation and thus probably moved more slowly than the main mudflow.

Figure 13 Oblique view of the landslide complex noted in Figure 11. The boundary of the landslide is indicated by a dotted line. Note the unvegetated track of a multi-lobed mudflow that travelled from the upper part of the complex to the Liard River.

The landslides at Nahanni Butte raise concerns about the safety of the Nahanni Park Ranger Station which is located at the foot of the colluvial slope on a low terrace adjacent to South Nahanni River. The Ranger Station was not affected by the 1988 landslides, but there is a possibility of it being damaged or destroyed in the future during a prolonged period of heavy rain. Although the hazard in the short term is low, since heavy rains similar to those in June

and July 1988, are infrequent, there is sufficient danger in the long term to consider relocating the station.
