COPPER-PLATE RESTORATION FOR CHARTS OF SPANISH HYDROGRAPHIC INSTITUTE

Lieutenant (H) Manuel de la HERA PACHECO.

Cartography Sub-Section, Cadiz, 15th December 1949.

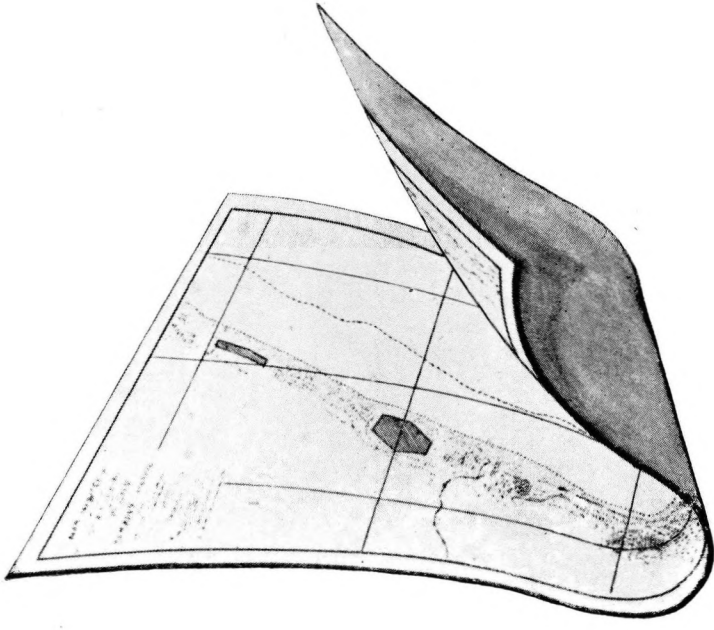
FIG. 2.
 Plancha N° 79
 Fondecadero de Fuengirola

All the copper plates were recovered, some of which had assumed the peculiar shapes shown in Figures 1, 2, and 3; and 8 photozincography originals were saved.

The force of the explosion and violent contact with the ground, and the consequent dispersal of the shelves (which finally came to rest on a bed of rubble while fragments of stone and iron rained down upon them from the upper floors) were more than sufficient reason for the warping as shown in Figs. 1, 2 and 3, as well as for the scraping previously described.

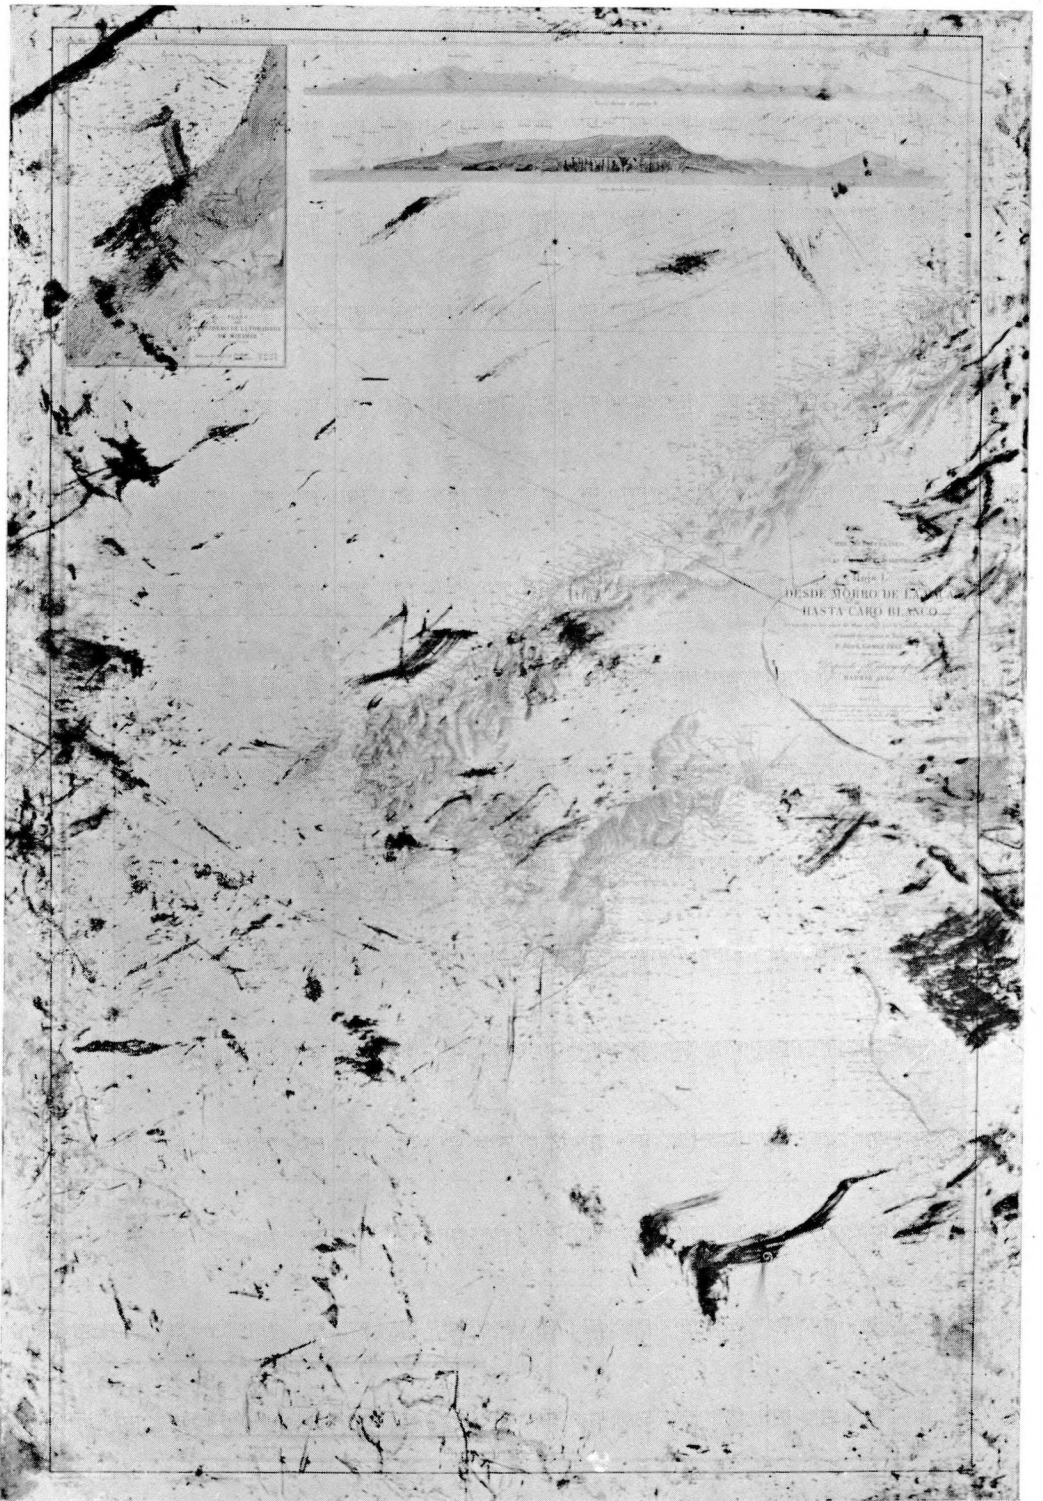
FIG. 4.

It was noticed that the plate was neither perforated nor warped, and a trial proof showed the condition represented in Fig. 4 — which is a photograph of the initial proof on paper.

Examination of Figure 4 leaves no room for doubt as to causes producing the dark spots on the proof ; they are the result of burrs on the engraved surface of the plate, not made, however, by a graver guided by any conscious hand, but by fragments of stone and metal. No portion has been left intact, especially the lower and side margins, and lower half of the plate. There is a dark spot indicating the presence of burrs beside gouges of varying depth and width, and in order to get a complete picture of the situation, the head office of the Sub-Section had the erasers eliminate the burrs by the following process, called *Rough Erasure Phase*.

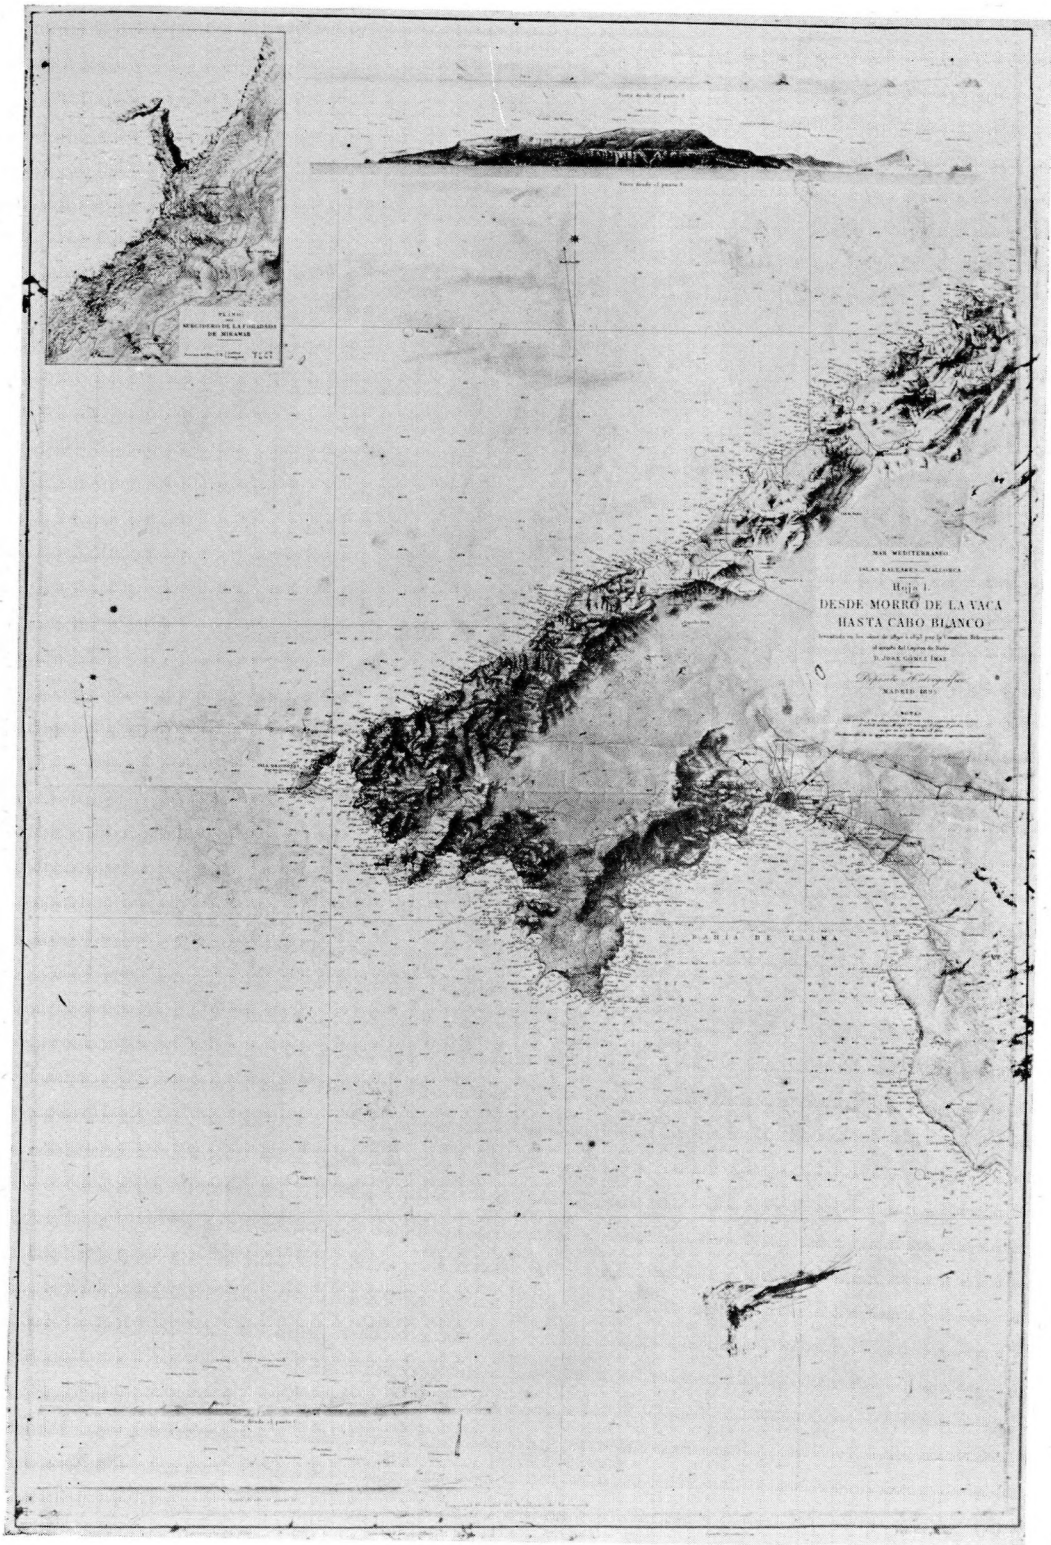
FIG. 6.

After 70 hours of treatment by these methods, the first erasing phase was considered as being over, and the proof represented by Fig. 6 was obtained (photograph of paper-proof). Compared with Fig. 4 it is far less confused. Practically all the large spots have disappeared, leaving the background much clearer and enabling each scratch to be classified and elimination methods to be determined.

Equipment consisted of a steel scraper and linden-tree charcoal, both essential in the acquisition of a smooth finish. With the scraper (Fig. 5) the burrs could be smoothed out quickly with no great trouble apart from keeping within the damaged areas so as not to rub out the neighbouring unaffected sections, and avoiding too close a scraping of the upper surface which would result in a widening and deepening of the grooves.

Both of these problems were solved by leaving off using the scraper before the burr entirely disappeared; as the upper surface of the plate was approached, recourse was had to charcoal.

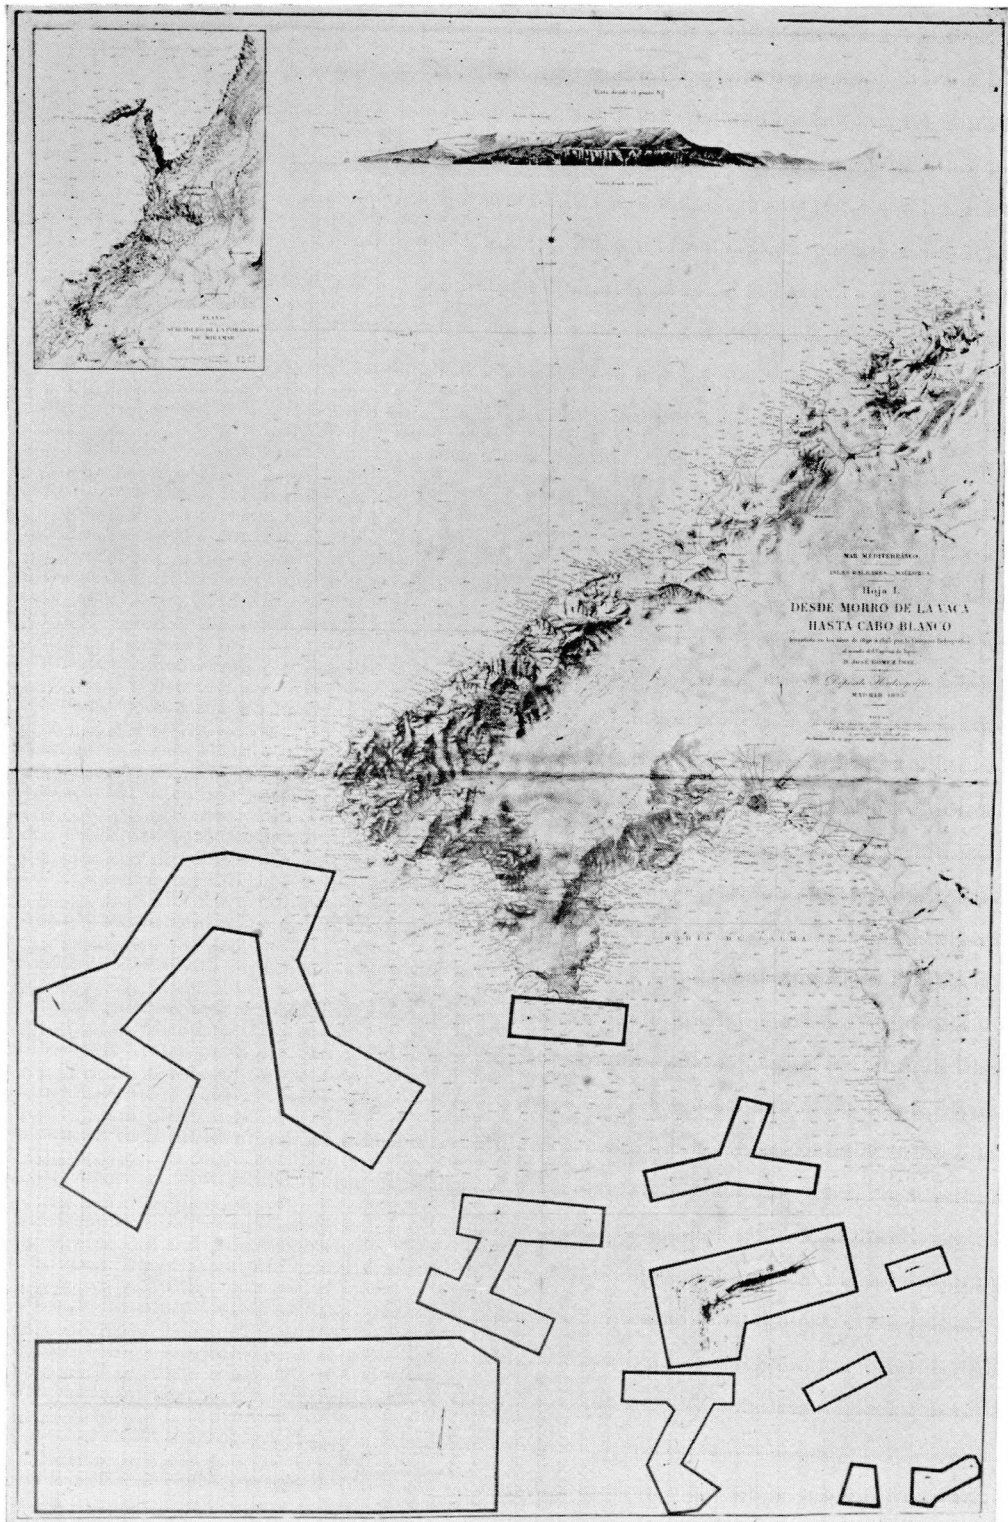
FIG. 9

It took 32 hours to complete this phase in the case of Plate No. 970. Figure 9, which reproduces a proof made at that time, shows the results obtained, including breaks in the outside grooves due to the removal of scratches upon them.

This grouping was decided upon by the head-office of the Sub-Section. Figure 9 shows the result of the examination with regard to Plate No. 970.

The defects to be corrected during the *Fine Erasing* phase are enclosed within the black lines. Defects outside these zones were entrusted for correction to less experienced employees, and the process designated as *Medium Erasing*.

The hammering process consisted in opening up a furrow on the front of the plate where there was a deep scratch, in such a way as to absorb the latter completely, and in then filling it in by hammering the back of the plate. This method had to be resorted to in the case of most of the scratches surrounded by the black lines on Figure 9.

Complete elimination is achieved by pushing the surrounding copper into the scratch with the straight steel burnisher (Fig. 7), by means of a quick rubbing motion of the slightly curved bevel end. The cracks are filled in with a consequent slight lowering of the surrounding surface.

When the scratches are at some distance away from the border grooves, there is no danger of the engraved portion's disappearance and in such cases use of the curved burnisher (Fig. 8) is recommended; quicker results can be obtained, as it is easier to handle, covers a wider surface, and can be operated with both hands, supplying heavier pressure.

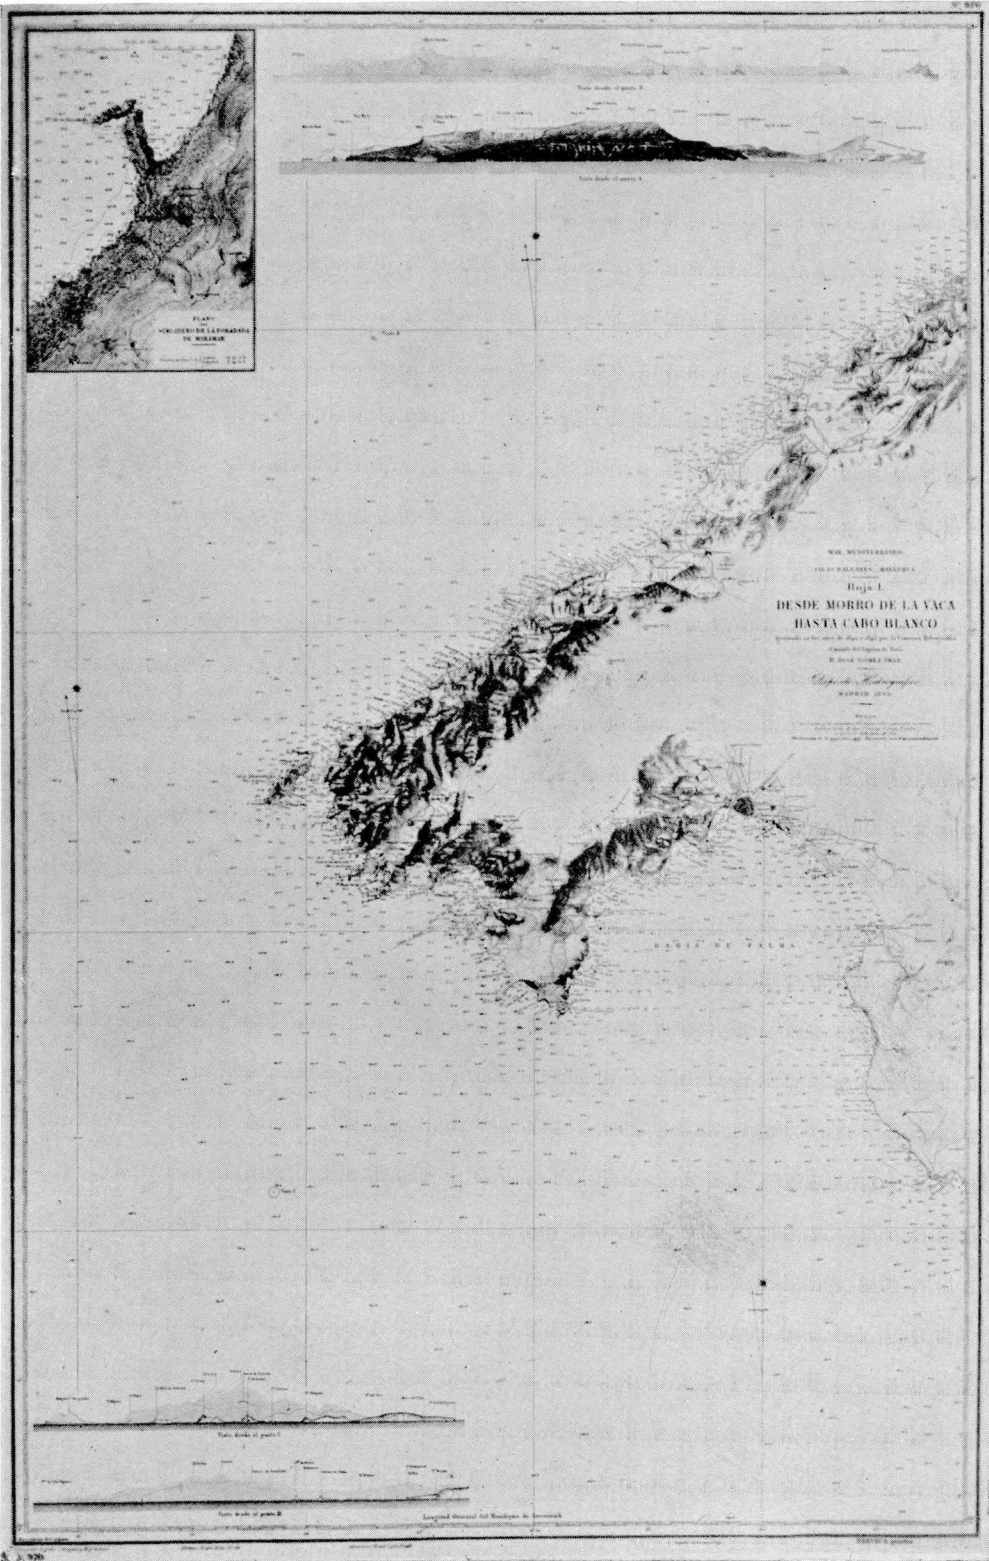
FIG. 12.

The final proof, reproduced in Figure 12, shows a chart in perfect condition for use in navigation. There are a few scattered and superficial scratches in the land areas, which are noticeable, but since the prime objective was to restore the plates so that prints could be obtained for navigation purposes, these were left for a later stage.

Restoring the engraved portions of Plate No. 970 took 270 hours. It should be mentioned, however, that the two coastal views on the lower part of the plate had to be completely re-engraved. It had taken an extra 18 hours to erase them completely, but it would have been more trouble for the engraver to deal with what had been left originally, particularly as regards the fitting of new depth curves to the old ones.
