## RADAR, COLLISIONS, AND THE RULES OF THE ROAD.

by Lieutenant Commander Joseph K. TAUSSIG, Jr., U.S. Navy.

(Extracted from United States Naval Institute Proceedings, Vol. 75, No 9, Annapolis, September, 1949).

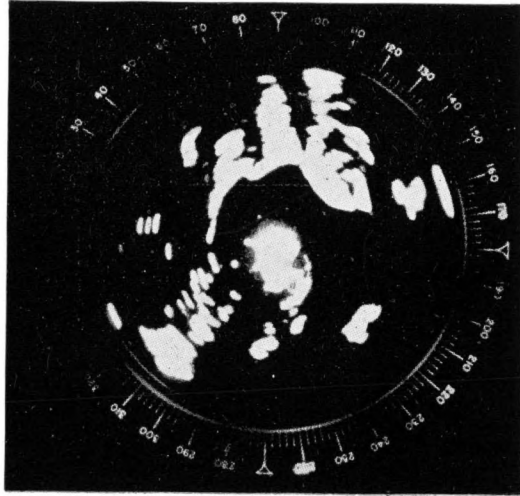
FIG. 2. — THE TWO BASIC TYPES OF RADAR SCOPE.

Figure 2 shows the two basic types of display presented to the viewer. The first is the old "A" type display, now mostly obsolete ; the second is the more modern "PPI" (Plan Position Indicator) display which eliminated many of the serious limitations of the "A" type. The "PPI" display gives the viewer a contemporaneous picture of the area around his ship. In general, his vessel is in the center of the plan, and targets show on the display in positions relative to his vessel.

On the right is the "A" Scope, where the range is determined by moving the depressed "step" until it coincides with the raised pip. On the left is a PPI Scope presentation taken on board a vessel in Tokyo Harbour.

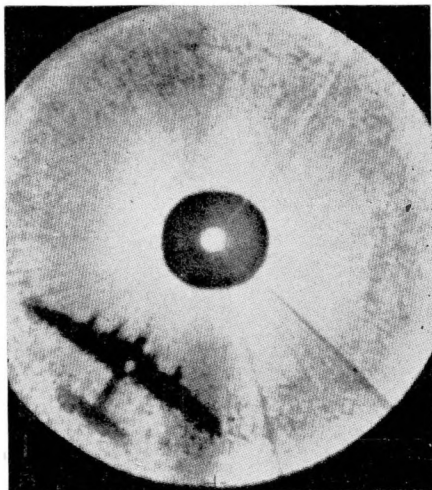
FIG. 3. — RADAR IS NOT LIKE TELEVISION.

Radar is not television. Figure 3 is a picture which was given wide circulation and publicity shortly after the security ban was lifted from radar discussion. The caption writer went overboard in his enthusiasm and has misled laymen into believing that radar can televise. Radar technicians themselves are not agreed as to what the picture itself represents or how it came about. The aircraft is between the viewer and the ground, but is so close that it has intercepted the radar wave either going from the antennae or returning, so that a normal echo is precluded. In any event, the picture is a freak. Figure 4 shows the display which can be expected from a modern set now generally in use.

This picture represents the unusual event in which the target (a bomber) is so close to the radar antenna that it intercepts the beam and prevents it from echoing. If the proportions were correct relative to the radar scope, this bomber would have a two-mile wing span!

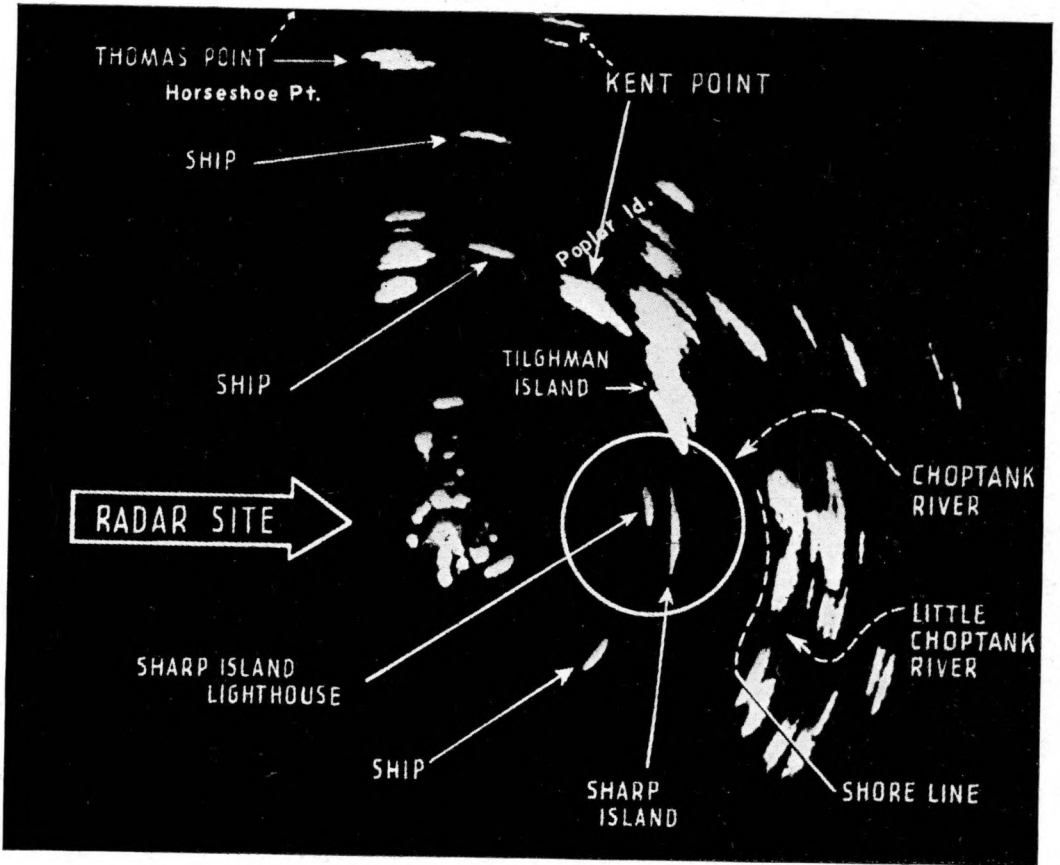
FIG. 4. — IT TAKES EXPERIENCE TO "READ" THE RADAR.

In this PPI presentation of the area around the Naval Research Laboratory, Chesapeake Bay Annex, the lighthouse appears to be similar to a ship. Note the distortion of the pips in general.
