# Marine accidents ascribe to man or machine?

**Author**BK Ramprasad<sup>1</sup>

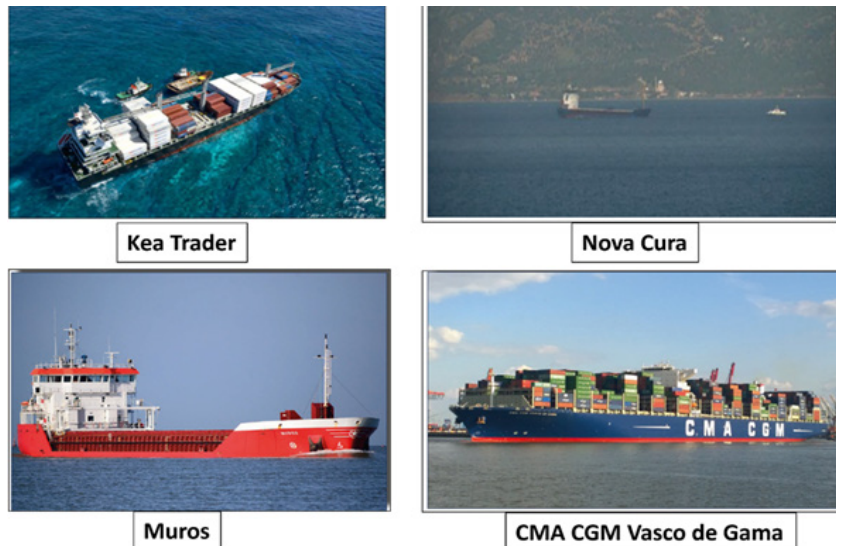
**Grounding of *Muros*:** At 0248 (UTC+1) on 3 December 2016, the bulk carrier *Muros* ran aground on Haisborough Sand on the east coast of the United Kingdom. Attempts to maneuver clear of the shallows were unsuccessful but the vessel was re-floated 6

days later with tug assistance (Fig. 5). There were no injuries and no pollution, but damage to *Muros's* rudder necessitated the vessel being towed to Rotterdam, Netherlands, for repair.

Fig. 5 Ill-fated ships ran aground.

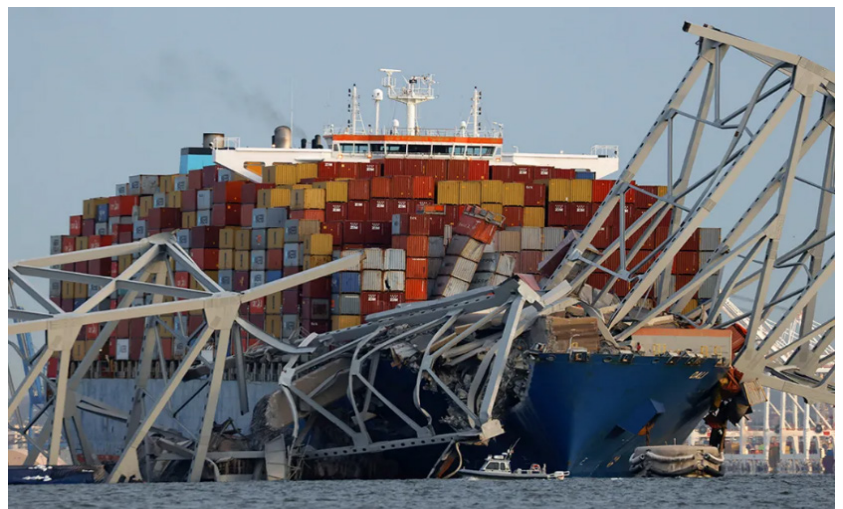
Baltimore, Maryland State, United States of America. The central part of the bridge is completely collapsed. The preliminary reports from the news agencies says that there was a power issues with the ship prior to collision and the crew made a mayday message to the authorities. Six construction workers who were working on the bridge are missing and presumed to be dead according to the news agency reports (BBC, 2024). The ship owner declared that entire 23-member crew onboard are safe. Since the bridge which was constructed in 1977, is a main life line for the trade in this area, the entire business came to a halt. The collapse of the bridge had an impact on the supply chain and worsely affected the ship movement into entry and exit of the Baltimore harbour. Detailed accident investigation report is awaited. Fig. 6 shows the allision of Dali against the bridge.

Fig. 6 Ill-fated cargo ship *Dali* which slammed into Francis Scott Key Bridge at Baltimore (Source: BBC News, [www.bbc.com/news](http://www.bbc.com/news) accessed on 26 March 2024).

In the recent allision of the cargo ship Dali which slammed the Francis Scott Key bridge at Baltimore port, the ship was identified a faulty pressure gauge for fuel heating by the authorities and the same was fixed before the ship leaving from the port at Singapore. Just before the allision, the Dali experience a blackout losing power and its steering control system. Such blackouts are rare but hazardous on ships. The preliminary reports say that the impure fuel used might be one of the reasons for power failure. The ship was undergoing routine engine check-up just before the allision. Human negligence and dilution of standards may be the cause of this particular accident. However, a detailed accident investigation report is awaited in this case.

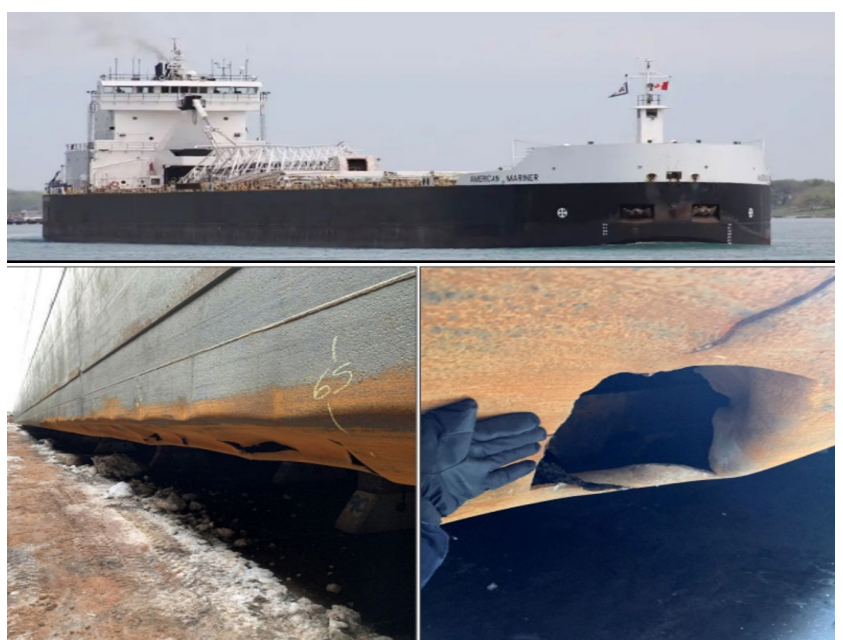
Fig. 7 Damage to the port water ballast tanks of bulk carrier *American Merine* due to grounding (Source: US Coast Guard).

aground on the shoals on the opposite side of the channel. American Mariner was outfitted with a RosePoint electronic chart system (ECS). The ECS was not configured to display the footprint of the vessel, according to the master, and safety depths were not programmed into the ECS. Which shows the un-familiarisation of bridge crew with the safety functions of the ECS system.
