Reassembly of a Sixteenth-Century Basque Chalupa

CHARLES D. MOORE

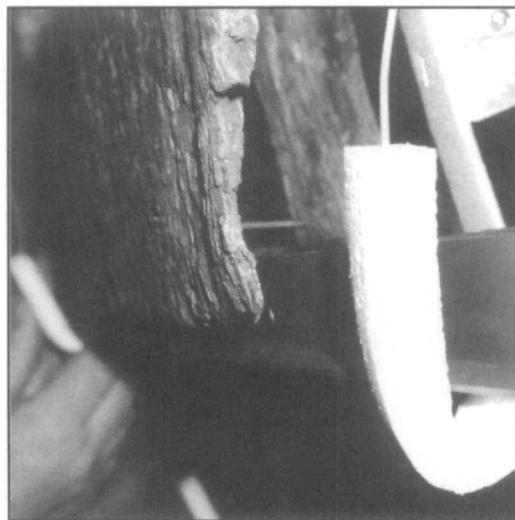
Fig. 2
Aluminium rail being installed between lapped planks (J. Moore)

(25 x 12 mm), run the length of the boat on each side beneath the lapped planks and at the sheer wale level (Fig. 2). The concept for the rail installation is based on those used along the lapped seams of the Viking ships reassembled at Roskilde, Denmark. The rails impart considerable strength to the wooden hull and yet are light enough to be bent carefully by hand against the curvature dictated by the planks, although a shrink press was necessary to shape the rise. The 8-foot (2.4-m) lengths of rail were joined using aluminum solder. These rails were secured directly to the cradles. Additional floating cradles were installed to provide temporary additional support during transport. We counted on this combination of permanent and temporary cradle support, along with light anchoring, to provide the right mix of rigidity and flexibility to minimize the impact of vibration and jarring on the artifact during the move. An air-ride trailer with environmental controls was employed, and the frame was mounted on blocks of foam during transport to further dampen vibration.

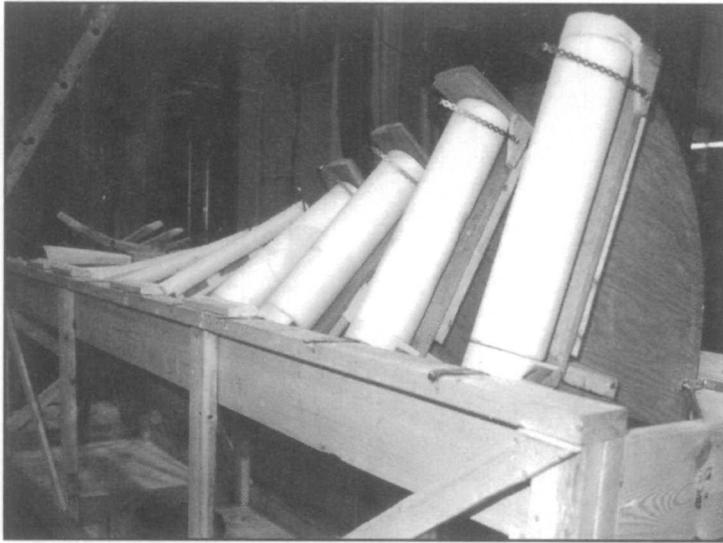
Fig. 3.
*Jig built to reshape the
garboard strakes
(R. Chan)*

thick garboards. These planks, when reassembled, needed to maintain a twist of nearly ninety degrees over half the boat's length; a slight over-bend had to be introduced prior to installing the planks. The jig consisted of a series of adjustable quadrants spaced approximately the same as the boat's frames. Those quadrants requiring the greatest movement were fitted with foam-covered rollers to minimize damage from friction to the surface of the planks (Fig. 3). Fitted with wheels, the whole

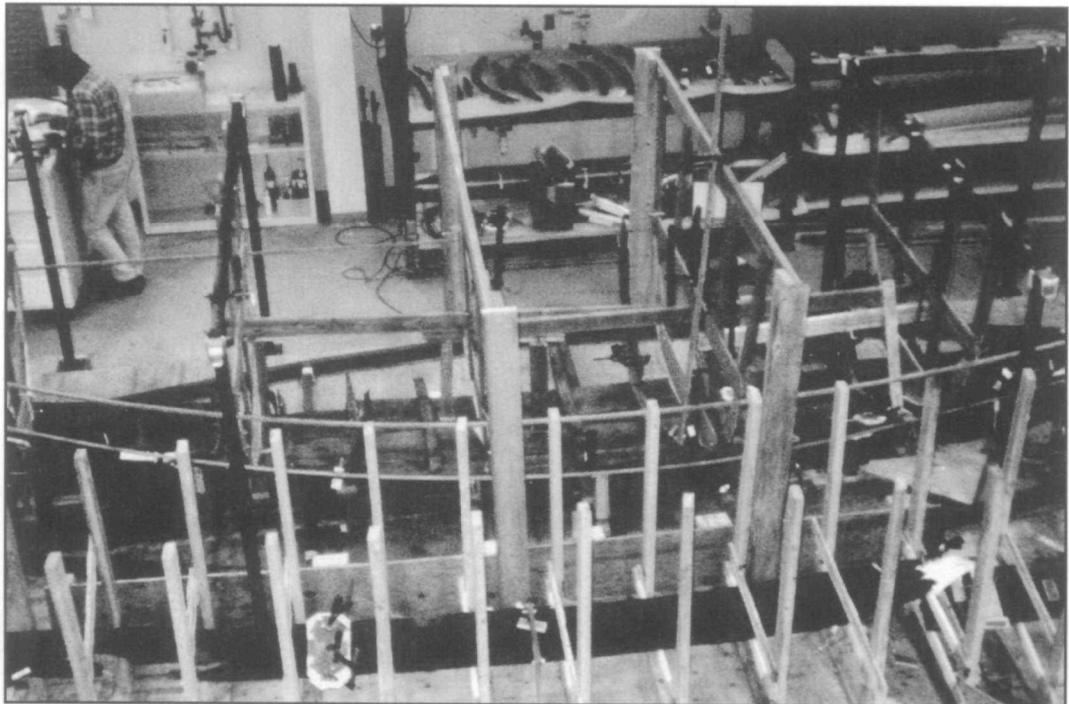
Fig. 4.
*The chalupa at an
intermediate stage of
reassembly with second
plank jig in the fore-
ground (J. Moore)*

of the garboard and below the lap planks were placed (Fig. 4). The jig was built with frames stationed in parallel locations to the chalupa's frames from stem to stern. While shaping actually occurred in the workshop (45 to 55 per cent RH), it was preceded with a week's preparation in the humidity chamber for each plank. Usually, these planks were shaped to a slight over-bend in the first attempt, although on rare occasions a small hydraulic jack was employed to assist in the bending. Just as the PEG-treated planks proved resilient to judiciously placed jacks, they also suffered no noticeable negative effects from quick-drying, being brought directly from the humidity chamber for placement into the workshop jig.

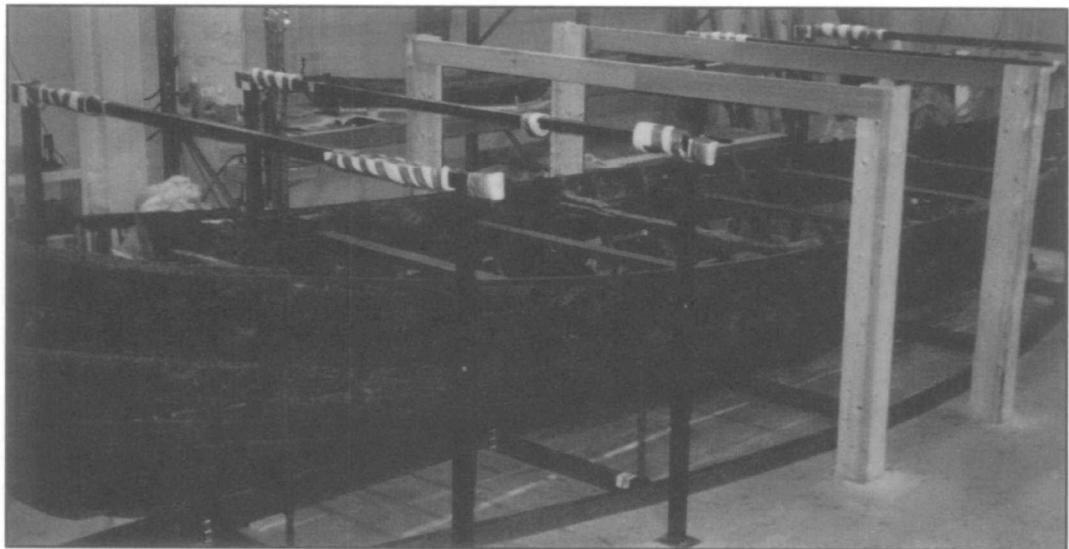
Fig. 5.
The reassembled
chalupa waiting to be
packed and shipped to
Red Bay, Labrador
(C. Moore)
