Some Twentieth-Century Canadian Earthquakes

Anne E. Stevens

Division of Seismology and Geothermal Studies

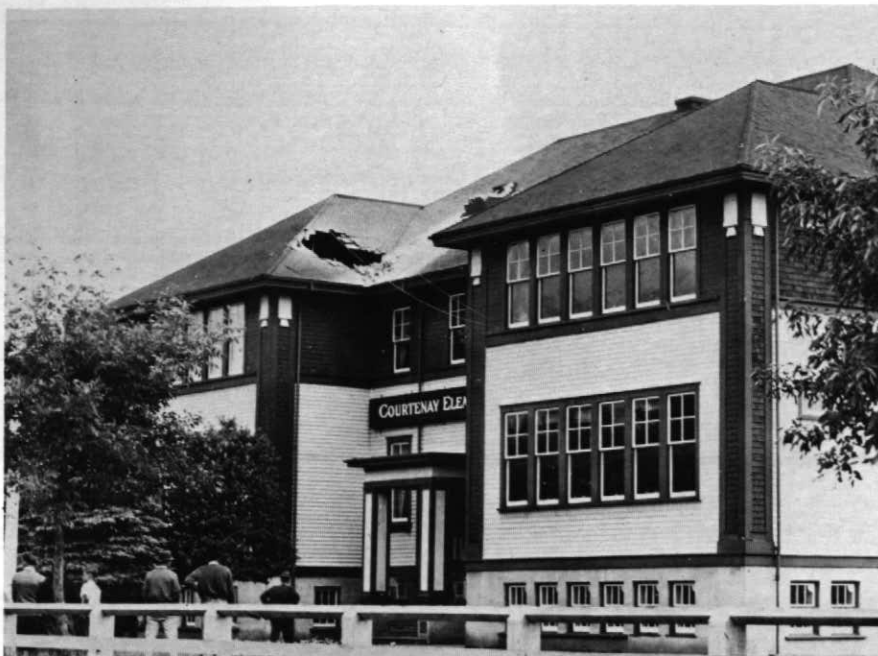
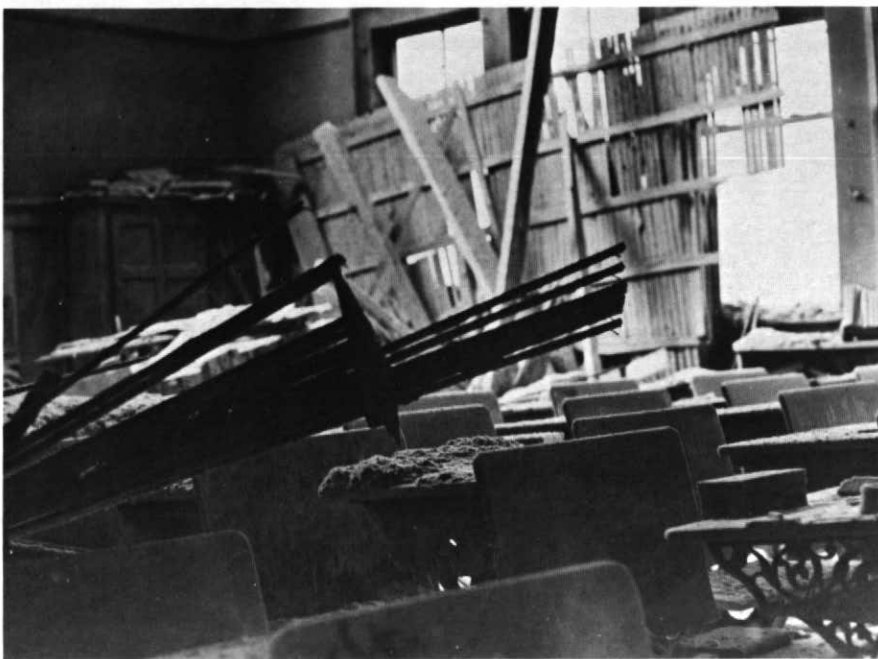
Chimney damage sometimes induces other damage. Figure 3b shows the interior of a schoolroom in Courtenay about 25 km south of the epicentre of the 1946 earthquake. Fortunately, the shock occurred about 10 a.m. local time on a Sunday morning when the classroom was empty. Damage here was caused when the large school chimney fell through the roof. In Courtenay about 25 per cent of the chimneys were damaged, mostly in the central part of town. Windows and bottles were cracked in some stores.

Figure 3
June 23, 1946. Elementary School,
Courtenay, B.C. The chimney, located above

the front entrance, fell sideways through the roof into a classroom. (Figs. 16 and 15, respectively, in Hodgson, 1946).
