Active Earth

The Development of Big Slide, near Quesnel, British Columbia, between 1953 and 1982.

Stephen G. Evans
 Department of Geology
 University of Alberta
 Edmonton, Alberta T6G 2E3

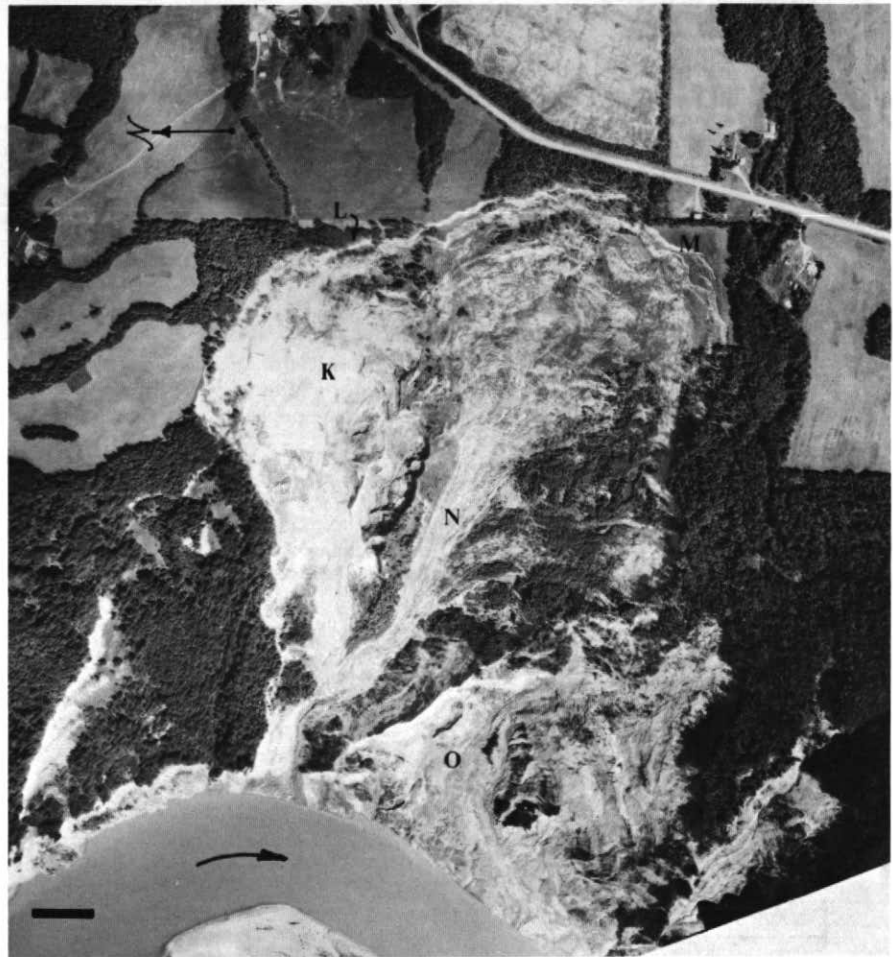
Figure 3: 1981 Air Photograph. K = North Bowl re-activated completely. Note broken ground. L = Active retrogression at North Bowl headscarp into in-situ glacio-lacustrine clay. M = Active retrogression at South Bowl headscarp has almost eliminated field (F in Fig. 2A). N =

Mudflow in South Gully. O = Extensive movements in landslide south of Big Slide. Note impingement of debris on Fraser River channel. Bar Scale = 100 m. Arrow denotes flow direction of Fraser River. (B.C. Air Photograph 81093-181).
