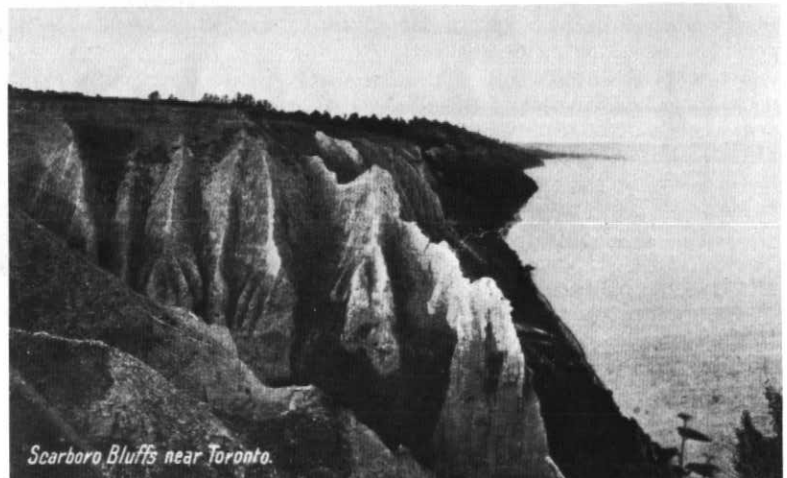
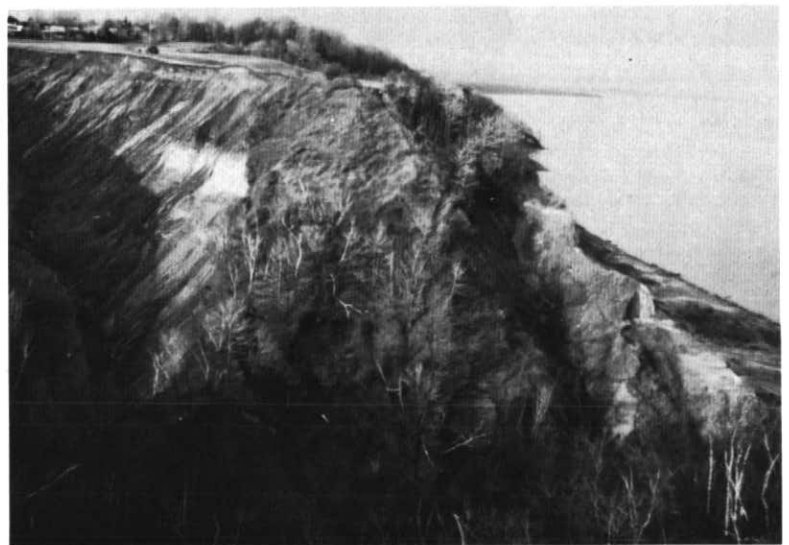
**Figure 5** A) Popular postcard of the early 1920's, depicting the view east from Sunnybrook over Cathedral Bluffs with their intensely dissected slopes and arêtes resembling cathedral buttresses. The present day view (B) shows largely planar slopes; it is evident from other evidence that gully and arêtes experience cyclic development over time from planar slopes to well-developed gully systems

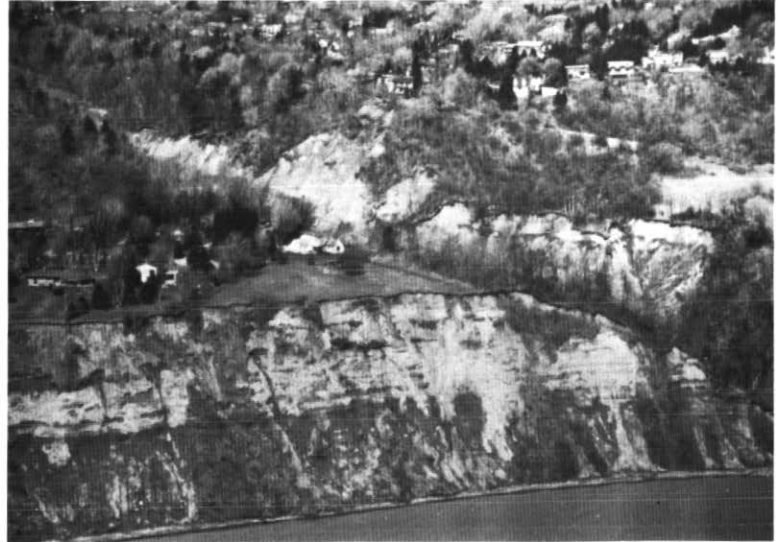
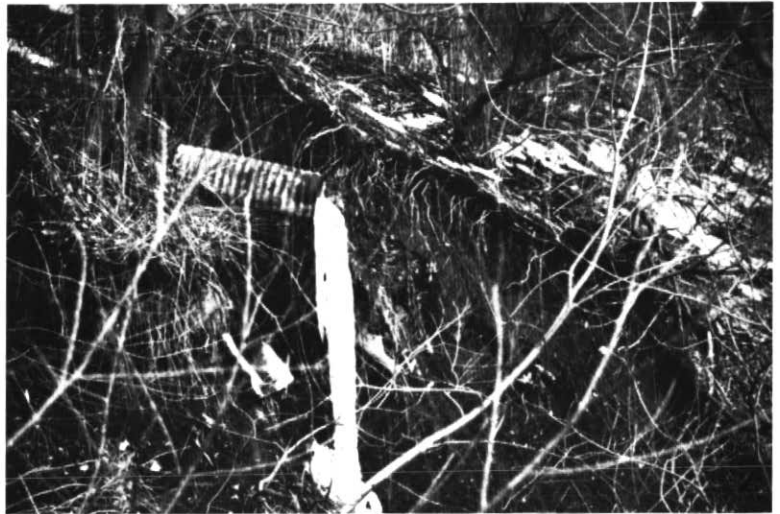
**Figure 6** **A)** Bellamy Ravine, one of the most impressive of the ravines along Scarborough Bluffs. Its headward development and rapid downcutting have been aided by rapid urbanization of its catchment (Fig. 4) and uncontrolled storm runoff (**B**)

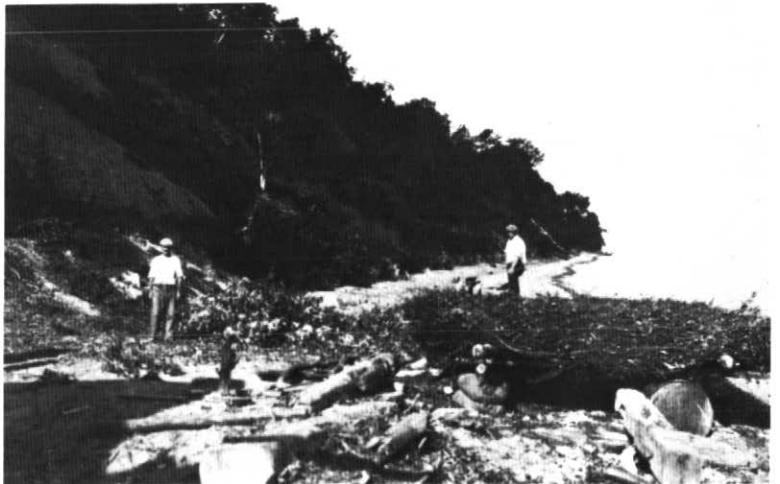
**Figure 7** Early attempts at remedial work: "Mississippi mats" constructed by laying brushwood, mostly willow, on a wooden frame, being placed around the intake for the Scarborough Waterworks (Fig. 3) in the mid 1930's (from the collection of A.P. Coleman)

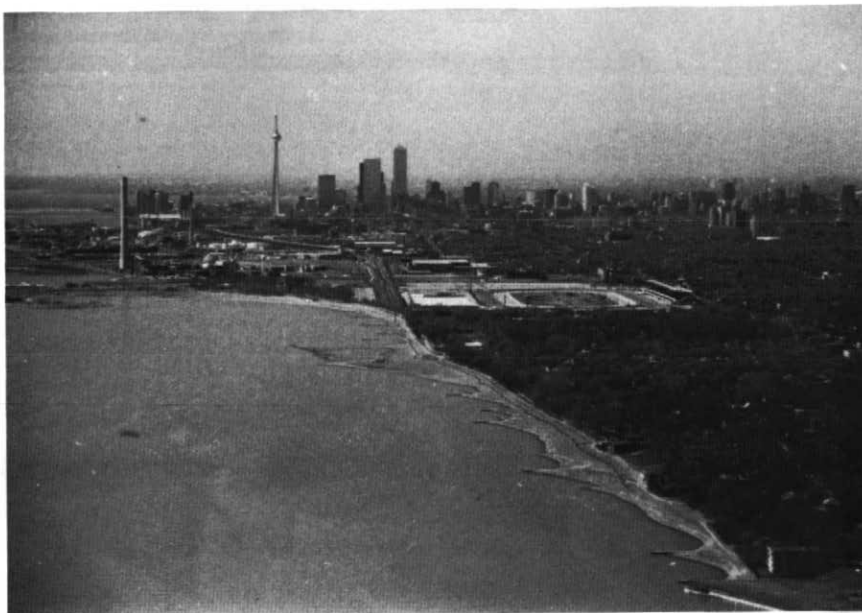
**Figure 8** View looking west of the Eastern Beaches (Fig. 2) toward the downtown core showing groyne and resulting entrapment of littoral sediment transported by the long shore drift system

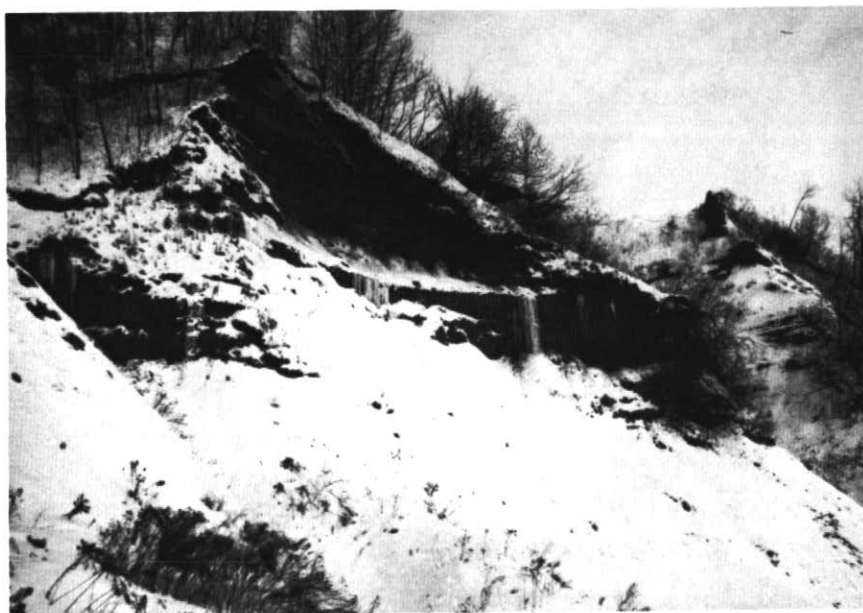
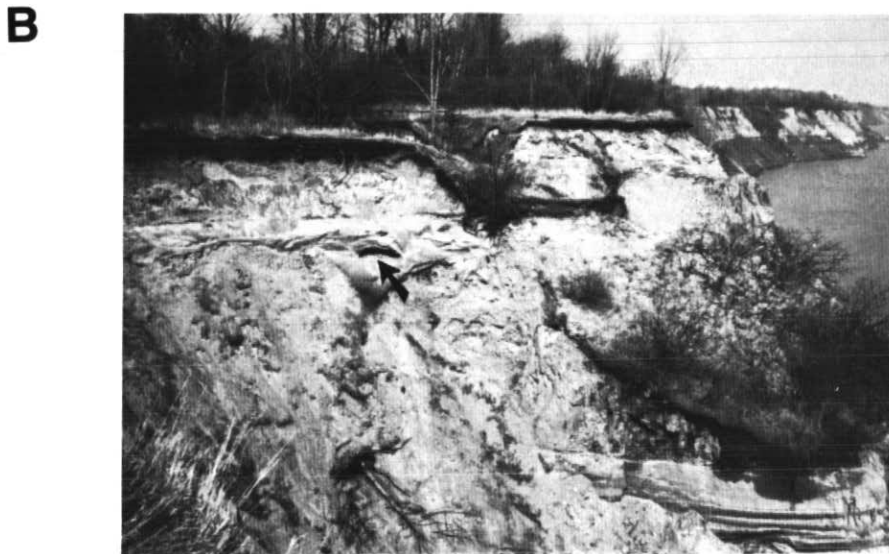
**Figure 9 A)** Icicles marking horizons of "pipes" formed by subsurface water seepage along juxtaposed sand and mud lithologies at the contact of the deltaic Scarborough Sands and Scarborough Clays (Fig. 3)

Planar slopes are undergoing parallel retreat in response either to groundwater seepage and piping (Fig. 9), with associated sloughing of surface sediment, or by minor, shallow, slab-like slides along the stress relief joints parallel to the cliff face (Fig. 10). Both these processes are most active in the spring. Debris accumulates at the slope foot as debris flows, which subsequently stabilize as a thick talus slope, and is removed during the following summer and fall by wave activity. Data indicate that during the winter, groundwater is prevented from escaping and high porewater pressures build up behind the frozen face to be released very rapidly as the slope thaws (Fig. 11). The role of freeze-thaw activity in acting to elevate porewater pressures in slopes and promote "spring sapping" is well-known in seasonally-cold climates. On the steeper slopes in areas of lithological homogeneity, slab-like masses of sediment are released from stress relief joints and accumulate as a steep talus slope at the cliff foot. The best example of this activity is seen to the west of Bluffers Park where the stratigraphically lowermost diamict unit and associated fine-grained facies fill in one of the large channels on the delta "basement". Here the entire cliff, up to 50 m high, overhangs the cliff foot in a series of spectacular arêtes (Fig. 10A). The progressive degradation of a large "needle"-like arête can be shown very clearly by a sequence of photographs taken by the late A.P. Coleman in the years between 1900 and 1936 (Fig. 10B). Individual arêtes are defined by deeply-cut gullies and resemble large cathedral buttresses (hence the name Cathedral Bluffs; Fig. 3). Erosion appears to have been accelerated along this stretch of the coast as a result of the beach starvation and stripping caused by the Bluffers Park Marina, though the magnitude of wave impact stresses at this site has yet to be determined.

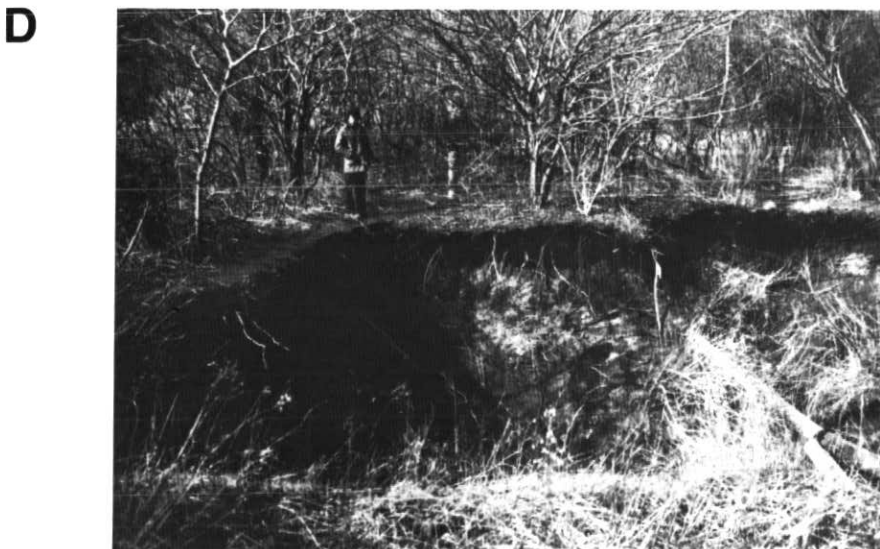
**Figure 9 B)** Large cave-like pipe (arrowed) associated with "sag basins" of sand formed by soft-sediment deformation on the upper surface of diamict units; **C)** 2 to 4: the formation of large erosional scallops, by spring sapping, in response to groundwater focussing within "sag basins" on top of impermeable Sunnybrook diamict in the area of Sylvan Park (Fig. 3). Unfocussed seepage occurs where no sag basins are present (1); **D)** Head of scallop showing collapsed area over subsurface pipe

Scalloped slopes, unlike the planar slopes described above, are not stable forms and appear to undergo a distinct sequential evolution. Immature scallops narrow downward and discharge via chutes well above lake level. The predominant process occurring within the scallop is spring mud flow activity and subsequent summer fluvial dissection by rills. Scallops enlarge by headward retreat and downcutting and are separated by large arêtes fronted by steep planar slopes described above (Fig. 12). The role of "sag basins" on the upper surface of the Sunnybrook diamict in focusing groundwater seepage and accelerating scallop growth rates has already been discussed above (Fig. 9). The scallops are

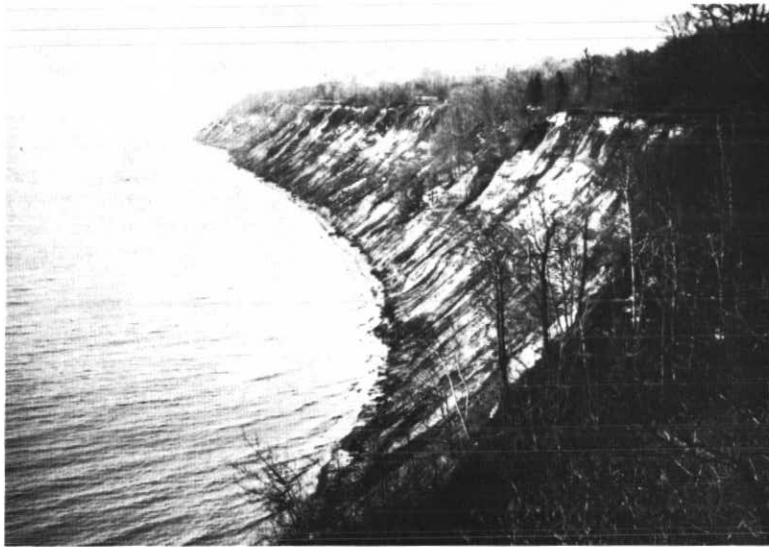
**Figure 11** A) Planar slopes at time of maximum spring snow melt, mudflows are moving downslope and have covered the beach area (B). Thaw of frozen bluff sediments allows high porewater pressures, built up behind the frozen face, to be dissipated thereby releasing water and generating mudflow activity. Note oblique wave approach to the coast which is responsible for littoral drift system (Fig. 2)

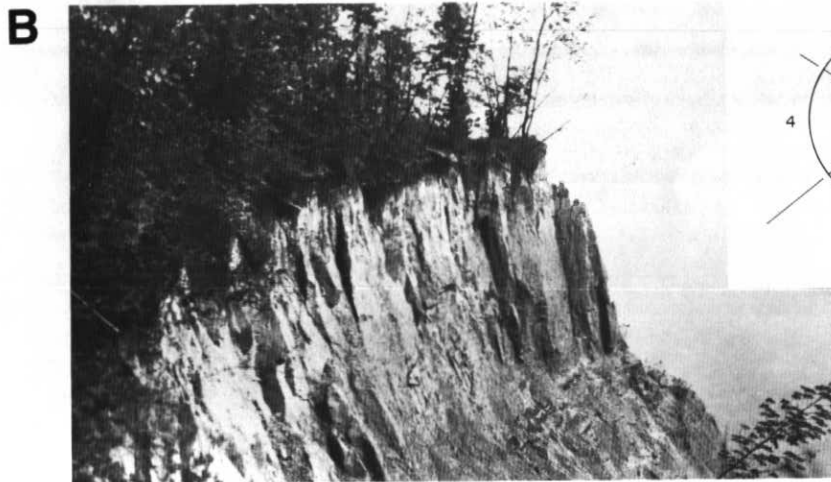
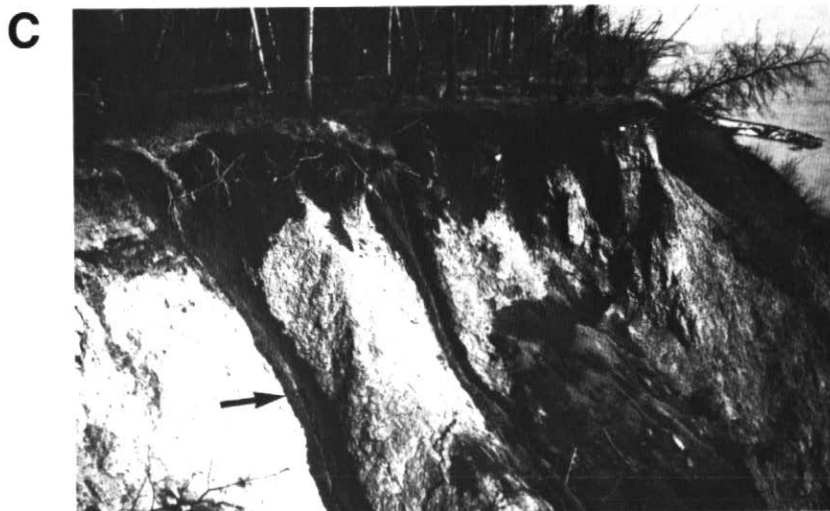
- 1 Bluff-parallel stress release joints.
- 2,3 Joints parallel to trend of palaeochannels in bedrock and on top of Scarborough sands.
- 4 Horizontal overburden stress release joints.

**Figure 13** **A)** Air photograph of multiple shallow rotational failures involving diamict in the area of South Marine Drive. Sunnybrook diamict fills a paleochannel (arrowed) cut into the underlying Scarborough Sands (Fig. 3); **B)** Joint sets affecting Sunnybrook diamict and penetrating into underlying Scarborough Sands. Numbers refer to relative order of importance of joint sets in South Marine Drive area; **C)** Surface derived snow meltwater emerging under pressure (arrowed) from joints exposed along open bluff face (March 1985). Joint fed recharge to sands at the base of the paleochannel (Fig. 3) results in high porewater pressures particularly where free release of water is prevented by a mantle of slump debris. Periods of rotational slumping are observed to be associated with release of water from slope
