Geological Hazards and Disasters in St. John's

DAVID LIVERMAN, NORM CATTO,
and MARTIN BATTERSON

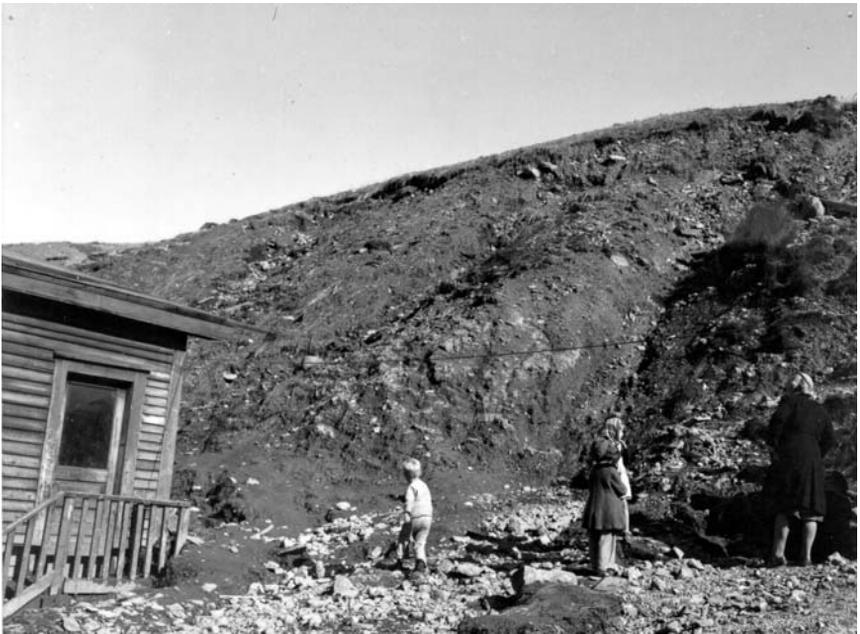
Figure 3. The scar left by the landslide of 15 September 1948 at 387 Southside Road (St. John's City Archives, used with permission).

Maureen Windsor (aged 3) was swept against the rear wall of the kitchen and apparently crushed against the chimney, being killed instantly. The landslide had, as in the 1936 disaster, broken through the rear wall of the house (Figure 3).

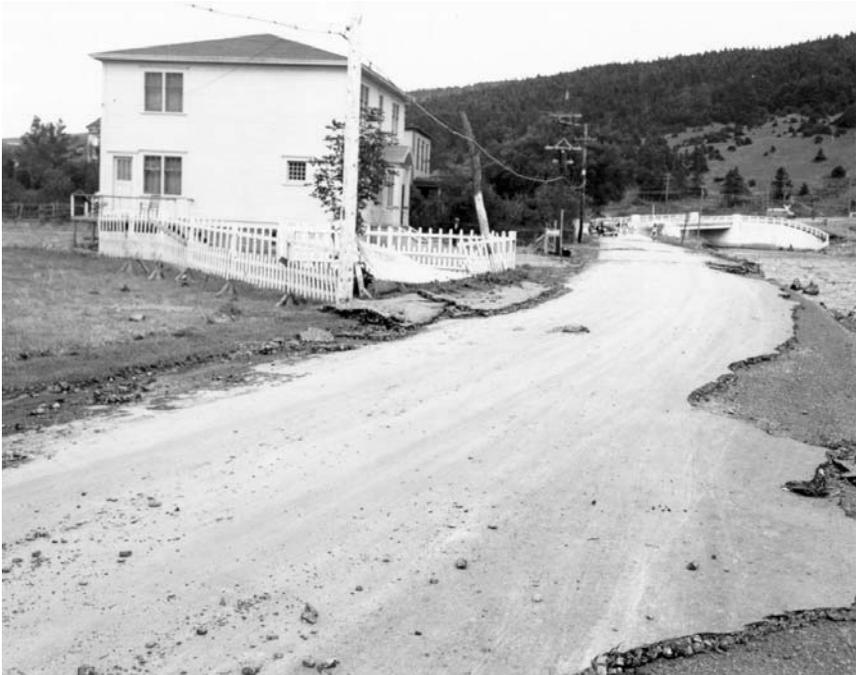
Figure 4. Flood damage on Southside Road, September 1948 (St. John's City Archives, used with permission).

for the flooding than the landslide. An *Evening Telegram* editorial (18 September) blamed poor planning for the flooding, which could have been prevented with proper culverting.

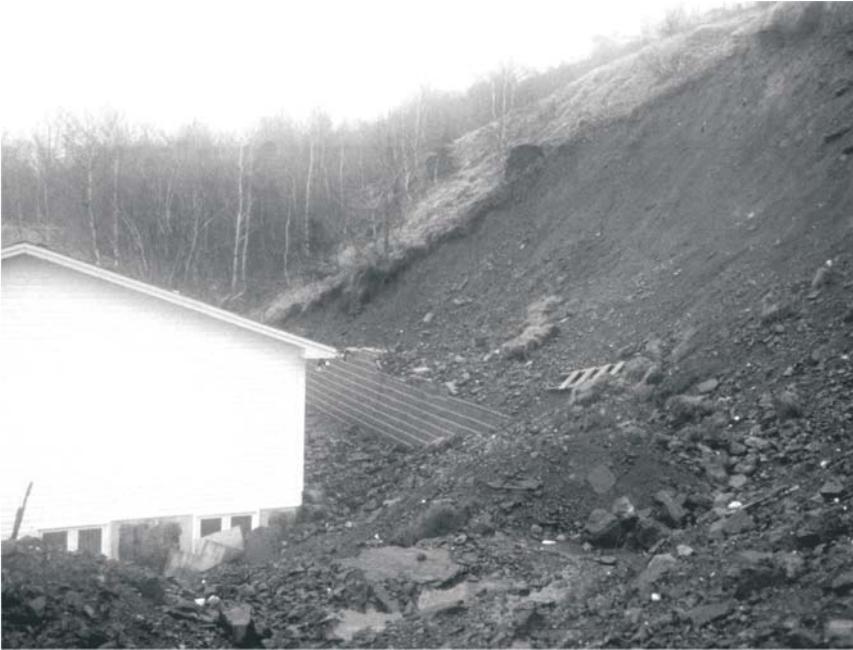
Figure 5. Recent construction on Southside Road, undercutting steep banks of till and increasing landslide hazard.

The slope stability and flooding problems no longer occur to the same extent, due to the construction of Pitts Memorial Drive in the early 1970s. This major highway is situated halfway up the slope, and much of the water that affected Southside Road is contained within ditches and culverts. Local residents state that flooding has not occurred for many years, although some difficulties persist along Symes Bridge Road. Slope stability, particularly rockfall, is still a problem on Pitts Memorial Drive after heavy rains and as a result of frost heaving. The road has been temporarily blocked completely or partially on several occasions since 1990. In spring 1996, a driver was injured when her vehicle hit rocks that had fallen into the road. Minor landslides have been observed on Southside Road after heavy rains. Currently, the City of St. John's, after consultation with the Newfoundland and Labrador Geological Survey, requires a geotechnical evaluation of slopes for any new construction in this area (Figure 5).

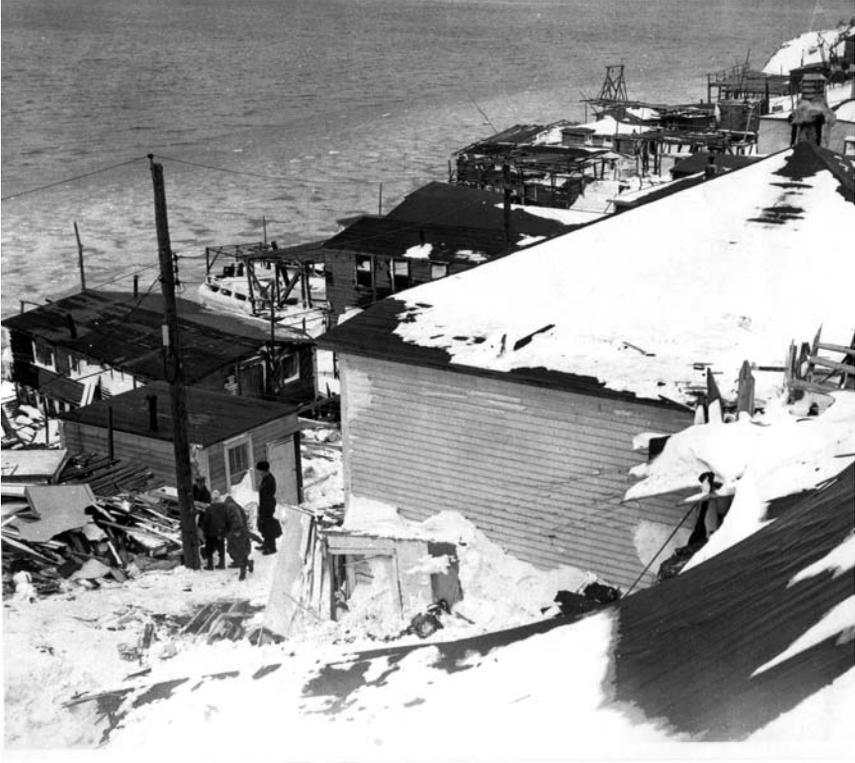
Figure 6. Aftermath of the 1959 Battery avalanche (from the collection of Shirley Eales, used with permission).

There are no records of further avalanches until 1959, when the worst geological disaster in St. John's history occurred. A ferocious storm hit St. John's on the night of 16 February, with winds reported up to 200 kilometres/hour, and depositing 55 centimetres (22 inches) of snow. At 1:05 a.m., residents in the Outer Battery heard a sound described as being louder than a clap of thunder. An avalanche struck two houses belonging to the families of Clarence Wells and Jim Piercey, sweeping them downslope and into the rear of two other houses. The houses contained 14 people who were all swept downslope and buried. Clarence Wells was the nephew of Alfred Wells, whose family was hit by the 1921 avalanche. The top storey of the Piercey house was ripped off, and the Wells house demolished (Figure 6).

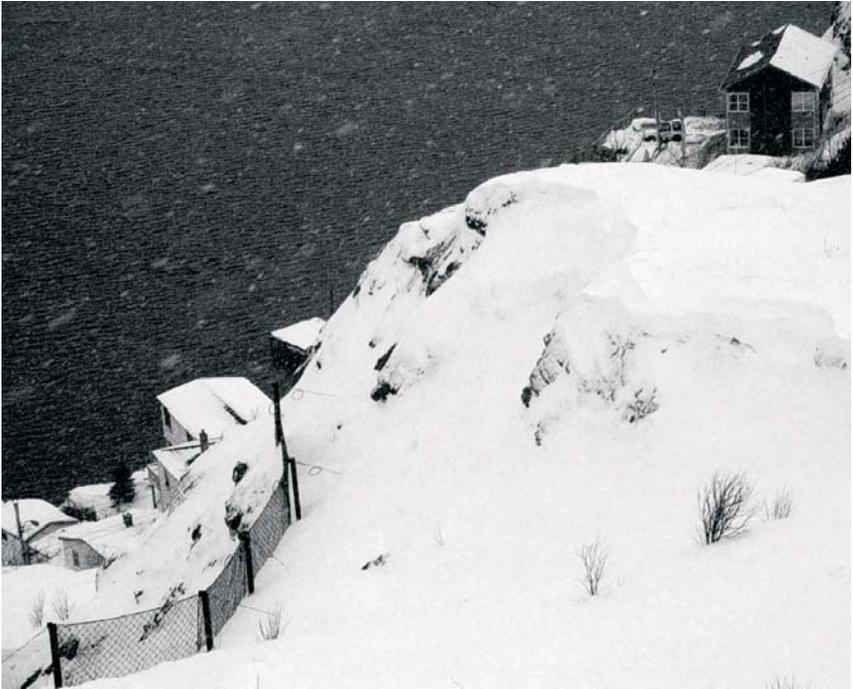
Figure 7. Protective fencing erected above the Outer Battery in 1998.

In October 1997, the City of St. John's let tenders on construction of safety fences and other measures to provide protection from rockfall and avalanche in the Outer Battery, with estimated costs in excess of \$300,000 (Figure 7). New warning signs have been placed on the North Head Trail to divert people from the slopes above the Battery. The protective fences were constructed in 1998 but have not yet been tested by a significant rockfall or avalanche.

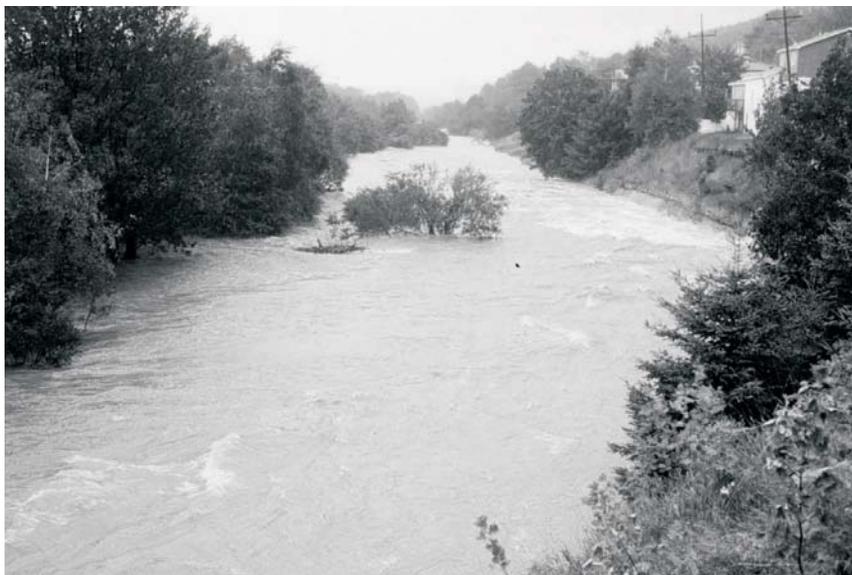
Figure 8a. The Waterford River in full flood, 19 September 2001.

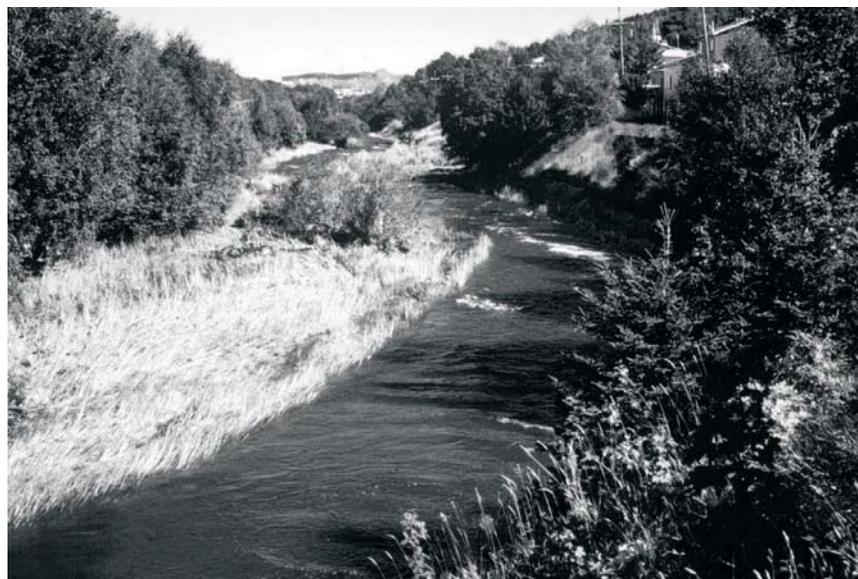
Figure 8b. Waterford River 24 hours later, showing effect of flood, and rapid return to normal water levels.

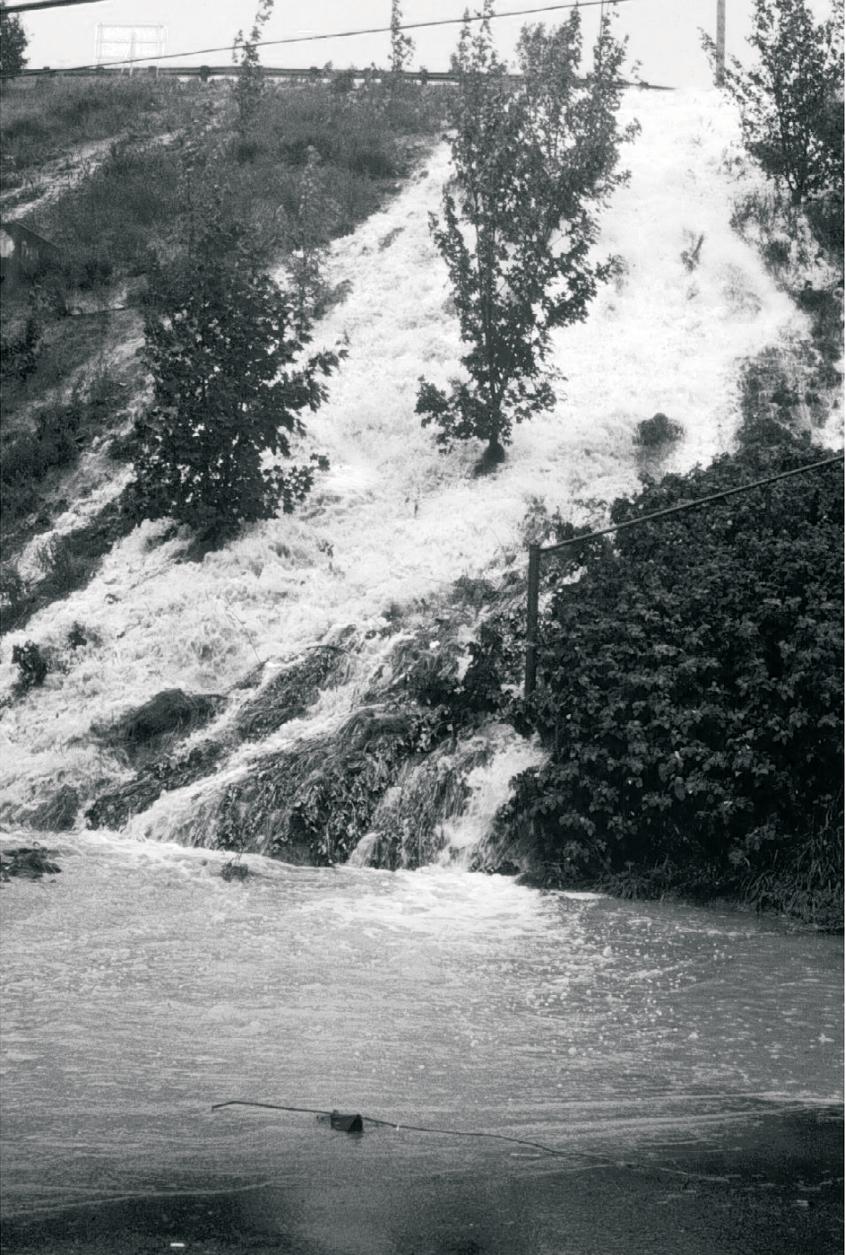
Figure 9. Waterfall created on Southside Road during September 2001 floods.

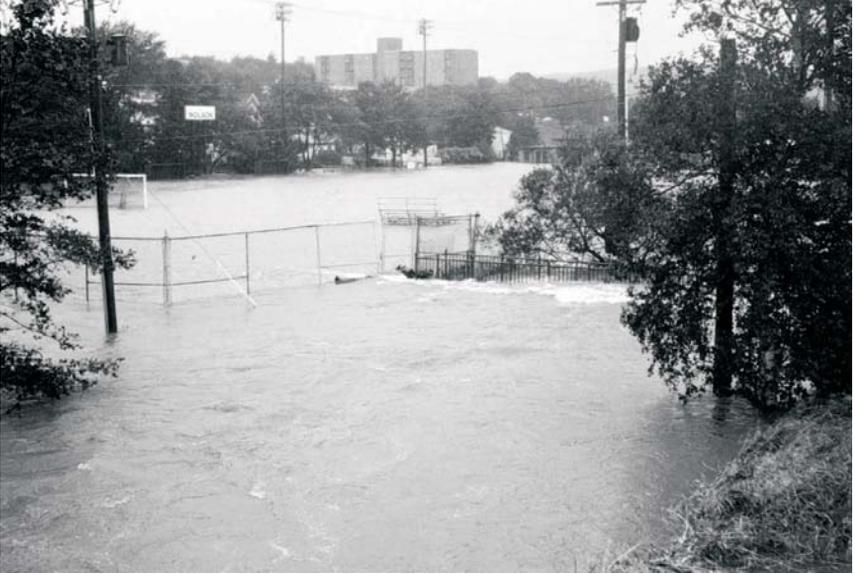
Figure 10. Floods cover soccer field at head of Quidi Vidi Lake, September 2001. Note footbridge over Rennie's River forming dam as it blocks flood waters.

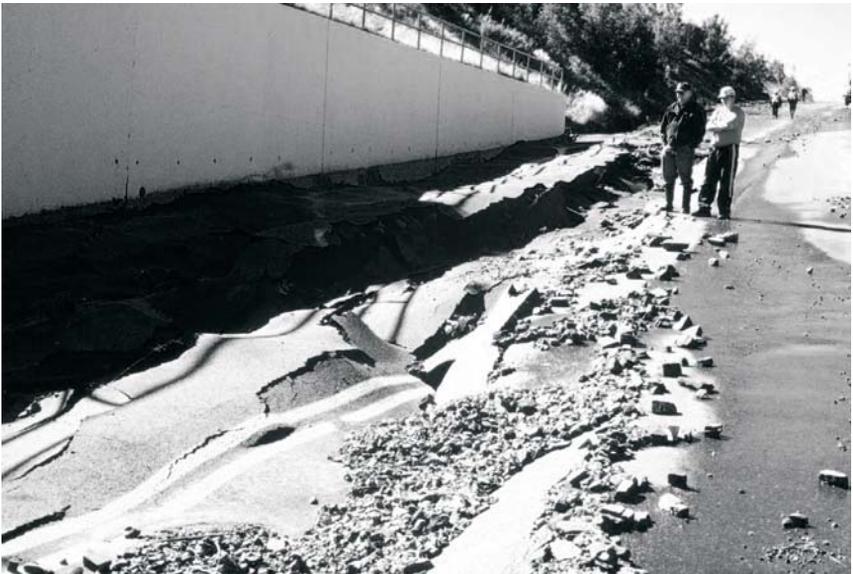
Figure 11. Flood damage on Shea Heights road, September 2001.

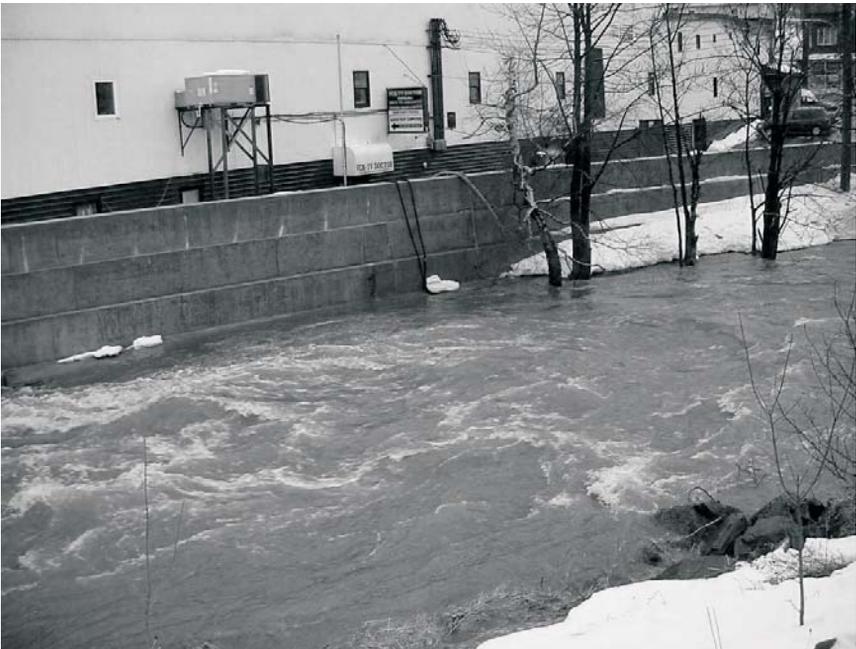
Figure 12. Flood protection, Waterford River, constructed after 2001 flood.

sional flooding. Thus by the 1940s, the area around Quidi Vidi Lake, previously mostly agricultural land, is often mentioned as being flooded, with houses damaged. By the 1960s, the Churchill Park-University Avenue-Avalon Mall area has been added to the area vulnerable to floods, and, by the 1980s, expansion of the city adjacent to the Virginia River, along Leary's Brook, and in the Goulds, meant that these areas were also vulnerable to flooding (Figure 12).
