A REPORT ON HYDROGRAPHIC ACTIVITIES FOLLOWING THE GREAT EAST JAPAN EARTHQUAKE

Hydrographic and Oceanographic Department,
Japan Coast Guard

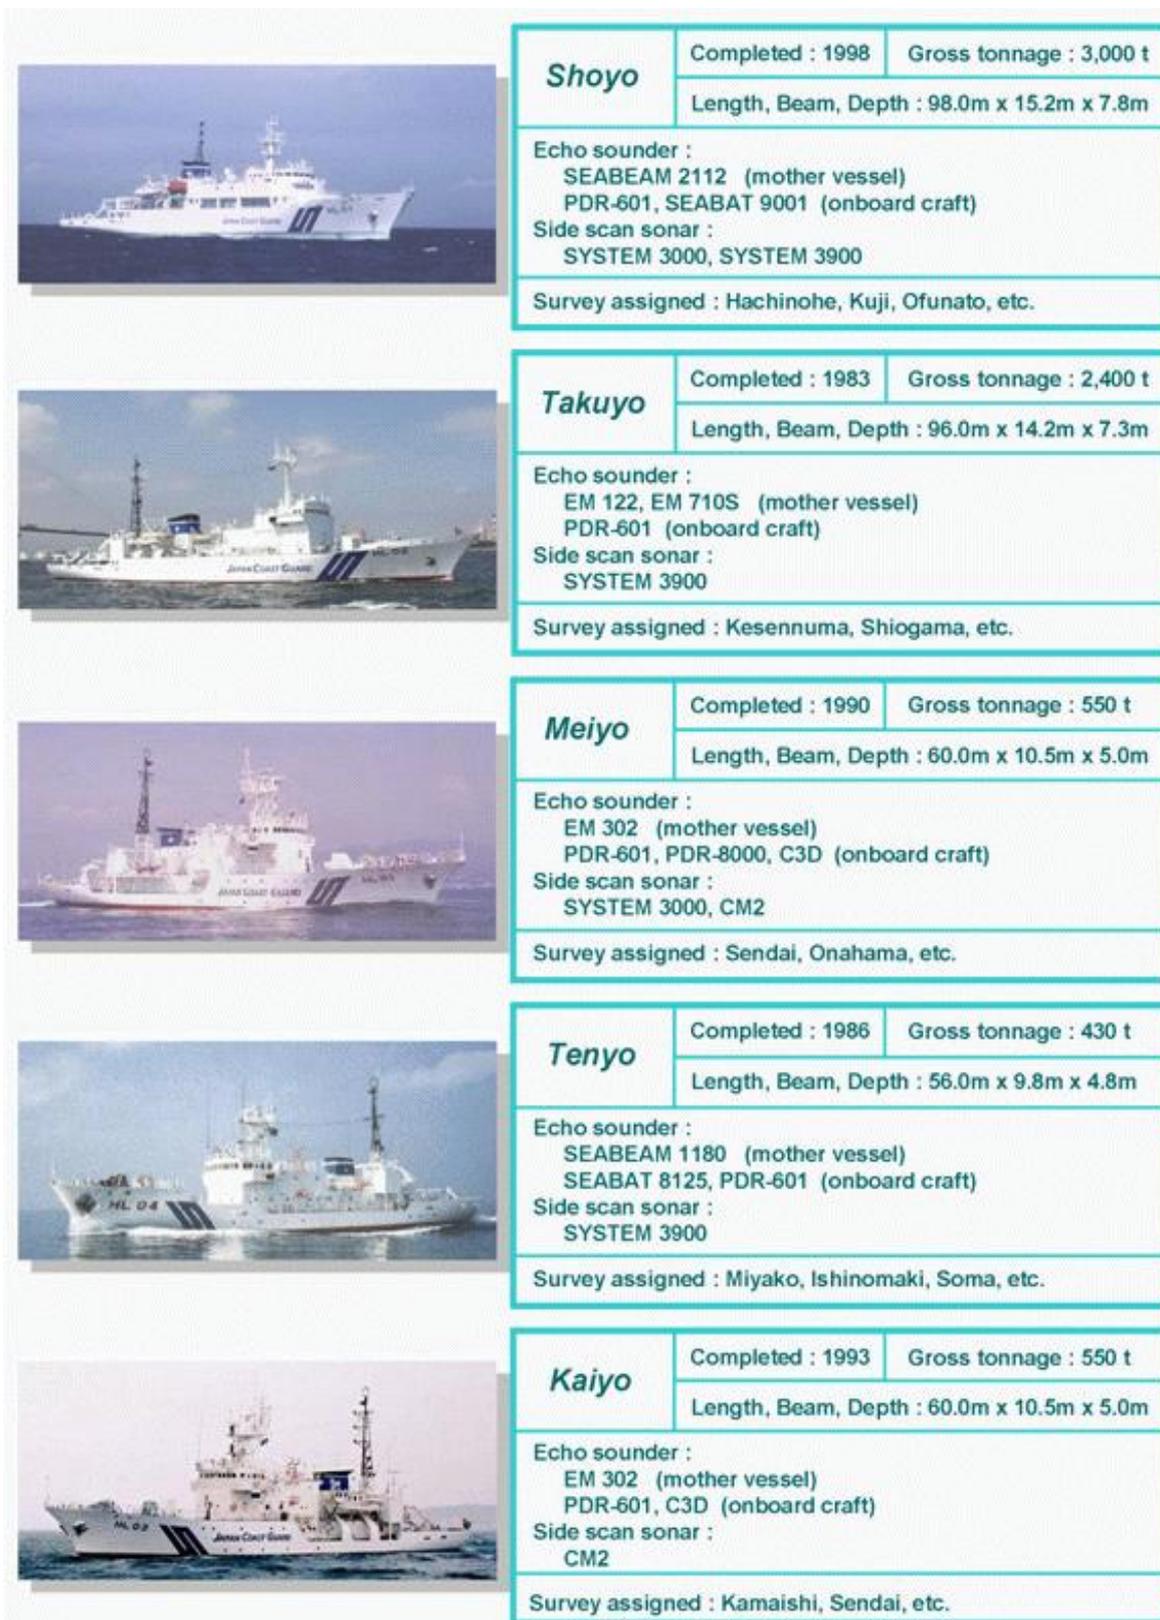
Figure 2 Specifications of the dispatched survey vessels.

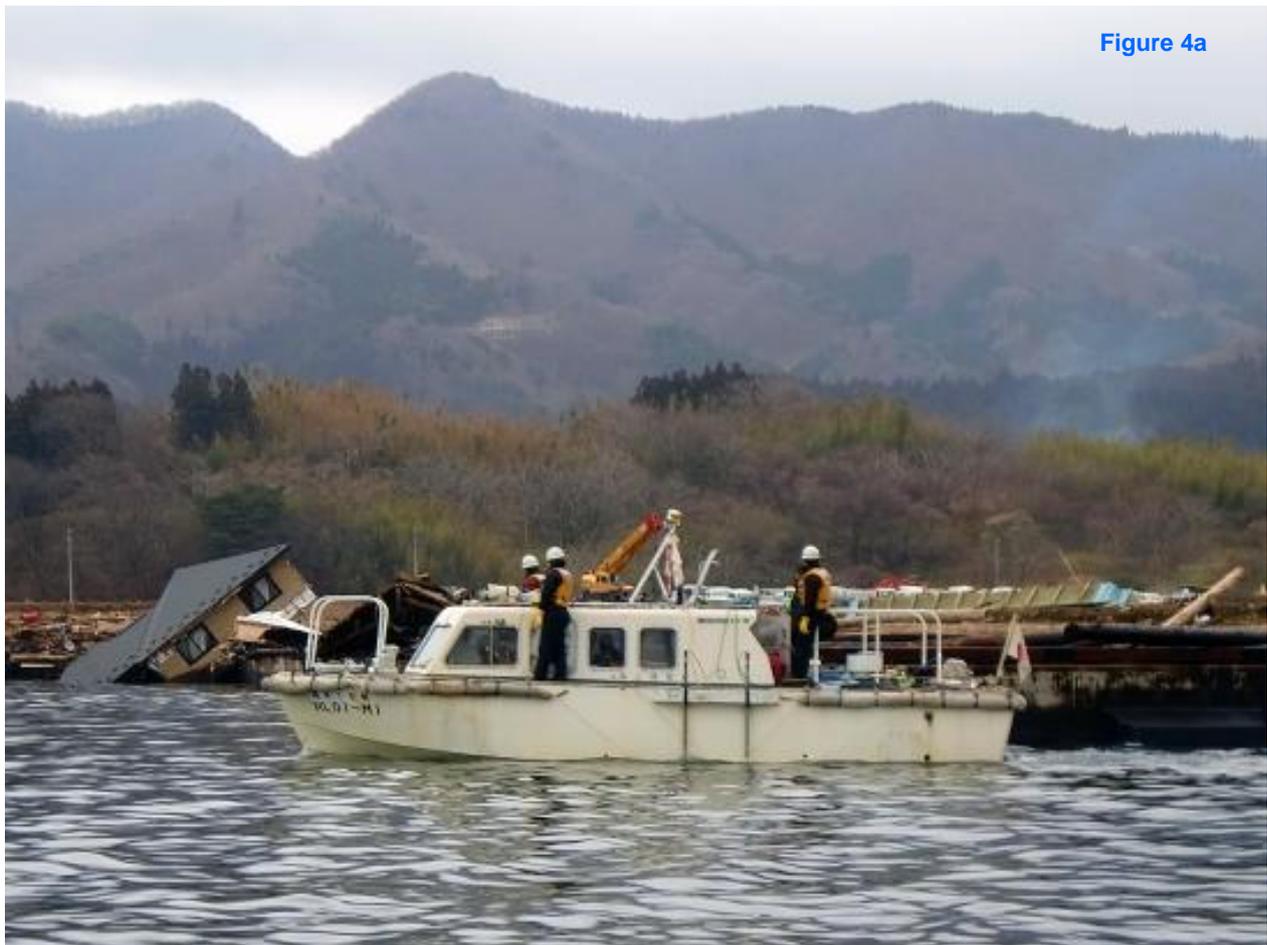
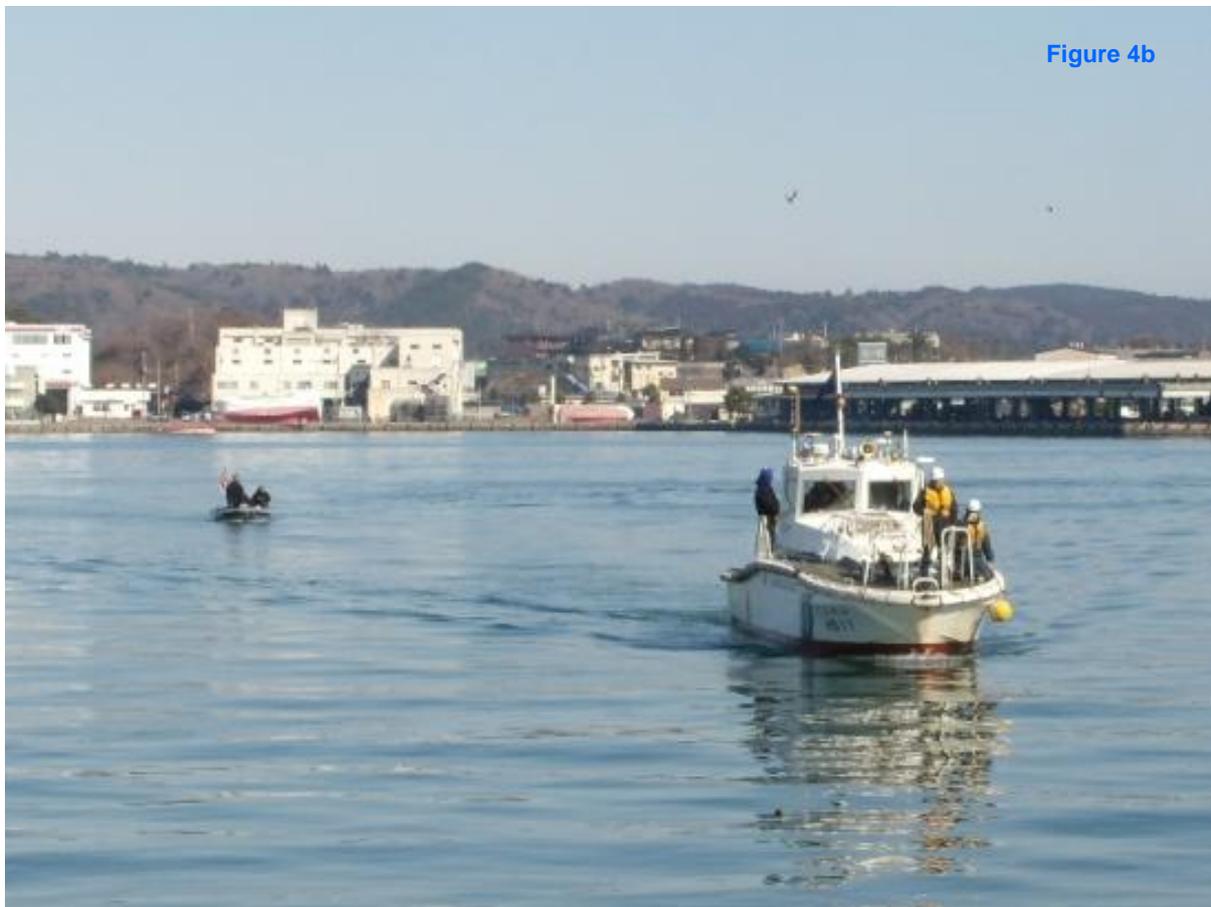
Figure 4a and 4b

The survey crafts engaged in the passage obstruction survey. a) Survey in Port of Ofunato, b) Survey in Shiogama Section of Port of Sendai-Shiogama. Maritime Self-Defense Force (rubber boat) supported our obstruction survey.

We identified passage obstructions on the seafloor using echo sounders and side scan sonars on survey vessels or onboard survey craft (*Figures 4a and 4b*). The most annoying obstacle during these surveys was nets and ropes drifting in the seawater. The survey vessels were repeatedly tangled up in these nets and ropes. These problems interrupted our surveys several times a day. At some ports, however, a diving unit of the Japan Maritime Self-Defense Force assigned to the areas supported our work by watching for obstructions around our survey vessels and craft with their rubber boats, or by removing tangled nets and ropes. This support helped us carry out the surveys without trouble. The port authorities removed the spotted large obstructions that could impede safe navigation of the vessels.

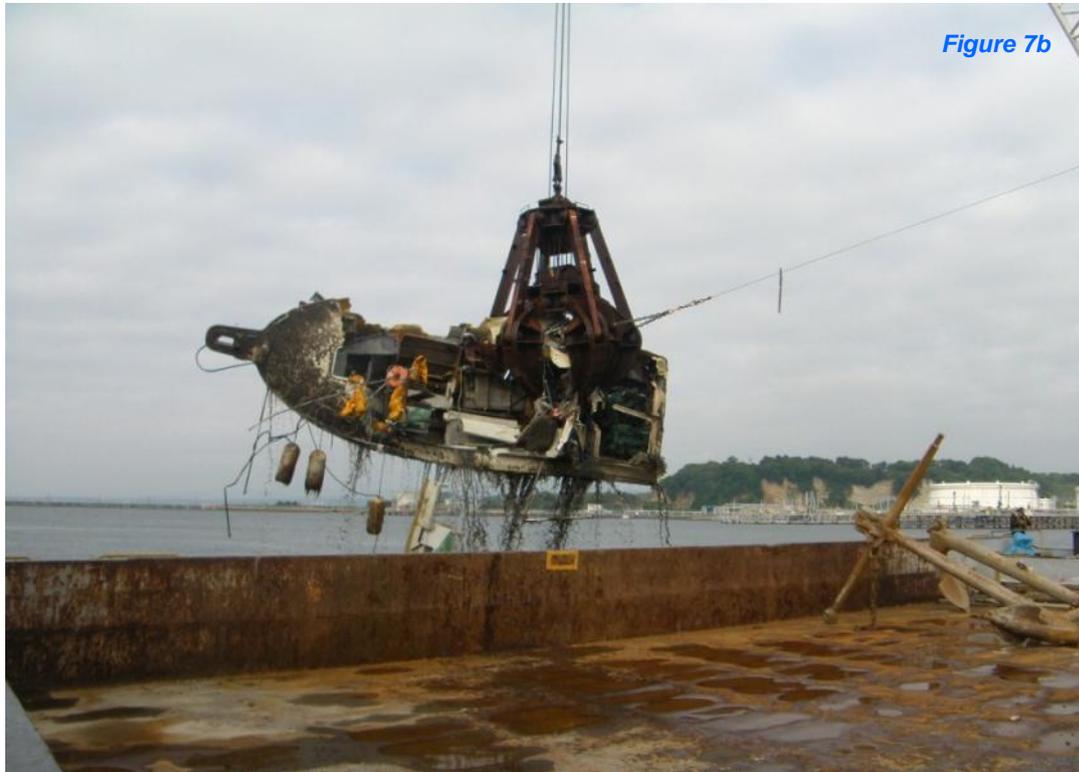
Figure 7a and 7b The record of a sunken pleasure boat on the seafloor measured by multibeam echo sounder (left panel) and the picture when it was salvaged (right panel).

The multibeam/singlebeam echo sounders and side scan sonars had an indispensable function to visualize the collected data immediately on site. This provided convincing information to the port authorities, who were then able to remove the detected obstructions. We realized that the onboard survey instruments to be used after the disaster must have a function of fast data processing speed as well as effective survey capacity. Figures 7a and 7b show sample records of a sunken ship on the seafloor and Figure 8 shows a fallen crane from a quay.
