# HYDROGRAPHIC SURVEY OF LAKE NYASA (1955 TO 1959)

by Lt. Cdr. R. T. BAILEY (\*), R.N.V.R.

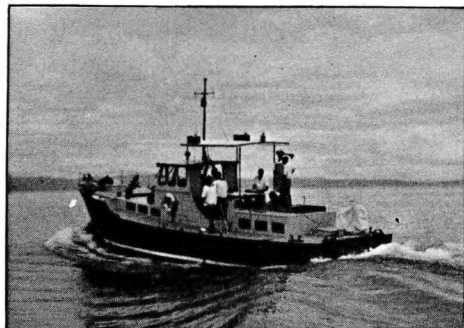
FIG. 4. — M.L. *Edmund Rhoades*, 46 feet, powered with two Gardner 6-cylinder diesel engines to give a speed of 10 knots.

Even before we reached the lake, or Africa, the need for a survey launch was realized. Using the hull design of a launch already being built for service on the lake, the lay-out of a survey launch was drawn up, and the building put in hand at the Berwick yard of the Fairmile Construction Co. Ltd. The hull dimensions had been very carefully planned to give clearance under the bridges on its journey by rail from Beira to the lake, and could not exceed 46 feet in length and 11 ft 3 in beam, with the moulded depth whittled down to something less than the normal for such a vessel. The superstructure was shipped separately. Had these limits not been accepted, it would have been a question of shipping the components of a vessel and reassembling at the lake shore. This has been the method adopted for all the larger vessels on the lake, including the first *Ilala*, brought out by Scottish missionaries in 1875, which was assembled at the Zambesi mouth, steamed up the river, dismantled and portaged in head-loads up the Murchison cataracts of the Shire River, and finally reassembled at the lake. It was a great day in March 1957 when the *Edmund Rhoades*, named after our predecessor, reached the railhead at Chipoka and was lowered successfully into the lake by an ancient break-down crane strained to its creaking limit. Every movable piece had to be stripped out of the launch to reduce her weight to less than the safe working load of 20 tons.

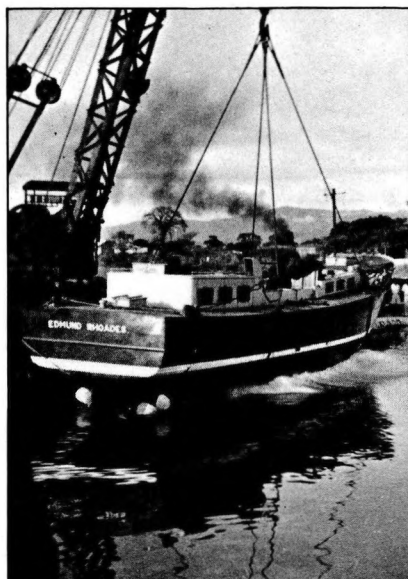
FIG. 8. — The stripped hull of M. L. *Edmund Rhoades* is lowered by crane into the waters of Lake Nyasa at Chipoka, at the end of her journey by sea and rail from England.

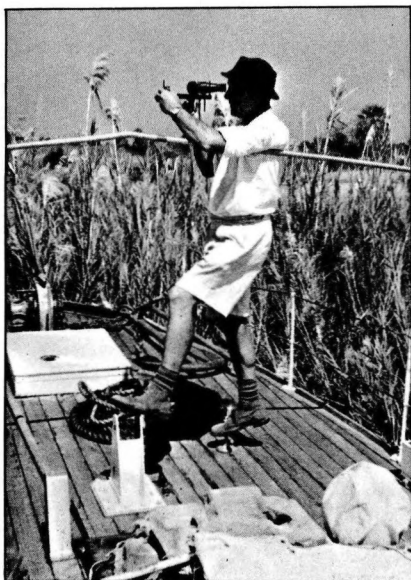
FIG. 9. — *End of line.* Lines of soundings were frequently carried right up to the shore. Commander TRIPP takes a sextant angle.

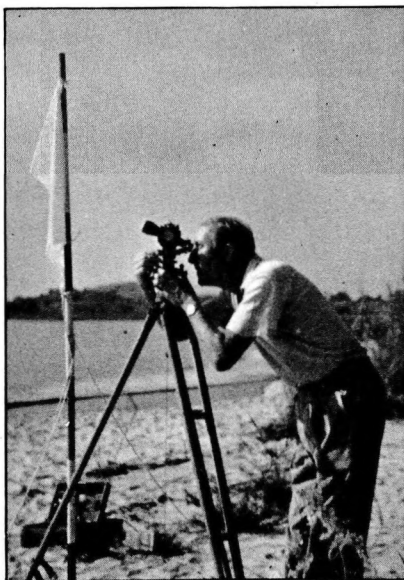
FIG. 10. — The author observing the sun for azimuth at the end of one of the beach base lines.
