THE DEMOLITION OF RIPPLE ROCK

by Mr. J.I.A. RUTLEY(*)

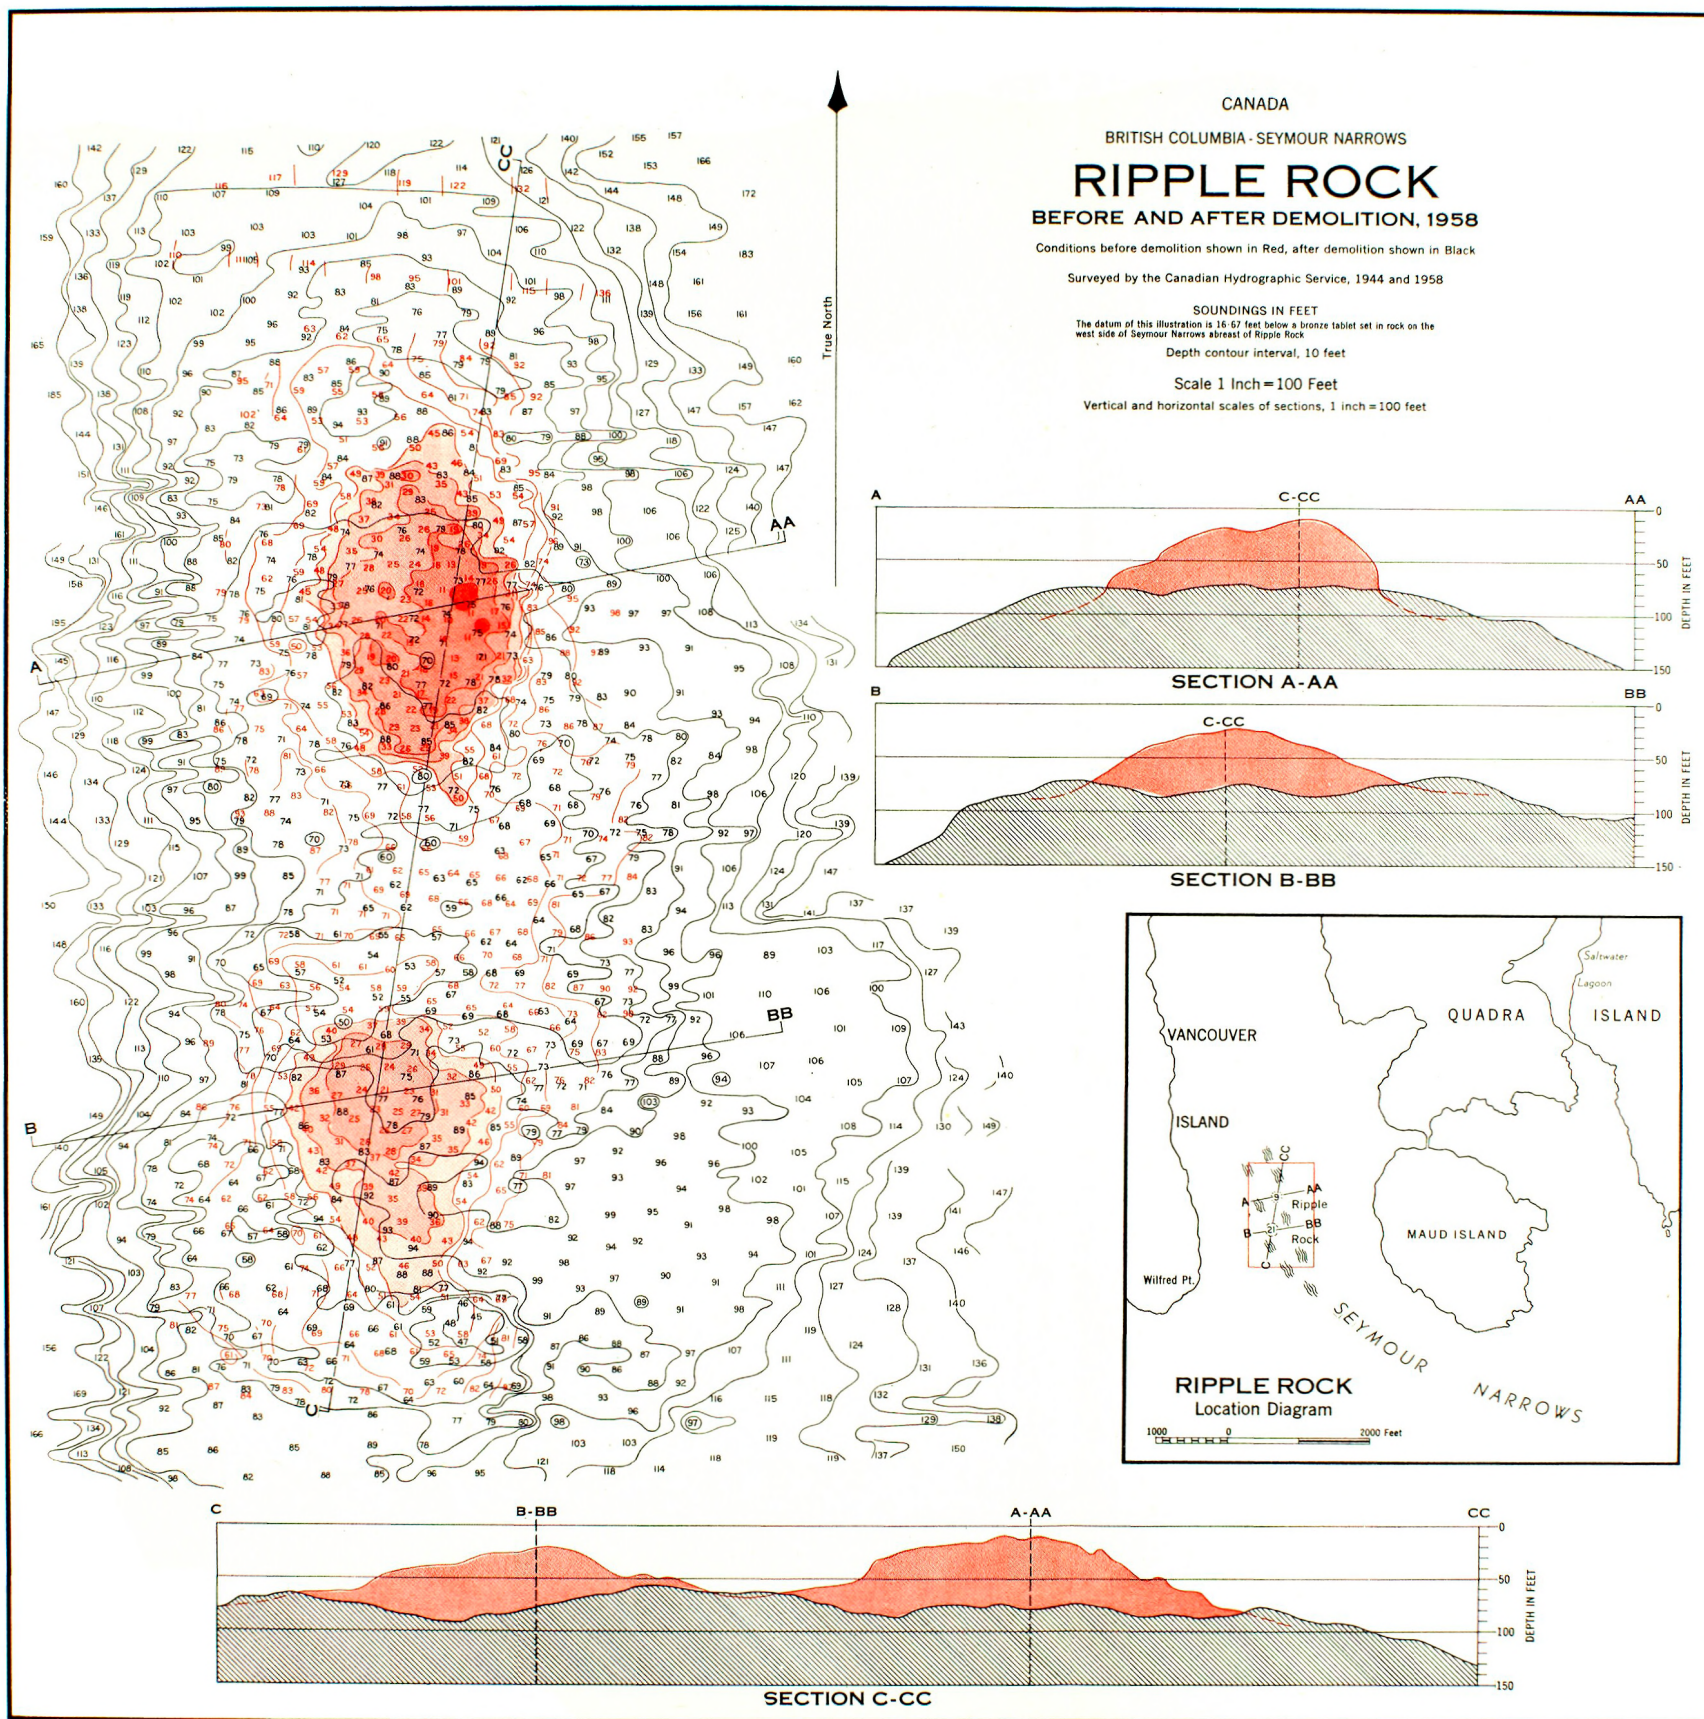
FIG. 4

That the result of this carefully planned and massive blast was entirely successful, is shown by a comparison of depths before and after demolition. (See chart fig. 4).

On the northern peak where there had been a depth of 9 feet, there is now a depth of 75 feet and over the entire area, formerly above the 10-fathom line, there is now a least depth of 70 feet.

On the southern peak, where previously there was 21 feet, there is now 77 feet, and little of the rock summit that rose above the 10-fathom line remains. The southern patch, extending above 10 fathoms, contains the shoalest depth on Ripple Rock, 45 feet, and as this is located in an area where there was formerly a depth in excess of 60 feet, this shoal consists of rock fragments dispersed by the blast. The larger northern area, extending above 10 fathoms is, in part, fragments of dispersed rock, as is the small 59-foot shoal close northward of it. Another shoal area with a least depth of 57 feet, consisting of rock fragments, lies about 180 feet southeast of the former southern head.

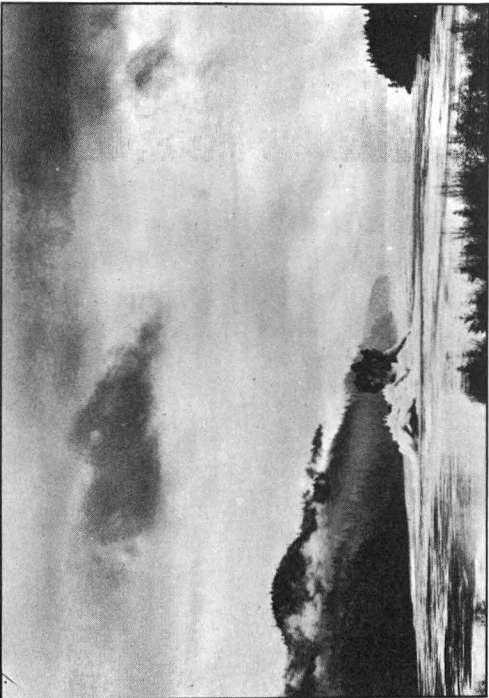
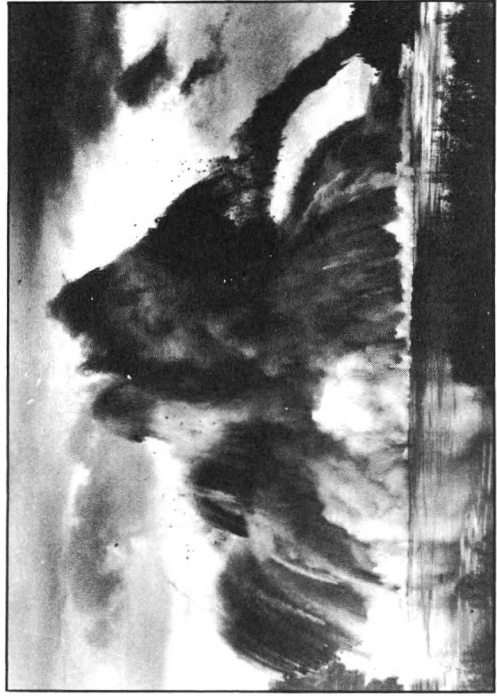
FIG. 7. — The blast at 9 31 04 a.m.

FIG. 9. — The blast at 9 31 09 a.m.

FIG. 6. — The blast at 9 31 02 a.m.

FIG. 8. — The blast at 9 31 07 a.m.

A feature of this demolition project, having particular interest to explosives, mining and construction engineers, as well as the public, was its great size. It was the largest non-atomic blast ever set off (see figures 5 to 9), a total of 2 756 324 pounds of explosives with a theoretical force, estimated by Du Pont technicians, capable of lifting the Empire State Building a mile in the air. The blast provided information on large underwater explosions previously unknown.
