VI. – LOW-WATER PHOTOGRAPHY IN COBSCOOK BAY, MAINE by Bennett G. JONES,

Coast and Geodetic Survey

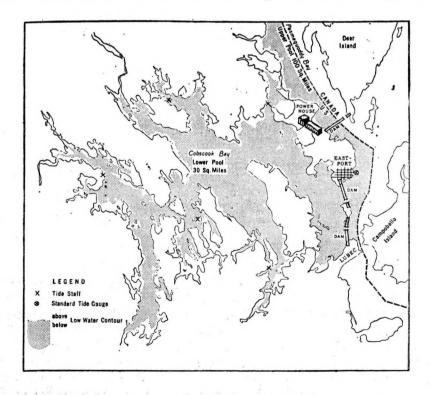
Fig. 1. Map of Cobscook Bay and vicinity.

Many readers of this paper will remember the Passamaquoddy Tidal-Power Project that received so much attention prior to and, particularly, during the early The project was not then completed but is again under study by the Corps 1930s. of Engineers. One plan for this power development is illustrated in figure 1 and is outlined briefly as background information. The water storage-area comprises some 130 square miles of Passamaquoddy Bay in New Brunswick and Cobscook Bay in Maine. The intake and outlet of tidal water into this vast storage-area will be controlled by dams and water gates that will also permit navigation to and from the Bay of Fundy. The inlet of tidal waters will be through gates at the Eastern entrance to Passamaquoddy Bay (outside of and north of the limits of figure 1). Passamaquoddy Bay will then comprise the upper water storage-area. Power generating-stations will be located in the narrow pass between Passamaquoddy and Cobscook Bays just north of Eastport. Water will be let out of the lower pool at the gates between Eastport and Lubec and controlled so that the minimum head between the upper and lower pools for generation of power will be not less than 6 or 8 feet. The vast volume of water will permit power generation under relatively small head.

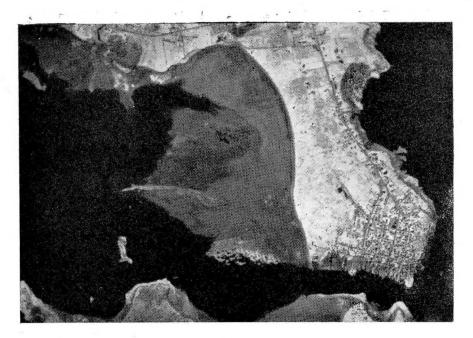
Fig. 2. Infrared photograph of low-water areas near Lubec, Maine.

Here was a gamble and not much different from the throw of dice. With all this preparation would we get photographic weather in the three available days? September 30 broke bright and clear and all tide staffs, including the staff at the Eastport gage, were occupied for observations during the low-water and half-tide photography. I can well remember sitting in a skiff reading the Eastport staff and listening for the drone of motors on that morning. We had the weather; would some mechanical failure on the plane make it impossible to take advantage of the weather? About 1000 I thought I detected a faint roar in the distance and soon the B-17 was overhead in the sunlight, taking simultaneously infrared and panchromatic single-lens photography. It was a beautiful sight and one that I shall not forget. The half-tide photography was completed at about 1130 but the plane remained in the air to start the low-water photography at about 1300 and completed it at 1430. Additional lower-altitude, low-water photographs were taken on October 2 but the job had to wait for the tide and could not be completed until about 1630, much too late in the afternoon. There was not enough light and shadows of trees were long. This affected the quality of the panchromatic photography much more than the infrared; the low-water line on the latter turned out to be quite clear and was apparent even through dense tree shadows. Figures 2 and 3 are copies of infrared and panchromatic photographs of one of the tide flats, and while not as clear as the originals, they illustrate the difference in definition of the water line and the superior quality of the infrared photography for this purpose.
