# PORTO-RICAN — NICARAGUAN AERIAL SURVEY.

(Extract from the Report of LIEUTENANT C. Mc GAULY, U. S. N.,  
COMMANDING OFFICER OF THE AERIAL SURVEY DETACHMENT, published by permission of  
REAR-ADMIRAL W. R. GHERARDI, U. S. N., HYDROGRAPHER).

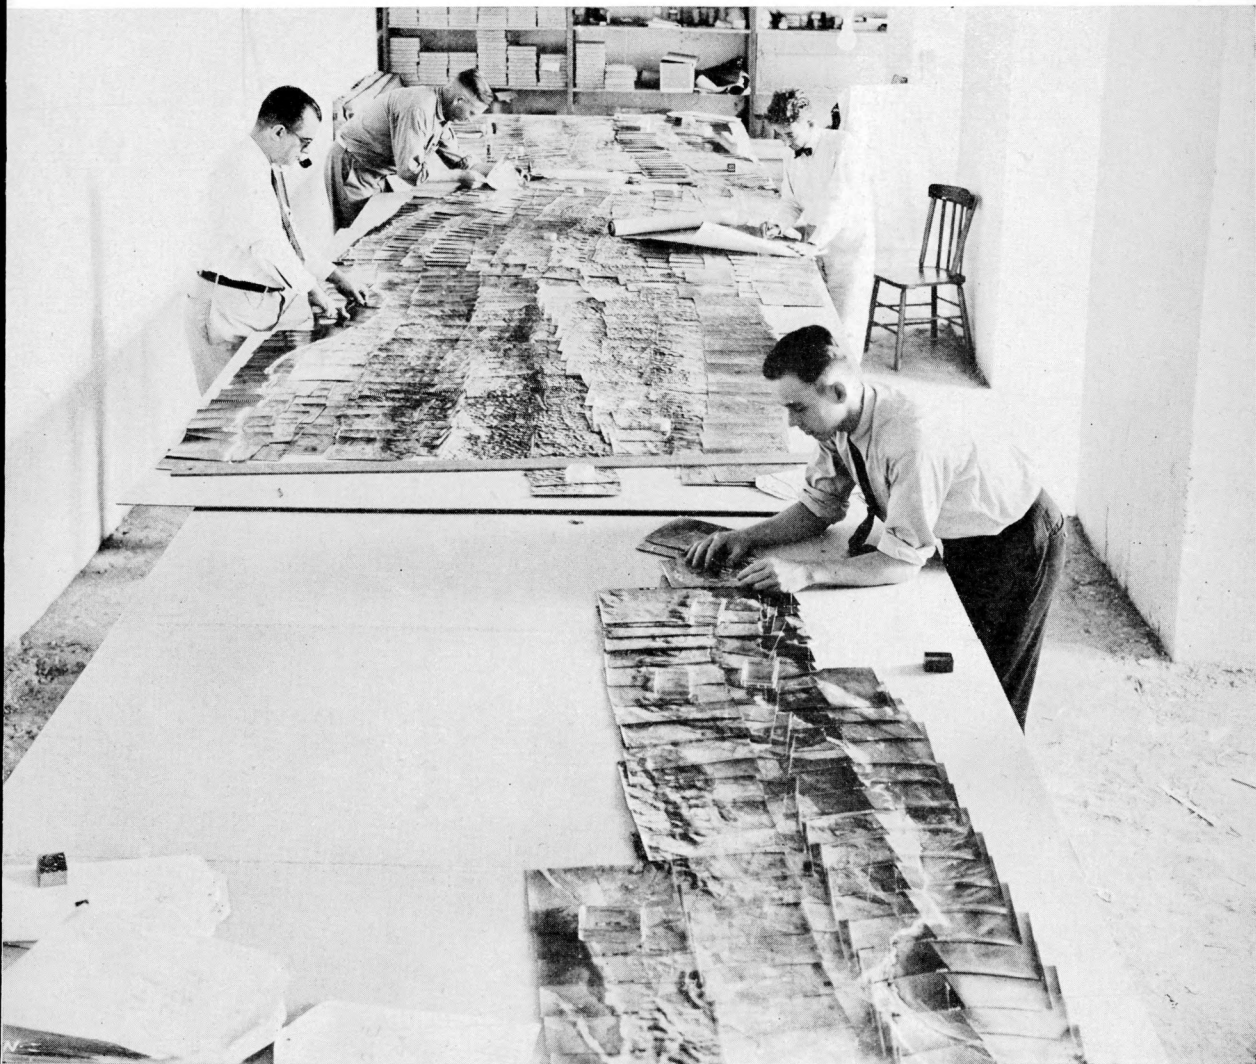
*Porto-Rican Survey — Levé à Porto-Rico*
