IMPACT OF CYCLONE IDAI ON THE HYDROGRAPIC SERVICES THE CASE OF MOZAMBIQUE

By S. Canhanga, S. Munguambe, H. Chavango and E. Macia
(**INAHINA - National Institute for Hydrography and Navigation**)
E-mail: scanhanga@inahina.gov.mz

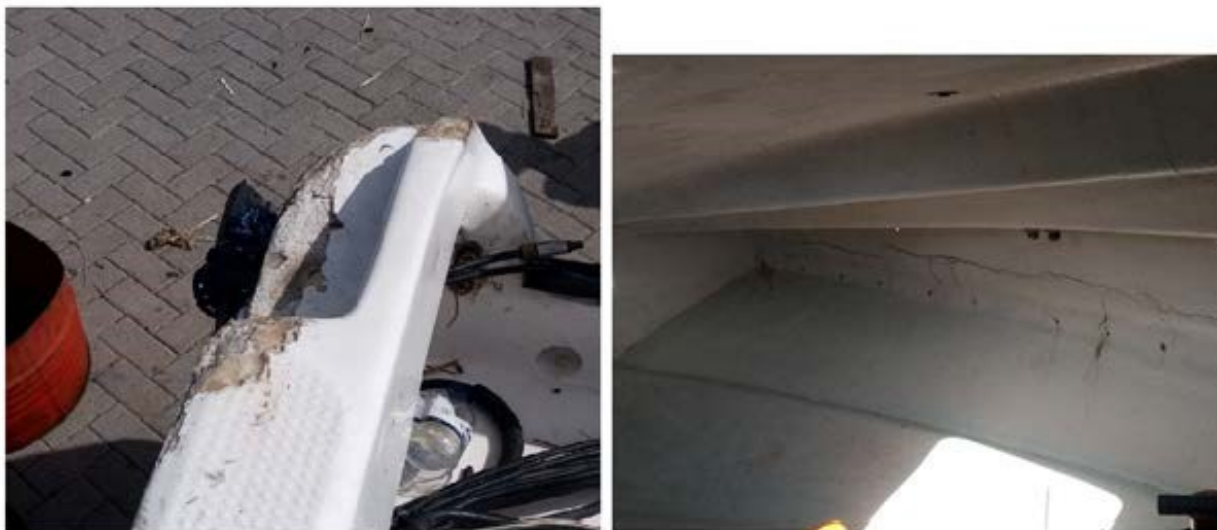
The Hydrographic boat *Lago Niassa* with all hydrographic equipment installed, drifted during the passage of the tropical cyclone Idai, and was found aground near the mouth of Buzi River, at a distance of approximately 10.0 Km from the quay/pier where it was docked. With assistance of a Vessel from the Fishery Office, the hydrographic boat was retrieved and brought back to the pier/quay. The mission assessed the vessel conditions, and the main findings were:

- The access door to the cabin broken
- Several breaches on the boat
- Failures of the starboard engine
- Damage to some of the hydrographic survey hardware

Figure 3 illustrates the damages suffered on the hydrographic boat *Lago Niassa*, upon the passage of cyclone Idai.

Figure 3: Damages from Cyclone Idai on the hydrographic survey boat. On the left side can be seen the breaches in the boat.

Due to the significance of the damages identified, the lack of capacity to repair the boat locally, the need to have this unit in Beira to support the maintenance of the Buoys along the Beira ac-

cess Channel, the boat was sent afterwards to one shipyard in Maputo, for restoration. The costs associated with restoration, as well as the mobilization costs of the boat to the Maputo Shipyard, was estimated at USD 40.000 (INAHINA, 2019).

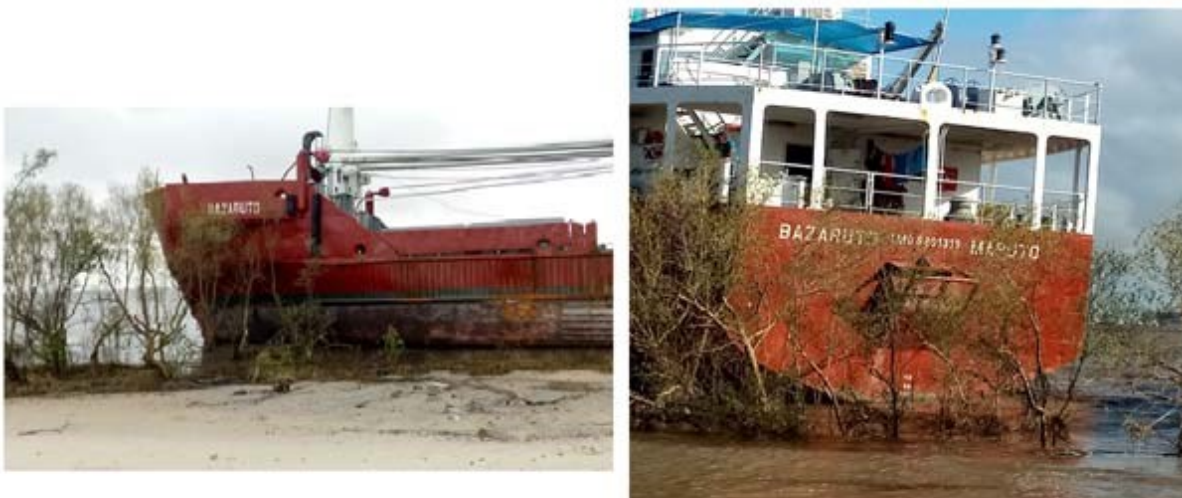
INAHINA maintains a Buoy Tender, *Bazaruto*, 52.3 meters length 11.2 meters beam, and 3.5 meters draft. Due to the very intense winds of approximately 230 Km/h, and higher wave heights likely exceeding 10 meters, the vessel crew withdrew from the vessel after starting the breaking of the vessel's mooring lines. The vessel drifted during the night running aground into mangroves, at a distance of approximately 2.5 Km from the quay. The mission assessed the vessel conditions, and the main findings were:

- A breach in the collision-tank
- A tear on the bow

Figures 4 below illustrate the damages suffered on the Buoy Tender *Bazaruto*, upon the passage of cyclone Idai.

Figures 4: Illustration of the Buoy Tender Bazaruto grounded approximately 2 Km from the quay.

After small technical intervention made by INAHINA, in collaboration with the other National companies, the vessel was finally rescued from its grounded position and docked again in the Beira quay/pier. The rescue operation was made by contracting a South Africa company, at a cost of approximately USD 45,000, and currently the Vessel is still docked for restoration. These interventions may cost approximately USD 100,000.

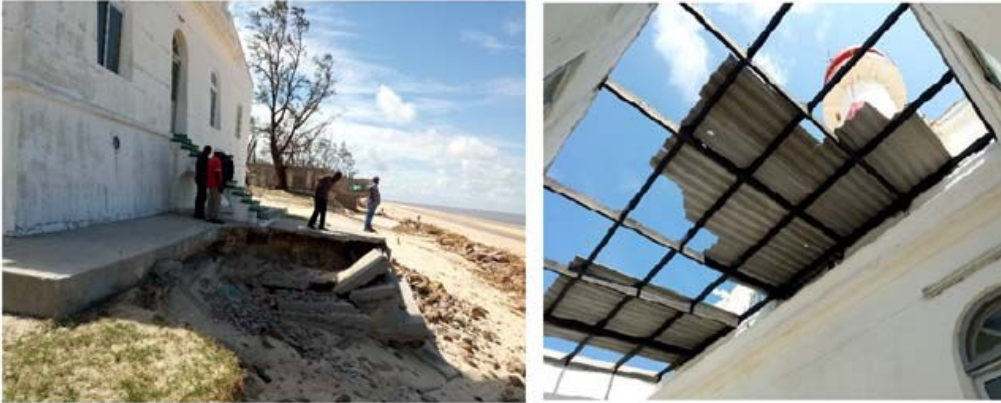
Illustration lighthouse upon the

Findings in the lighthouse were as the followings:

- The protection wall was completely destroyed
- The sand material around the lighthouse had moved, exposing the underlying lighthouse structure to saltwater, and leaving the steps to access the lighthouse at risk of collapse.

Figures 5 below show the damages suffered on lighthouse, upon the passage of cyclone

Figure 5: of the damages passage of cyclone Idai. It can be seen from the picture the removal of sand material, as well as the risky of collapsing the steps that provide access to the lighthouse

The mission identified a consulting company to assess the damages and come up with a technical and financial proposal to restore the lighthouse. The restoration includes building of a structure for coastal protection. The restoration costs of the lighthouse, including the technical study, is estimated at USD 750 000

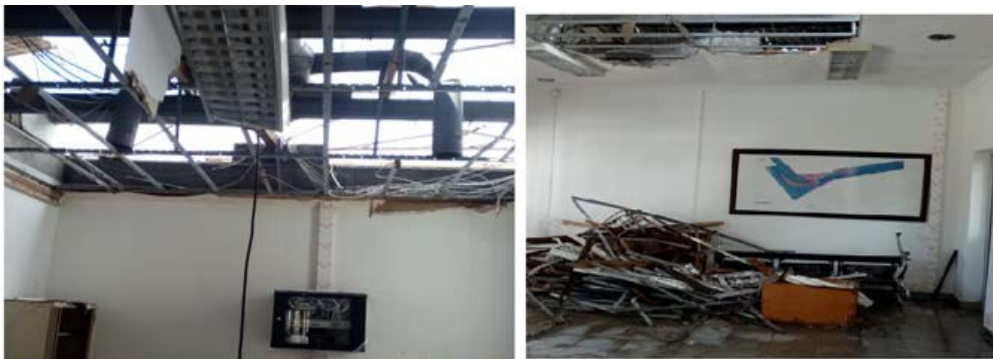
The cyclone Idai has caused:

- The removal of the roof of the INAHINA's office in Beira
- Destruction of all the furniture
- All the computer equipment was damaged due to rain and saltwater intrusion into the office
- All the documents and archives were wet as result of water entering into the offices

Figures 6 below illustrate the status of the INAHINA's office, upon the passage of cyclone Idai.

Figures 6: Illustration of the INAHINA's Office upon the occurrence of cyclone Idai. From the figure it is possible to see the damages on the computer equipment, ceil, and furniture.

The estimated costs for recovering activities of the INAHINA's office in Beira is estimated to be

approximately USD 120000.
