A Planter House: The Simeon Perkins House, 1766-7, Liverpool, Nova Scotia

Allen Penney, Associate Professor
The Technical University of Nova Scotia

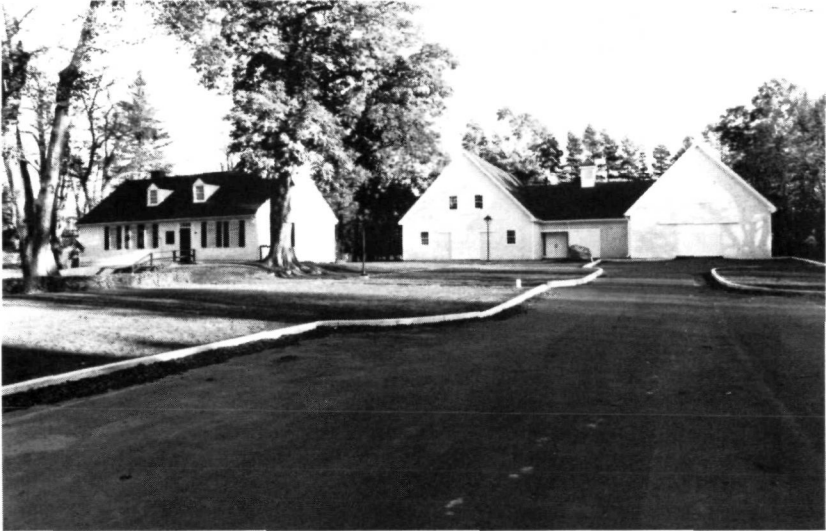
1. The Simeon Perkins House in 1982 with the new Queen's County Museum built beside it. The size and proximity of the latter are an aggressive and unfortunate intrusion, diminishing the house.

Our interpretation of any house is greatly influenced by the setting. The Simeon Perkins House (Figure 1) was built in 1766 in Liverpool, Nova Scotia.² By 1981 it had become severely compromised as a historic house because of the dramatic change in its context.³ Visually overpowered by a new museum built too close beside it, Perkins house had become a cottage in the front yard of the museum.

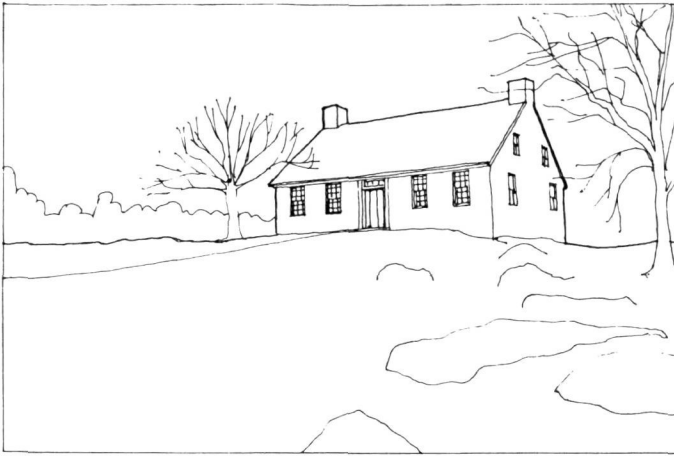
5. The Moses Farnham house at Uxbridge, Massachusetts, built in 1766 and located about 65 km north of Norwichtown, Connecticut. Although built of brick, this house is remarkably similar to the initial phase of the Perkins house. There are end chimneys within the exterior wall, corner fireplaces in the main rooms and there is a central hallway with a staircase boxed in with vertical boards. Drawn from a photograph taken in June 1894, the original is in the collection of the American Society, Worcester, Massachusetts.

With this evidence of the owner's personal life, we can now attempt to interpret his house. Even the most ordinary descriptions of the architecture are confused by obscure terminology or mis-information. A standard design of house throughout New England is the so-called 'Cape Cod' or 'one-and-a-half storey' house, which are misleading terms and might be replaced with the more accurate 'floor-and-a-half' house, for the houses are externally single storey and internally are undoubtedly two stories high with an upper floor reduced in size by the lack of headroom at the eaves. These houses are typically built with a massive central chimney where several fireplaces are connected into one flue. Much less common is the house with end chimneys, though they can be found, including a brick house (Figure 5) in Uxbridge, Massachusetts, built the same year as Perkins House in 1766. It too has corner fireplaces.

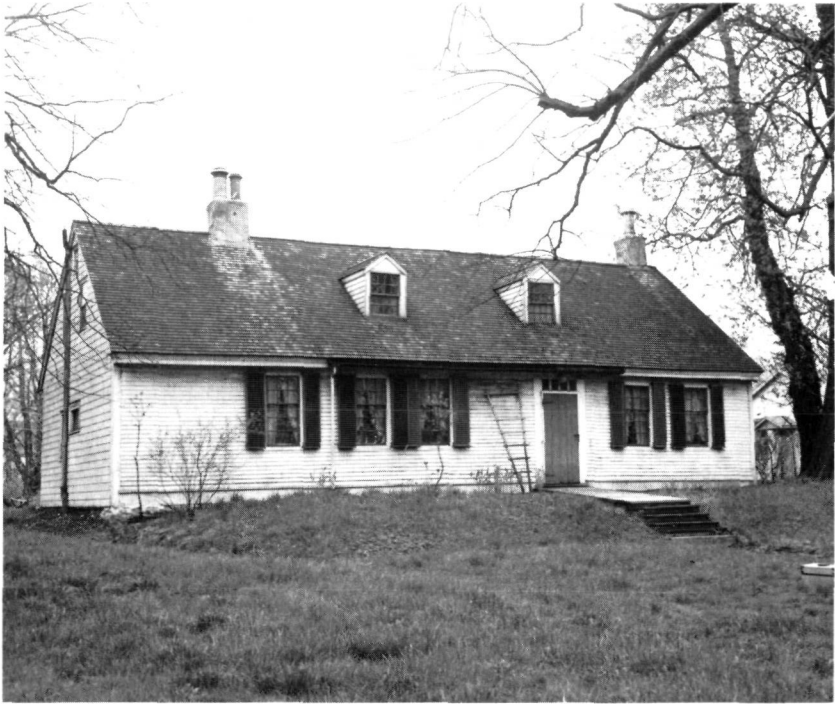
9. The north front in 1947. Note the horizontal window and plumbing stack on the east end, (left hand side) and the Victorian Gothic Chimney Pots. The overall deformation of the house can be seen by the drooping ends.

Board cuts in the main roof show where the chimney was first positioned. Simeon Perkins wrote that he called in a “chimney doctor”⁴⁰ for this chimney, but later photographs suggest the “doctor” was unsuccessful in his cure because Gothic Revival style chimney pots were added during the latter half of the nineteenth century and were still in place in 1947.⁴¹
