Earthquake Reconnaissance: Guatemala, February 1976

D.H. Weichert
Division of Seismology & Geothermal Studies
Earth Physics Branch
Department of Energy, Mines & Resources
Ottawa, Ontario K1A 0Y3

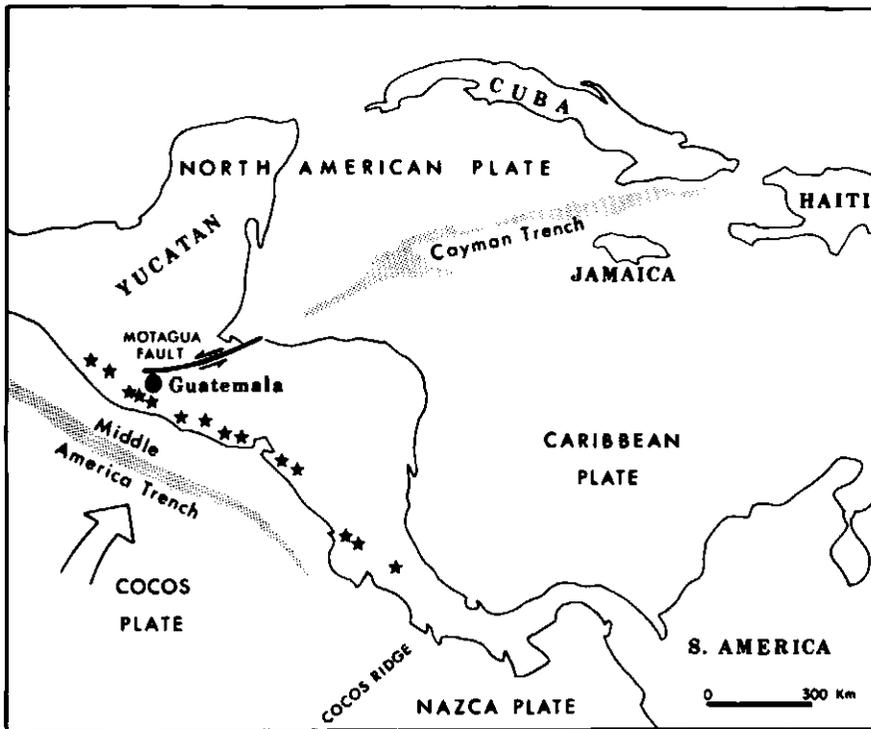
Figure 1
Schematic tectonic map of the Caribbean and Central America.

Information Service as 15.27° N and 89.25° W, in the Motagua valley, as shown in Figure 2, about 160 km northeast of Guatemala City at a shallow focal depth of perhaps 5 km. The great damage and location of this earthquake suggested a different global tectonic mechanism, also shown in Figure 1. Although the details of current and past plate motions in the Caribbean area are still controversial, a cursory inspection of the coastal outlines of the Antilles arc, the Puerto Rican trench and its continuation into the Cayman trench after passing between and shearing off Cuba and Haiti, gives a rather vivid indication of the present-day boundary between the North American and Caribbean plates. Towards the southwest the Cayman trough continues into the Gulf of Honduras, cleaving Central America between the Yucatan and Honduran peninsulas. On land this tectonic boundary continues and is recognized as the Polochic-Chixoy and Motagua fault systems (Figs. 1 and 2). This structural feature may originally have been formed by plate collision in the Lower Cretaceous (110 million years ago), while the left lateral motion indicated by the offset of Cuba against Haiti may have started in the Tertiary (55 million years ago). The Caribbean plate may then have collided with and been held back by the Cocos plate, while the North American continent continued to move in a westerly direction.

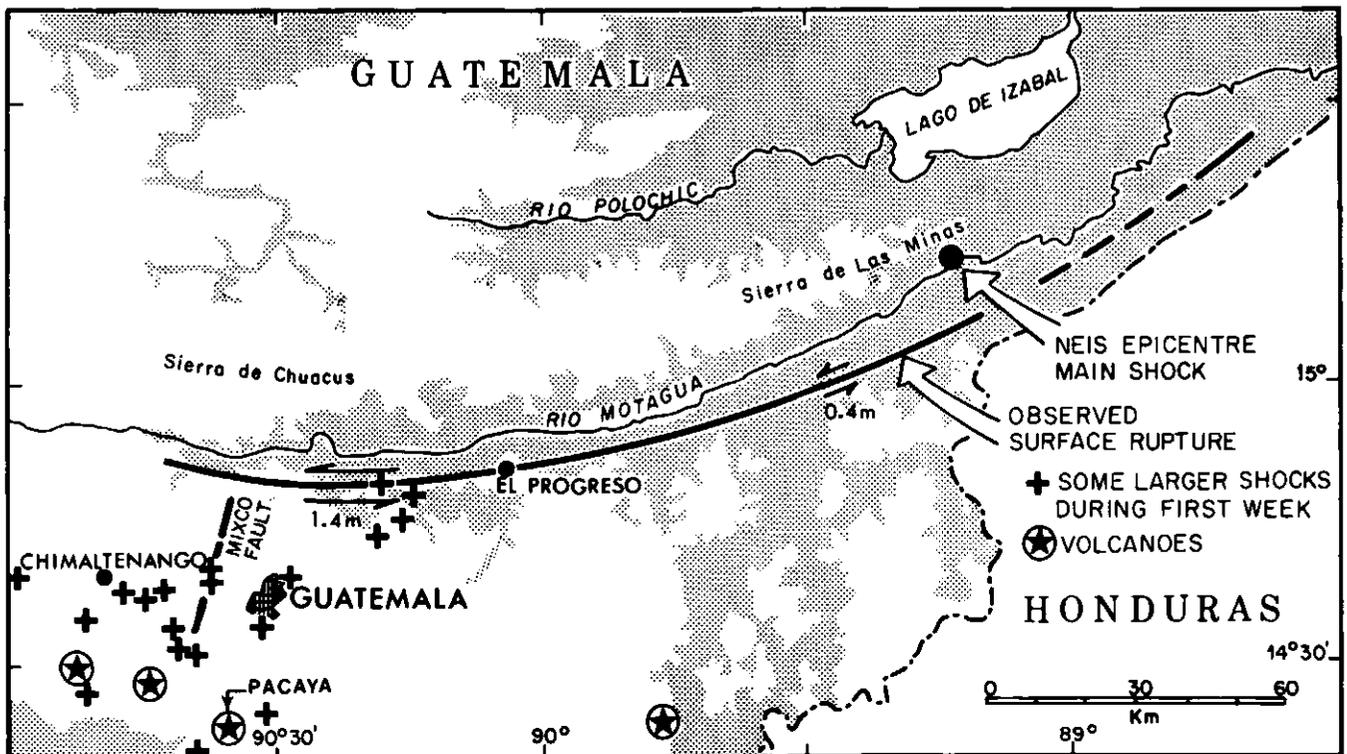
Figure 2
Diagram of Guatemalan earthquake setting.

also reported for the Mixco fault, a N-NE trending structure (see Fig. 2).

The locations of the larger aftershocks that occurred during the first week, shown in Figure 2, are only a preliminary and incomplete sample of the many hundreds of shocks during that time. These locations were obtained by our Mexican colleagues, who operated their smoker seismographs out of the observatory as headquarters (smokers are seismograph systems recording on paper smoked over a sooty flame: still considered as best quality recording by many). The epicenters in Figure 2 do not clearly define any particular tectonic structure. There is a weak suggestion of activity extending to the southwest in the general location of secondary faulting along the Mixco fault near the volcanic line. Renewed smoke eruptions of Pacaya volcano bore witness to some interaction, and seismograph systems to study this area were set up by the Venezuelan group. The severe aftershock that followed the original earthquake within two and a half days, causing wide-spread damage by knocking down previously weakened structures, was probably located there.
