Rain-Induced Landslides in the Canadian Cordillera, July 1988

S.G. Evans
 Geological Survey of Canada
 601 Booth Street
 Ottawa, Ontario K1A 0E8

Abstract

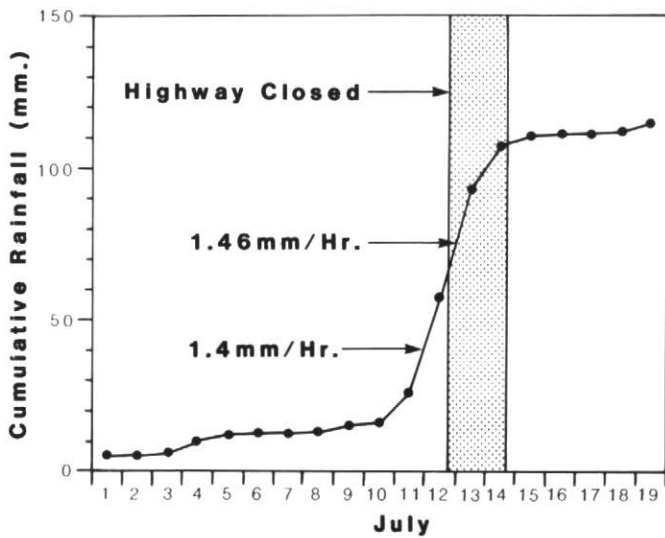
In 1988, the Alaska Highway was closed at 2000 h on July 12. It was severed in six locations by sediment-water flow processes, either by the destruction of the roadbed itself or by the deposition of material on the surface of the road (Figure 2). These flows were triggered by rainfall of 68.8 mm in 48 hours on July 12 and 13 (Figure 4). The Alaska Highway was re-opened at 1800 h on July 14, 1988.

Figure 4 Cumulative rainfall measured at Muncho Lake, July 1-19, 1988. The Alaska Highway was closed at 2000 h on July 12 and was re-opened at 1800 h on July 14.

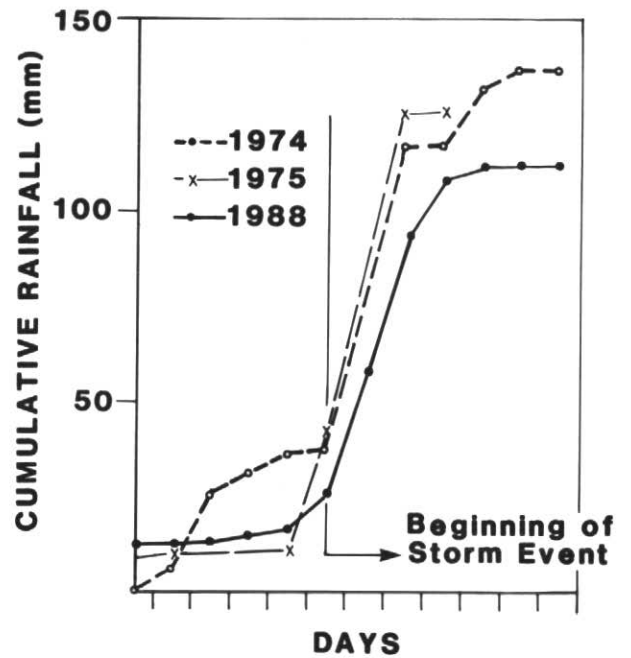
The cumulative rainfall for the 1988 event, as measured at the Muncho Lake meteorological station, is compared to the rainfall for the destructive storm events of 1974 and 1975 in Figure 5. Data for the 1979 event were unavailable. It appears that although there are substantial differences in antecedent rainfall, there is a broad similarity between the intensity and magnitude of the rainfall that triggered the debris flows.

Figure 5 Comparisons of cumulative rainfall at Muncho Lake for the 1974, 1975 and 1988 debris flow events.

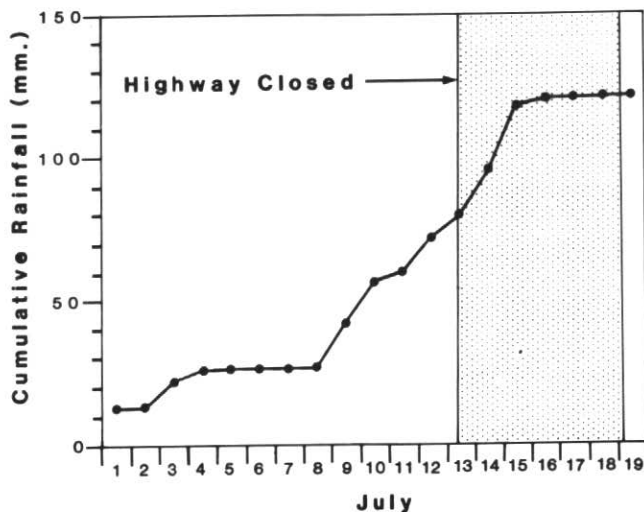
opened to the travelling public at 0100 h on July 19. Records from Burwash Landing indicate sustained rainfall from July 8 to July 15 (Figure 10). During this period 91.6 mm fell at an average rate of 13 mm/24 hours.

Figure 10 Cumulative rainfall at a Burwash Landing, July 1-19, 1988. The Alaska Highway was closed between 0315 h on July 13 and re-opened to traffic at 0100 h on July 19, 1988.
