Reassembly of a Sixteenth-Century Basque Chalupa

CHARLES D. MOORE

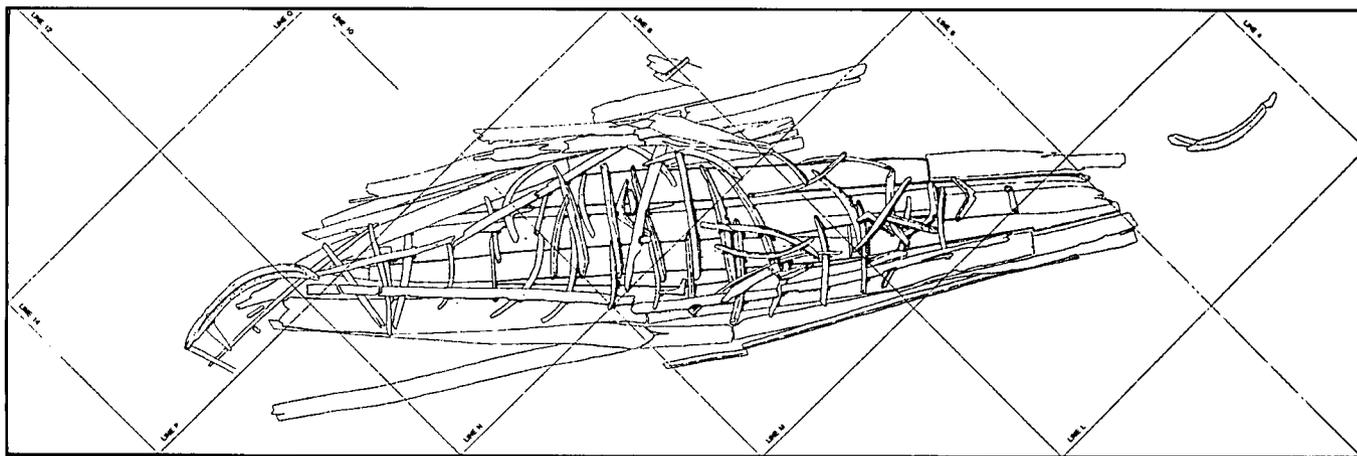
One of the chalupas recovered from Red Bay was buried under the stern quarter of the galleon and is particularly well-preserved (Fig. 1). About ninety per cent of the principal original structure is extant, including the stem, stern post, scarfed keel and mast step, in addition to most of the boat's nineteen frames and planks. A smaller proportion of the sheer wales, risers and other internal structures has survived. In late 1996 the decision was made to reassemble this boat.

Fig. 1
Site plan for the chalupa found underneath the starboard stern quarter of the Basque whaling ship believed to be the *San Juan* (D. Larsen)
