COPPER-PLATE RESTORATION FOR CHARTS OF SPANISH HYDROGRAPHIC INSTITUTE

Lieutenant (H) Manuel de la HERA PACHECO.

Cartography Sub-Section, Cadiz, 15th December 1949.

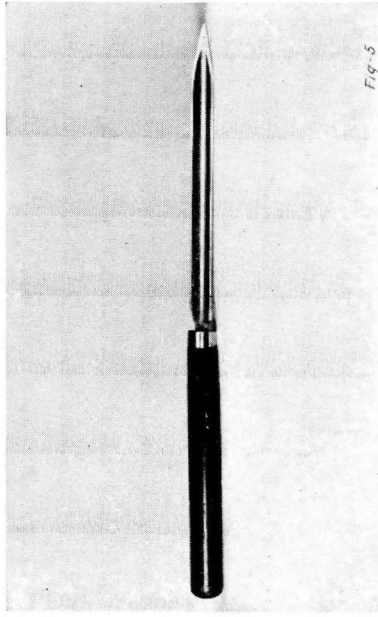
FIG. 5. — The Scraper.

Equipment consisted of a steel scraper and linden-tree charcoal, both essential in the acquisition of a smooth finish. With the scraper (Fig. 5) the burrs could be smoothed out quickly with no great trouble apart from keeping within the damaged areas so as not to rub out the neighbouring unaffected sections, and avoiding too close a scraping of the upper surface which would result in a widening and deepening of the grooves.
