Building Stones of Canada's Federal Parliament Buildings

D.E. Lawrence
Geological Survey of Canada
 601 Booth Street
 Ottawa, Ontario K1A 0E8
 lawrence@nrcan.gc.ca

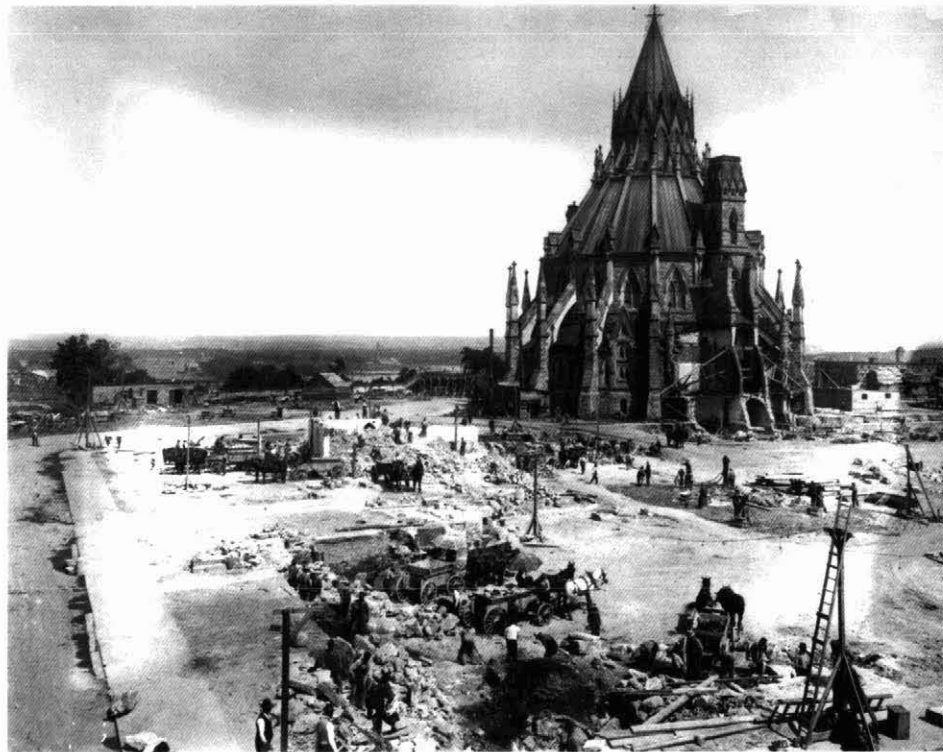
Figure 3 Preparation of Parliament Hill for reconstruction of the Centre Block, 15 August 1916. Workmen with horse teams are removing the last of the rubble from the foundations of the former building. In the middle ground, in front of the Library, another crew is drilling blast holes for foundation excavations. Only the Parliamentary Library remains intact. Its shored up entrance, which connected it to the Centre Block, can be seen beyond the drilling crew. National Archives of Canada PA130624.

The reconstructed Centre Block had its beginnings with the destruction of the original building. The February 1916 fire started in the Parliamentary Reading Room, ravaged the Centre Block and Victoria Tower, and killed 7 people. Only the Library was spared (Fig. 3). At first it was thought that the facade of the original Centre Building could be saved; however, following investigation of the walls and foundations, it was deemed that this would be imprudent and unsafe. The reconstruction for the Centre Block began almost immediately, and by the fall of 1916 was well underway (Fig. 4).

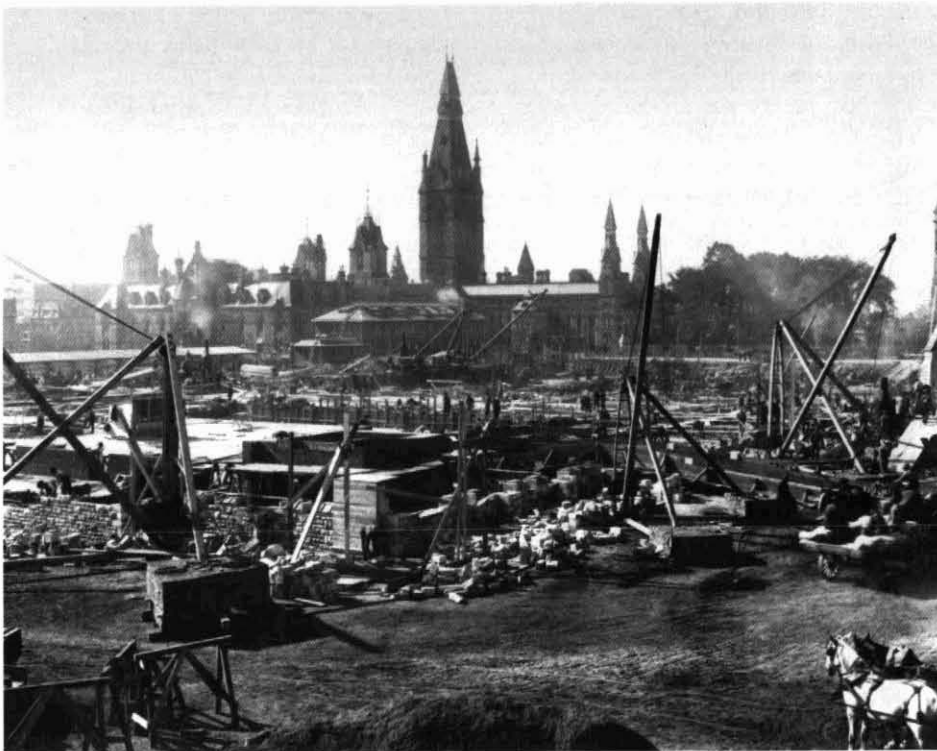
Figure 4 View looking southwest showing the early stages of the reconstruction of the Centre Block. Beyond the construction on the left is the stone cutting shed and to the right the architect's offices. The West Block is in the background. Photo taken 26 September 1916. National Archives of Canada C6361.

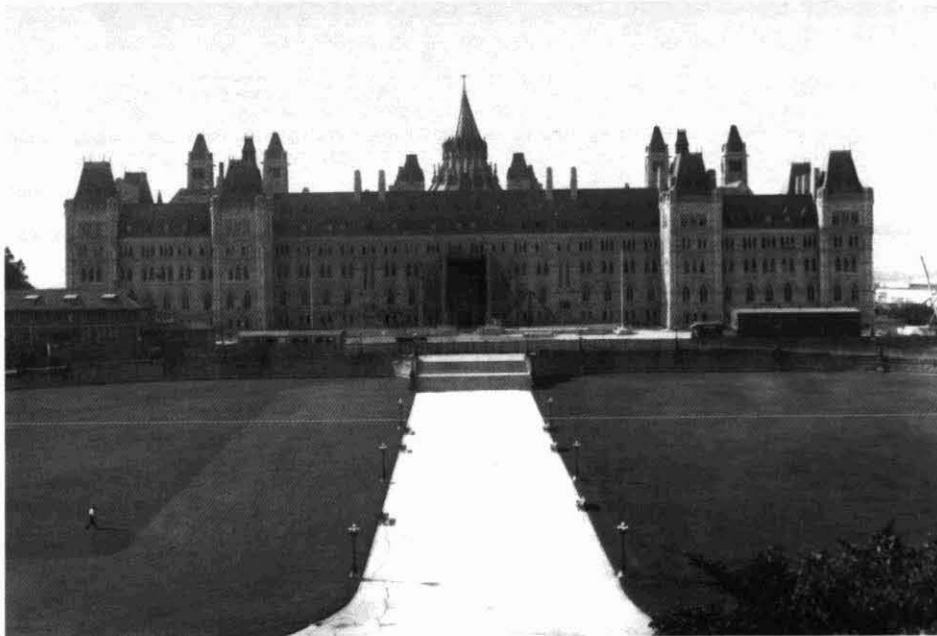
Figure 12 The nearly completed Centre Block, in 1919. Construction of the Peace Tower had not been started at this time. The stone masons' shed and the architect's site office can be seen on the left in front of the building. W.J. Topley, National Archives of Canada PA 12925.

The unfinished Centre Block was officially opened on 26 February 1920 (Fig. 12).

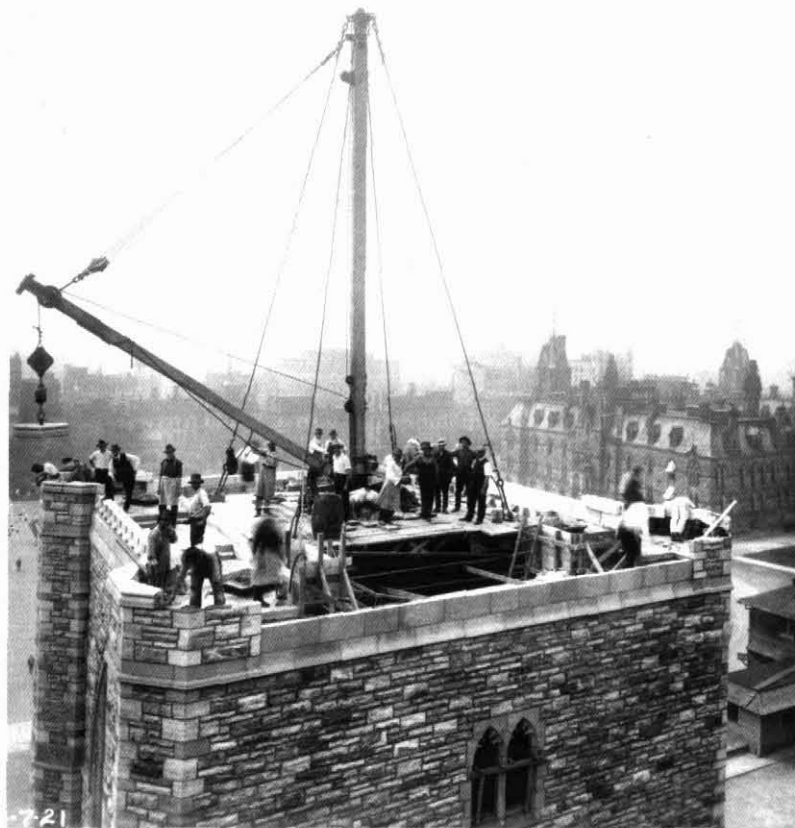
Figure 13 Stone masons at work on the Peace Tower, 4 June 1921. Note the concrete forms and the derrick used to lift and place the stone. The photo was taken from the almost completed Centre Block. The temporary building in the right foreground is the architect's office. The West Block can be seen in the background. National Archives of Canada, C38750.

Following Pearson's departure, the Department of Public Works took charge of the construction of the tower, then at the 46 m level (Fig. 13). It remained at this level for the next 2 years while claims for additional fees from contractors and architects were being disputed. Fortunately, Pearson was retained under a new agreement, to design and supervise the completion of the tower. His plans and estimate of \$546,171 to complete the tower were approved in January 1924.

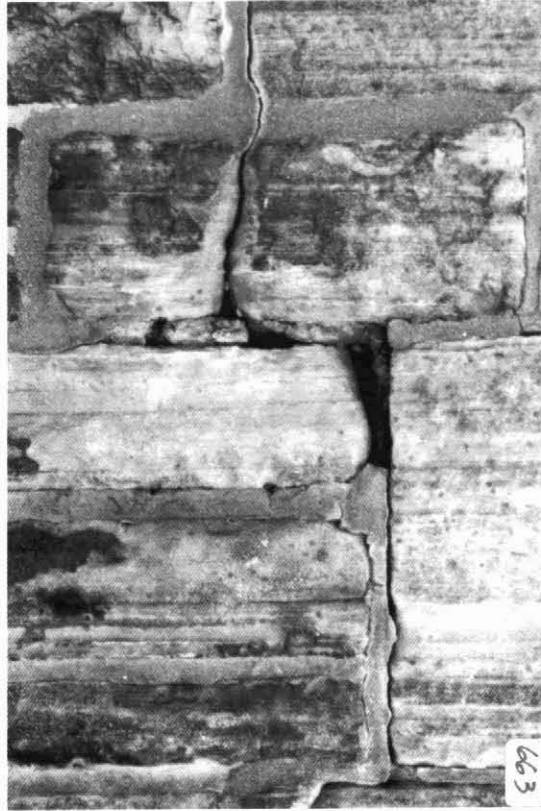
Figure 15 Deterioration of mortar due to freeze/thaw cycling. Note the adjacent Nepean Sandstone, heavily soiled in part, has also suffered. Cracked mortar and stone facilitated further entry of moisture. PWGSC, 1995.

through the stone (Fig. 15). When this moisture freezes near the outside surface of the stone it expands, building up stresses which cause exfoliation of the surface (Keith Blades, personal communication, September 2000). Although sulphate pollution has diminished with the removal of a paper mill formerly situated on the Ottawa River just upstream from Parliament Hill, carbon dioxide pollution has increased. Silica-bound atmospheric dirt is particularly noticeable on the Ohio Sandstone.

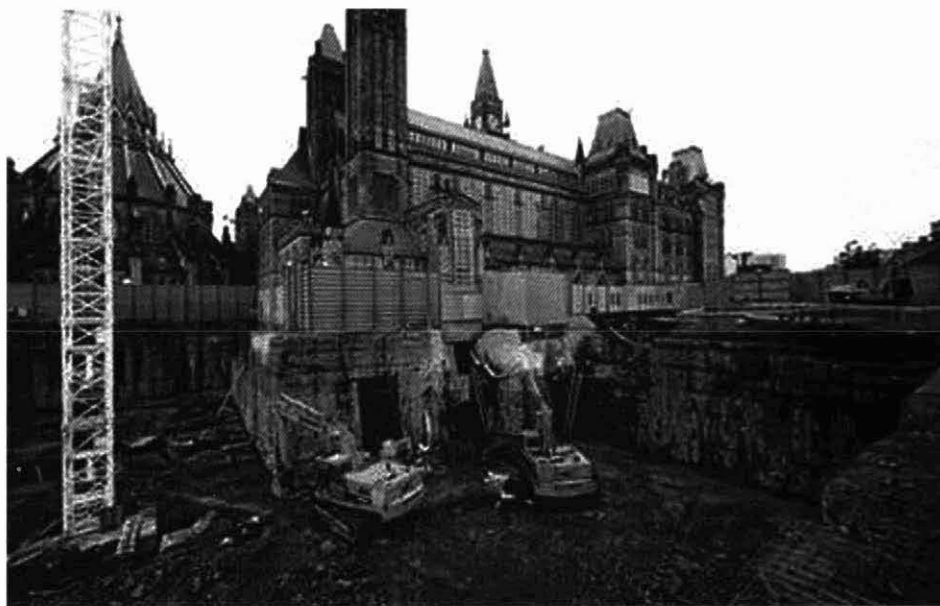
Figure 17 Excavation for the Centre Block Underground Services space (CBUS) involved the removal of about 30,000 m³ of rock during a 3-month period in 1997. PWGSC 1997.

A 2-storey underground space approximately 50 x 40 m, called the Centre Block Underground Services (CBUS), was excavated on the north side of the Centre Block (Fig. 17). An innovative system of monitored and controlled blasting was carried out. This was done without disruption to existing heritage
