RADIO AIDS TO HYDROGRAPHIC SURVEYING AT LIVERPOOL (*)

by Lieutenant Commander D. J. KNIGHT, R.N. (Ret'd.), A.R.I.C.S.

Assistant Marine Surveyor and Water Bailiff
Mersey Docks and Harbour Board

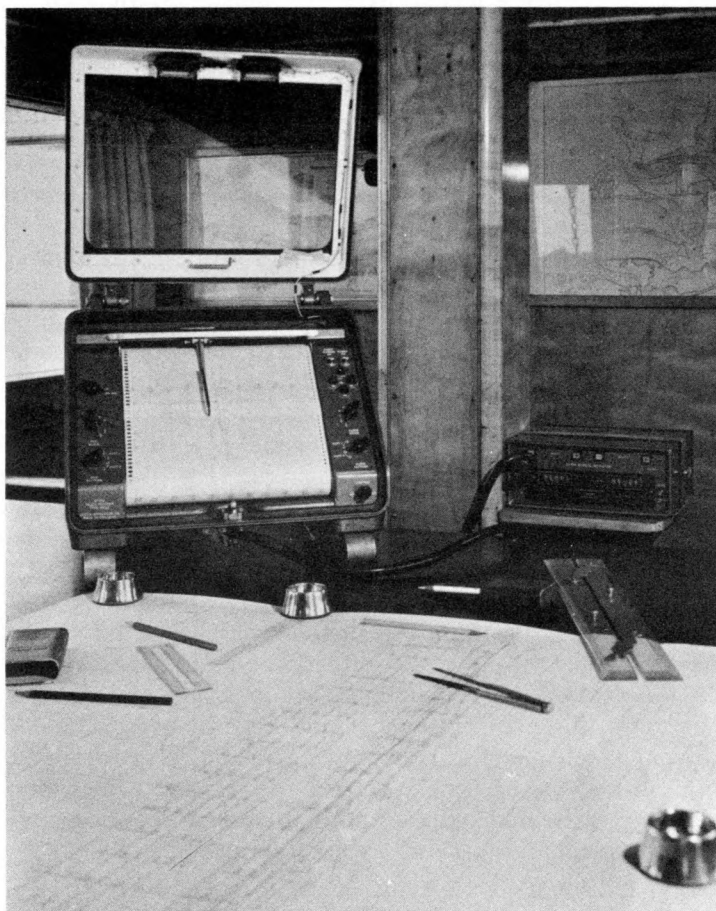
FIG. 2. — Remote display and Hi-Fix track plotter in S.T. *Vigilant*.

The actual trial was carried out in June, 1960, with a receiver fitted to the salvage/surveying tender *Vigilant* (figure 2). As anticipated, visibility was poor throughout the trials, and for a week varied between two and four miles. This enabled fixing to be carried out in the various areas but not all on the same day and, in the vicinity of the Tongue Beacon, resort had to be made to fixing by bearing and distance from the beacon instead of fixing on three shore marks.
